**ACCIDENT**

<b>Aircraft Type and Registration:</b>	Reims Cessna F172N, G-LTEE	
<b>No &amp; Type of Engines:</b>	1 Lycoming O-320-H2AD piston engine	
<b>Year of Manufacture:</b>	1978 (Serial no: 1772)	
<b>Date &amp; Time (UTC):</b>	5 May 2014 at 1339 hrs	
<b>Location:</b>	Fairoaks Airport, Surrey	
<b>Type of Flight:</b>	Private	
<b>Persons on Board:</b>	Crew - 1	Passengers - 1
<b>Injuries:</b>	Crew - 1 (Minor)	Passengers - 1 (Minor)
<b>Nature of Damage:</b>	Damage to left wing spar, wing and body panels, tail, propeller and windscreen	
<b>Commander's Licence:</b>	Private Pilot's Licence	
<b>Commander's Age:</b>	55 years	
<b>Commander's Flying Experience:</b>	113 hours (of which 7 were on type) Last 90 days - 10 hours Last 28 days - 3 hours	
<b>Information Source:</b>	Aircraft Accident Report Form submitted by the pilot and further enquiries by the AAIB

**Synopsis**

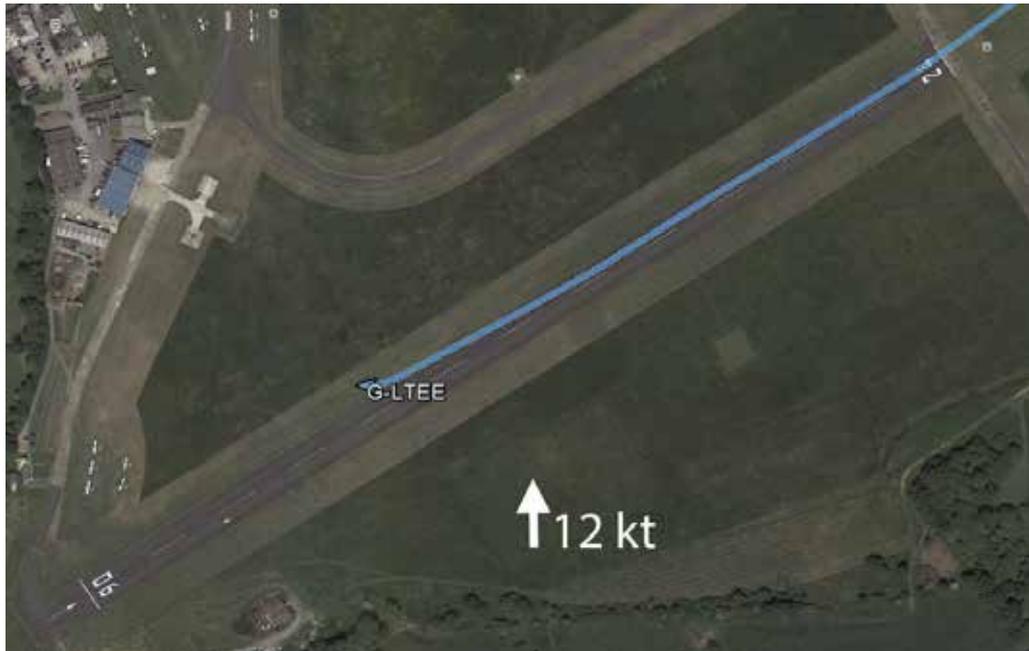
**Figure 1**

centreline and the pilot initially allowed the aircraft to decelerate without touching the brakes. At about 320 m from the runway threshold, the aircraft started to drift to the right<sup>1</sup> (Figure 1); this was possibly coincident with initial brake application. The pilot applied left rudder but the aircraft continued to drift to the right and departed the runway surface at about 30 kt. The ground was soft and boggy causing the aircraft to decelerate quickly as the nosewheel ploughed the ground to a depth of about 30 cm. Just as the aircraft was about to stop it pitched forwards onto its back. The pilot and his passenger were left hanging upside down but were able to release their harnesses and exit through the doors.

Aircraft ground track from GPS data (*image ©Google Earth*)
