INCIDENT

Aircraft Type and Registration:	Airbus A340-311, G-VAEL
No & Type of Engines:	4 CFM56-5C2 turbofan engines
Year of Manufacture:	1993
Date & Time (UTC):	30 April 1995 at 0407 hrs
Location:	Over Liège, Belgium
Type of Flight:	Public Transport
Persons on Board:	Crew - Not known Passengers - Not known
Injuries:	Crew - None Passengers - None
Nature of Damage:	Car destroyed, building roof and ceiling damaged
Commander's Licence:	Airline Transport Pilot's Licence
Commander's Age:	49 years
Commander's Flying Experience:	14,500 hours (of which 250 hours were on type) Last 90 days - 202 hours Last 28 days - 54 hours
Information Source:	Request by Belgian authorities and inquiries and inspection by the AAIB

Potable Water System

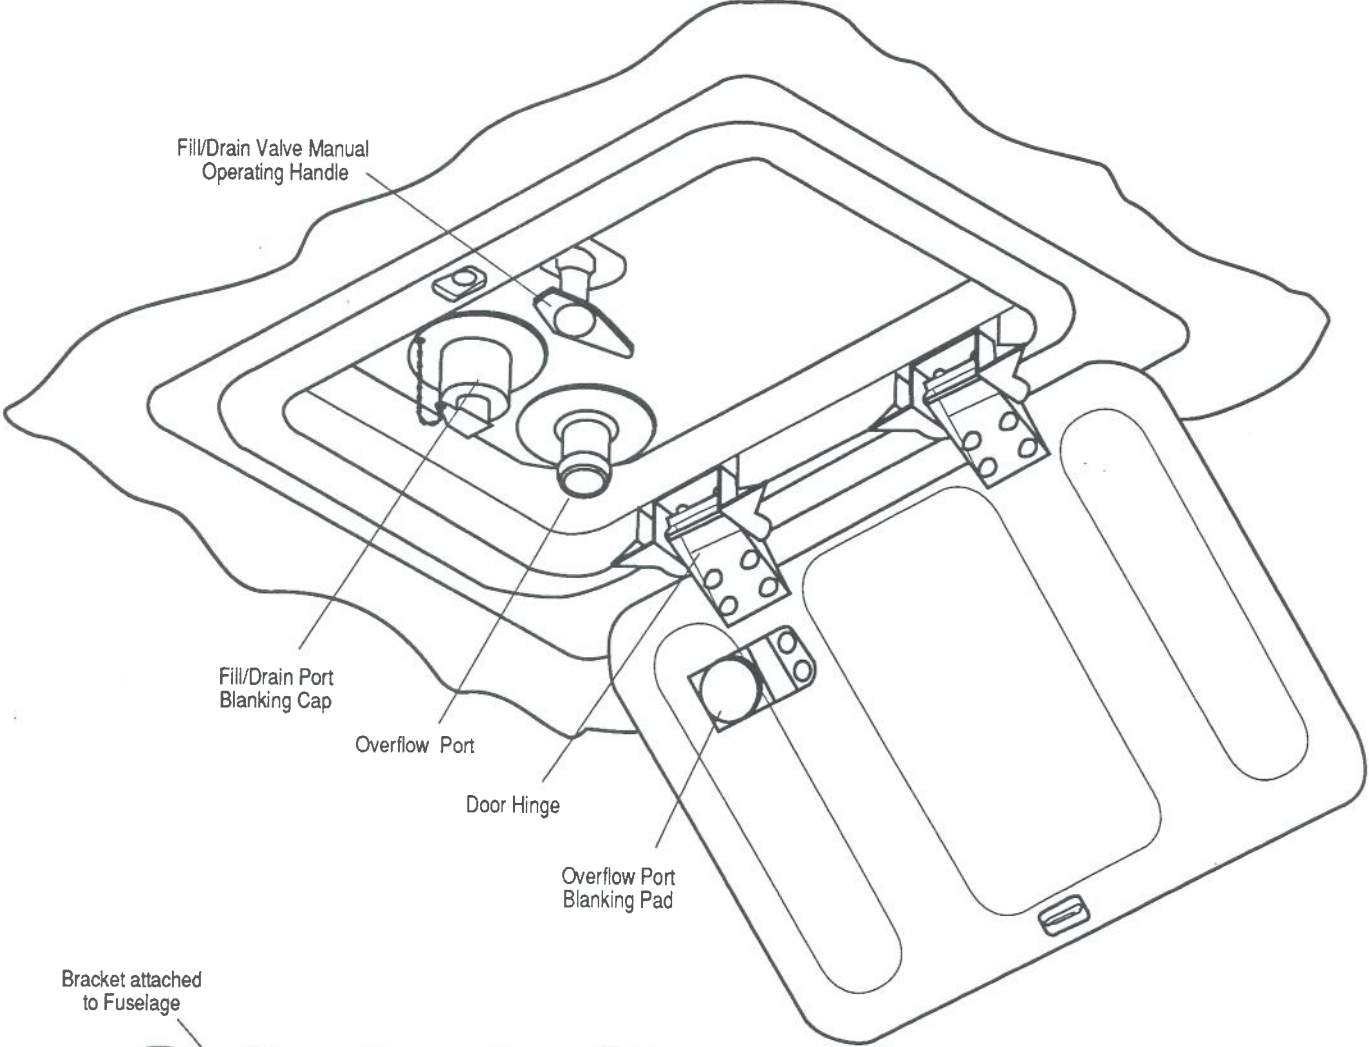
POTABLE WATER SERVICING PANEL

The normal filling point for the system is at a port in a Water Servicing Panel (Fig 2) located in the lower rear fuselage. The port comprises a protruding open-ended pipe with an external land formed near its end. The pipeline from the port branches into two and passes to the bottom of each tank, via a Fill/Drain valve in each branch. The Fill/Drain line can also be connected, via a Filling Line Drain Valve, to a drain port in an Aft Drain Panel located in the fuselage undersurface, and additional Drain Valves allow the tanks to be isolated from the

The quantity of water that could be released into the Water Servicing Panel through a leaking Aft Overflow Valve would appear to depend on the aircraft attitude. On the ground it would be limited to the reported 2 ltr capacity of the overflow line between the Aft Tank and the Overflow Valve; this line could possibly remain partially full after manual tank replenishment, or after normal replenishment should a malfunction allow an overflow to occur before the system automatically shut off the valves. It appeared possible that the potential quantity would be much greater with the aircraft in a nose up attitude, particularly if tanks were fairly full, as the raising of the Forward Tanks relative to the Aft Tank causes water to transfer rearwards through the interconnecting feed line and thence into the aft overflow line (Fig 1.2). Reports suggested that such a transfer would occur during cruise, typically with a 2 to 3° nose up body angle, while tanks were fairly full. The manufacturer considered that the addition of a water-tight blanking cap at the Overflow Port was not possible, because of a need to maintain consistency with the Aft Drain Panel Overflow Port. To prevent possible ice build-up in the Water Servicing Panel in the event of Overflow Valve leakage, a mandatory modification is to be introduced to replace the Overflow Port blanking pad with a drain funnel intended to pass any water leaking from the Overflow Port overboard and to increase the drainage provision in the door.

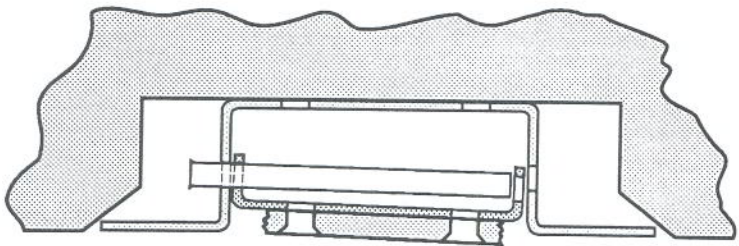
Door Hinge Section (Pin disengaged)

Two sample A340 aircraft (one of which was G-VAEL) inspected during maintenance checks in September 1995 required replacement of the Aft Fill/Drain/Overflow Valve due to leakage. No Fill/Drain Port cap or lanyard was present at the panel in either case. One of the aircraft required replacement of a Water Servicing Panel door hinge due to its partial separation, the hinge pin having migrated axially and disengaged from both the fuselage and the door brackets at one side (Fig 3.3).

Some information suggested that in previous cases ice build-up in the Servicing Panel in-flight due to water leakage past the valves may have inflicted mechanical damage to the door attachments resulting in detachment of the door. However, examination of the failed hinge noted above suggested that partial failure of a hinge in normal service was also a distinct possibility. The 4.93 mm diameter pin normally protruded marginally beyond the fixed bracket, by approximately 0.5 mm, and had been slightly swaged at either end to retain the pin axially (Fig 2). This had produced an end diameter at one end of 5.11 mm, which marginally prevented the end from passing through the bracket holes, but the end which had migrated out had a diameter of only 5.00 mm, allowing it to migrate readily through the brackets. No distress was apparent suggestive of forcible pin migration. Wear markings indicated that the pin may have been in its partially disengaged position for an appreciable period of operation. Further migration of the pin sufficient to disengage it from the other side of the hinge as well would probably be prevented by the surrounding structure but partial disengagement could result in overloading of hinge elements.

The evidence indicated that while some of the cases of door loss could have been due to ice build-up in the Water Servicing Panel, this could not have been the situation in at least one case, where the door detached at low level on departure from Hong Kong. The marginal means of hinge pin retention noted above indicated that pin disengagement from the hinge could have been a factor in some cases. The manufacturer is to introduce mandatory modification to alter the door catch arrangement and to replace the swaged hinge pins with longer pins retained by a split pin at either end.

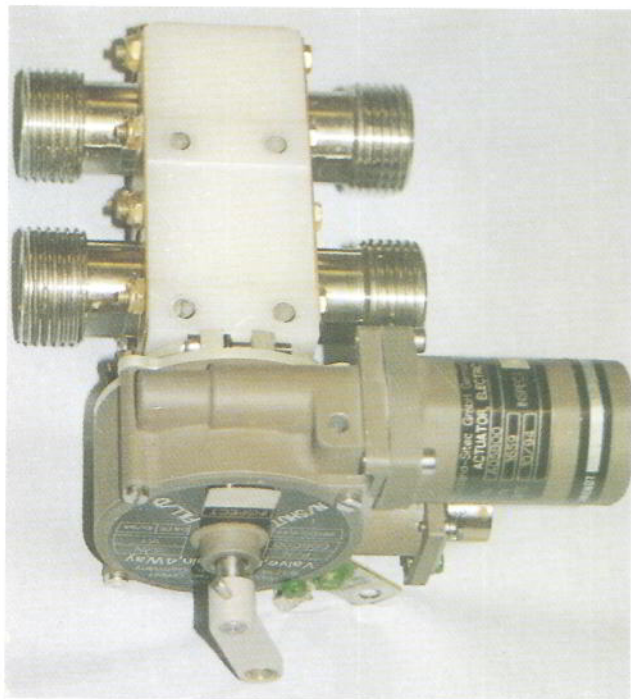
3.2 Fill/Drain/Overflow Valve

The Fill/Drain Valves are ball type valves (Fig 3.2), each consisting of a rotatable bored stainless steel ball contained inside a plastic body provided with two ports. The Fill/Drain and Overflow valves associated with each tank are ganged together and are operated in unison by an electric motorised actuator, via an overload clutch, or manually via a teleflex cable drive from a manual handle. Ball travel is restricted by actuator limit switches, or by mechanical stops when the valve pair is operated manually.

Examination of one of the above rejected valves (MSN 151 from G-VAEL) confirmed that the Overflow Valve leaked when fully closed and revealed that the valve ball was loose in its body and exhibited gross play on the operating spindle. A manufacturer's defect investigation report is awaited. It was also noticeable that there was a relatively small amount of overtravel of the Fill/Drain Valve ball in its body from the point of flow cut-off to the point where the actuator closed limit switch operated, measured at 2.5 mm at the manual operating cable connection point, equivalent to 5° of lever and ball

Freezing is also considered to have caused many of the Fill/Drain/Overflow Valve problems; signs of mechanical damage consistent with the effects of freezing, such as bent flanges, have reportedly been found on most of the failed valves. The addition of valve port heater cuffs did not apparently prevent water freezing in the valve in all situations, reportedly because of incorrect location of the temperature sensor controlling the cuff, and further action to modify the sensor location has been carried out. The manufacturer reportedly intends to optimise the protection of the valve by further action to ensure correct sensor location.
