ACCIDENT

Aircraft Type and Registration:	Acrosport 2, G-CGAK	
No & Type of Engines:	1 Lycoming O-360 A1A piston engine	
Year of Manufacture:	2010	
Date & Time (UTC):	20 August 2011 at 1236 hrs	
Location:	Duxford Airfield, Cambridgeshire	
Type of Flight:	Private	
Persons on Board:	Crew - 1	Passengers - 1
Injuries:	Crew - None	Passengers - None
Nature of Damage:	Damage to the right landing gear, wing and propeller. , engine shock-loaded	
Commander's Licence:	Private Pilot's Licence	
Commander's Age:	55 years	
Commander's Flying Experience:	2,821 hours (of which 70 were on type) Last 90 days - 29 hours Last 28 days - 7 hours	
Information Source:	Aircraft Accident Report Form submitted by the pilot and AAIB enquiries

Synopsis

Following a normal landing, the right landing gear collapsed during the ground roll as a result of a failure of the right landing gear cross-strut.

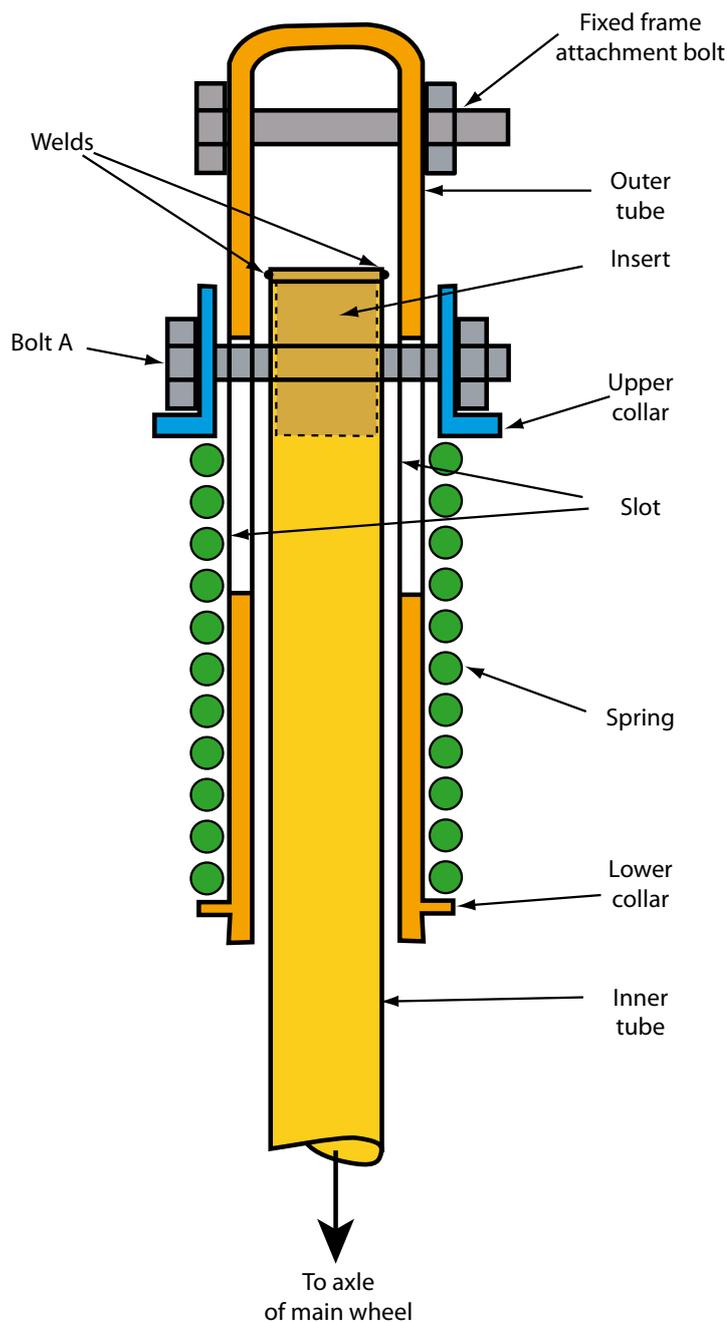
Figure 2

tube which is connected to a fixed frame at the fuselage. See Figure 2. A spring is fitted over the outside of the outer tube and is retained in place by a lower collar welded to the tube and an upper collar which is held in place by Bolt 'A'. Bolt 'A' passes through a slot in the outer tube and a hole in the inner tube and insert. As the landing leg moves outwards, the inner tube moves downwards causing the upper collar to compress the spring. On G-CGAK an insert had been welded in two positions into the end of the inner tube in order to increase the maximum 'tear out' force that the tube could sustain.

Schematic drawing of the cross-strut
