SERIOUS INCIDENT

Aircraft Type and Registration:	Rockwell Commander 112TC, G-BLTK	
No & Type of Engines:	1 Lycoming TO-360-C1A6D piston engine	
Year of Manufacture:	1976	
Date & Time (UTC):	19 August 2009 at 1046 hrs	
Location:	Blackbushe Airport, Surrey	
Type of Flight:	Private	
Persons on Board:	Crew - 2	Passengers - None
Injuries:	Crew - None	Passengers - N/A
Nature of Damage:	Damage to propeller and possible engine shock-loading	
Commander's Licence:	Private Pilot's Licence	
Commander's Age:	53 years	
Commander's Flying Experience:	805 hours (of which 136 were on type) Last 90 days - 0 hours Last 28 days - 0 hours	
Information Source:	Aircraft Accident Report Form submitted by the pilot and further enquiries by the AAIB

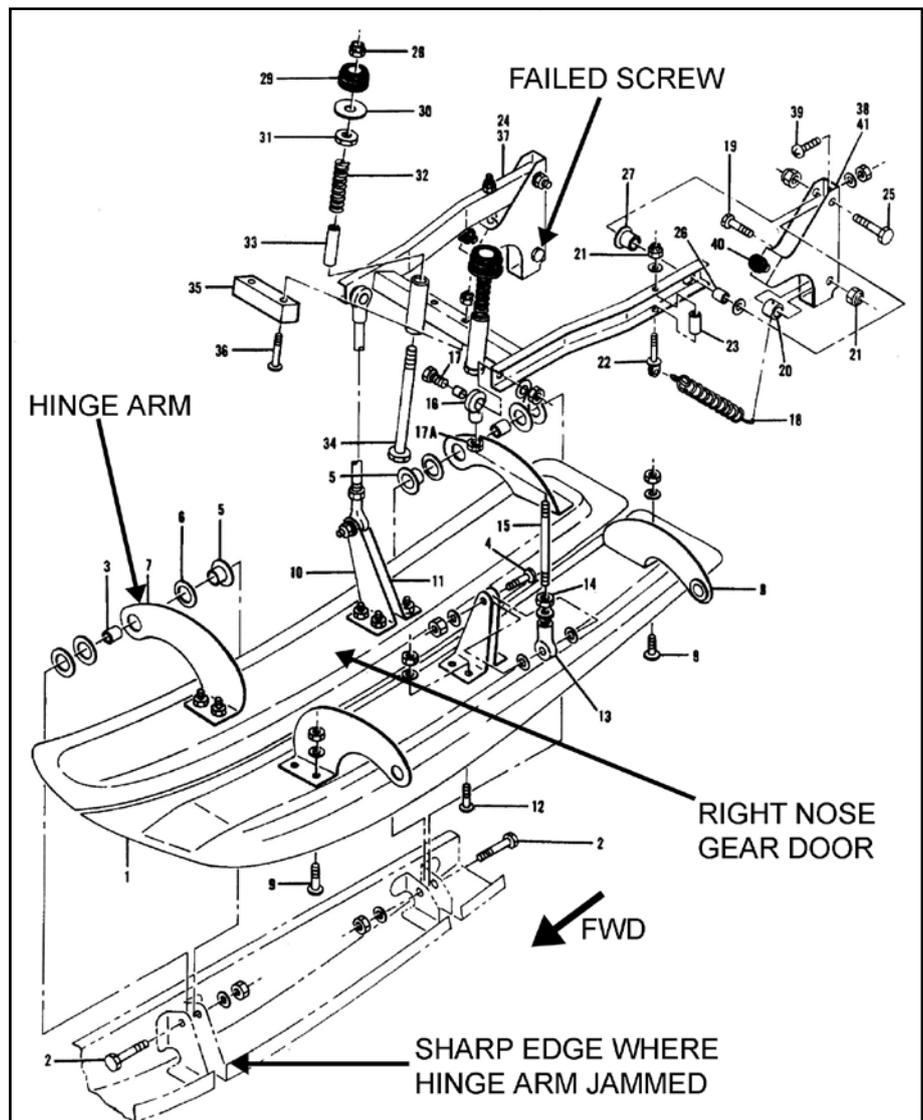
Figure 1

A Licensed Aircraft Engineer examined the aircraft and determined that the nose gear had failed to extend because the right nose gear door had jammed near its hinge. He also discovered that a screw which attached the right lower engine cowling to the nose gear structure had failed in shear

(see Figure 1). This would have caused the engine cowling to drop slightly and to move the right nose gear door. The door hinge operates in a narrow slot with sharp edges (see Figure 1) and a slight movement of the door could cause it to jam at the hinge. The engineer could not determine what had caused the screw to fail, but said that it was also possible that the screw had failed as a consequence of the door not opening, and the force of the nose gear actuator sheared the screw.

Nose gear door installation on G-BLTK

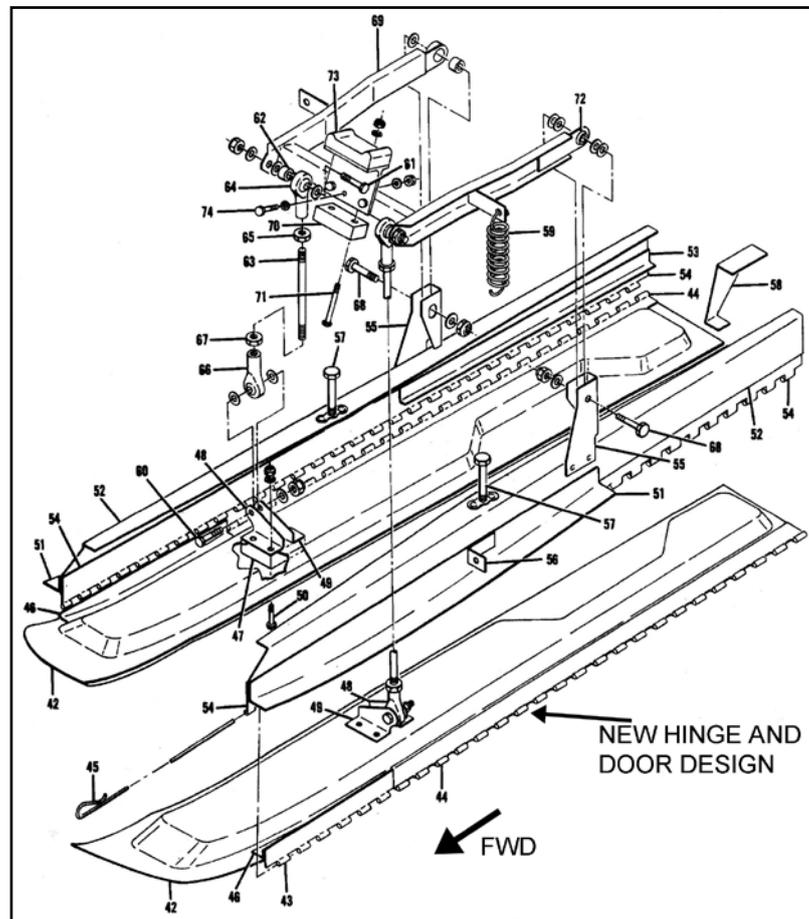
Figure 2

Modified Nose gear door installation fitted to Model 112B-500 and subsequent serial numbers and Model 112TCA-13150 and subsequent serial numbers

Later models of the Rockwell Commander 112 were fitted with nose gear doors that had a ‘piano-wire’ hinge (see Figure 2). This type of hinge would not have jammed in the same manner as the original design.
