No: 9/91

Ref: EW/C91/4/2

**Aircraft Type and Registration:** Boeing 757-23A, G-OOOH  
**No & Type of Engines:** 2 Rolls-Royce RB 211-535E4 turbofan engines  
**Year of Manufacture:** 1989  
**Date & Time (UTC):** 15 April 1991 at 1718 hrs  
**Location:** London Gatwick Airport  
**Type of Flight:** Public Transport  
**Persons on Board:** Crew - N/K Passengers - N/K Total 227  
**Injuries:** Crew - None Passengers - None  
**Nature of Damage:** Left nose wheel broken-up and nose wheel axle damaged  
**Commander's Licence:** Airline Transport Pilot's Licence  
**Commander's Age:** 42 years  
**Commander's Flying Experience:** 6,900 hours (of which 155 hours were on type)  
**Information Source:** AAIB Field Investigation

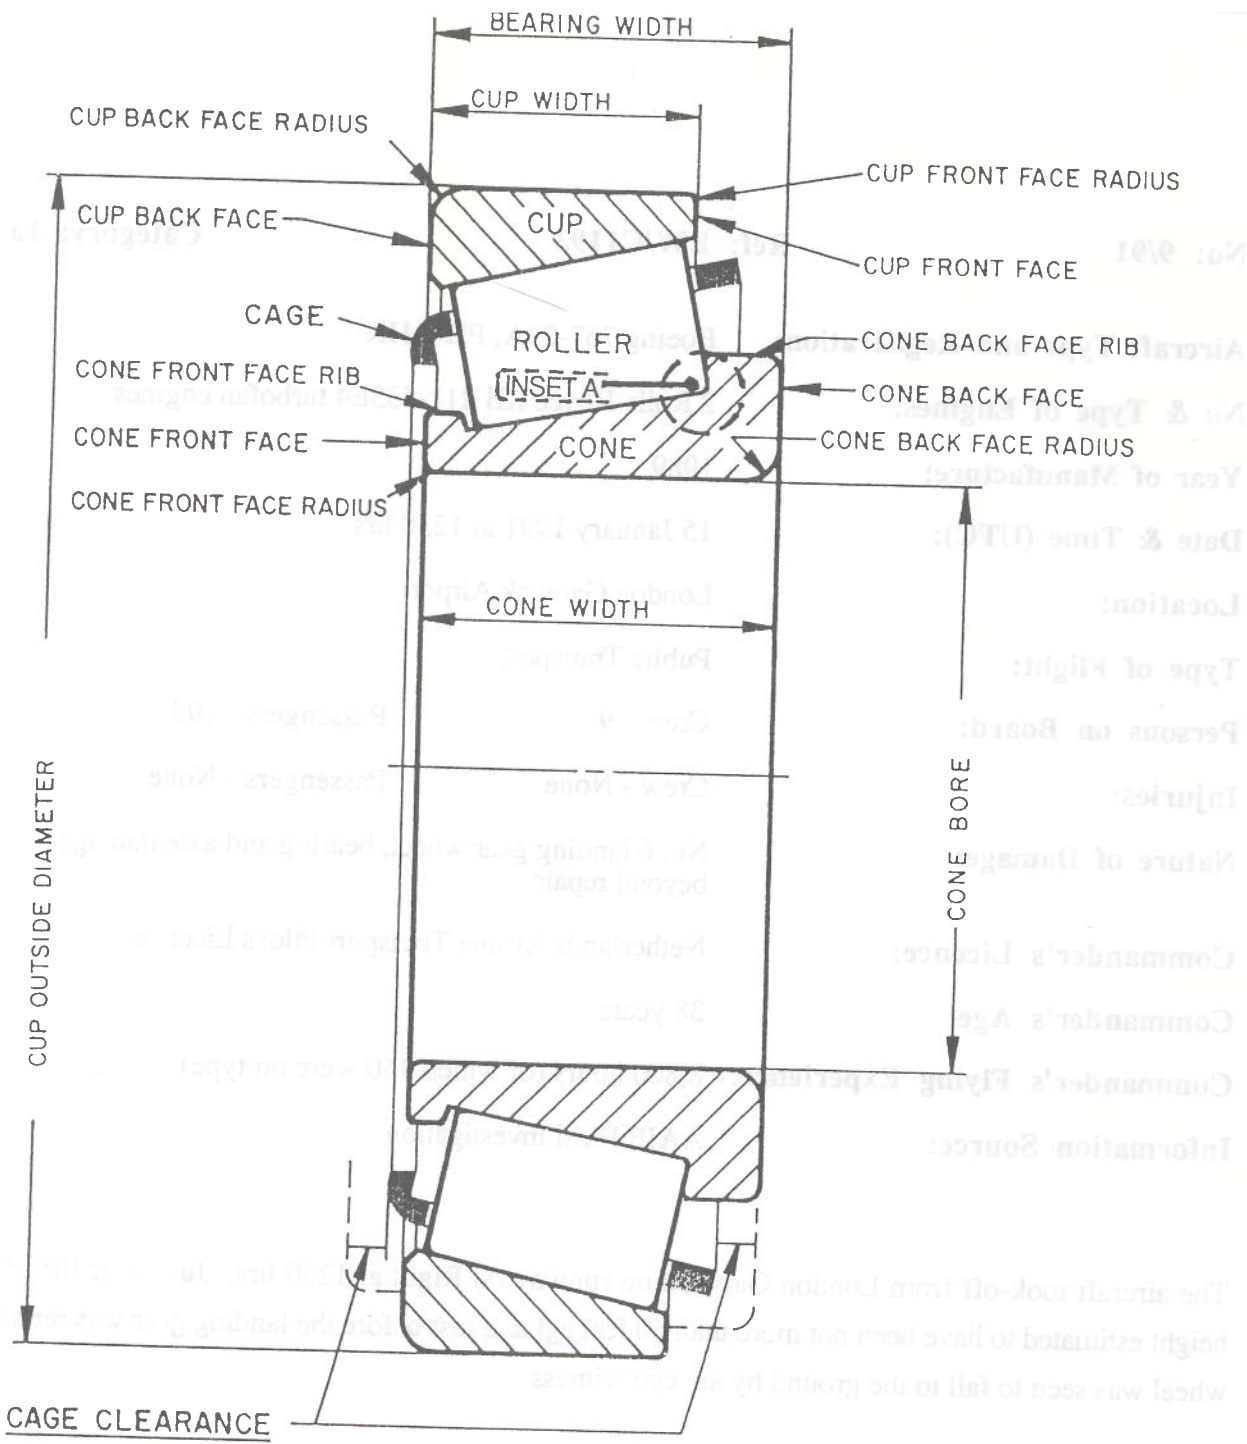
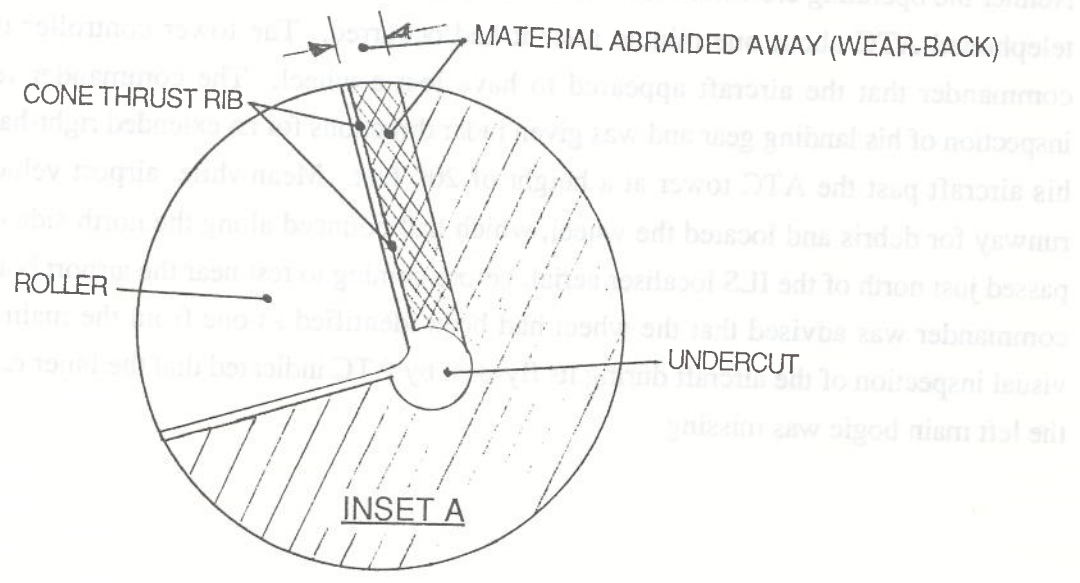
**ILLUSTRATED ROLLER BEARING**

The outboard bearing had suffered severe frictional heat deformation at the cone thrust rib, cage failure and subsequent hub failure. Due to the severe damage it was difficult to obtain conclusive evidence as to the cause. However a small section of the cone thrust rib was visible and showed considerable 'wear-back' prior to the final bearing collapse. This wear-back was a good indication that there had been insufficient quantity/quality of lubricant between the roller end face and the rib face which had allowed metal-to-metal contact with the resultant extreme wear. The bearing section is shown in the accompanying diagrams.

It is thus considered that the damage evident on the remains of the outboard bearing had occurred as a result of water contamination, with possible formate and acetate formation, which had degraded the grease. This water contamination had probably caused pitting of the bearing surfaces which could have resulted in 'rough-running' and vibration, inducing wear at the outboard cone rib/roller end, which would have produced excessive clearance and culminated in the rollers and cage "rolling-out" from between the tracks.
