EXTRACT OF RECORDING OF RADIOCOMMUNICATION.

This is the transcript of radiocommunication on frequency 131.10 Mhz between Brussels ACC (Airways) and the aircraft G-APEC (BEA LINE 706).

Concluding section of track of G-APEC on 2<sup>nd</sup> October 1971  
derived from flight recorder data

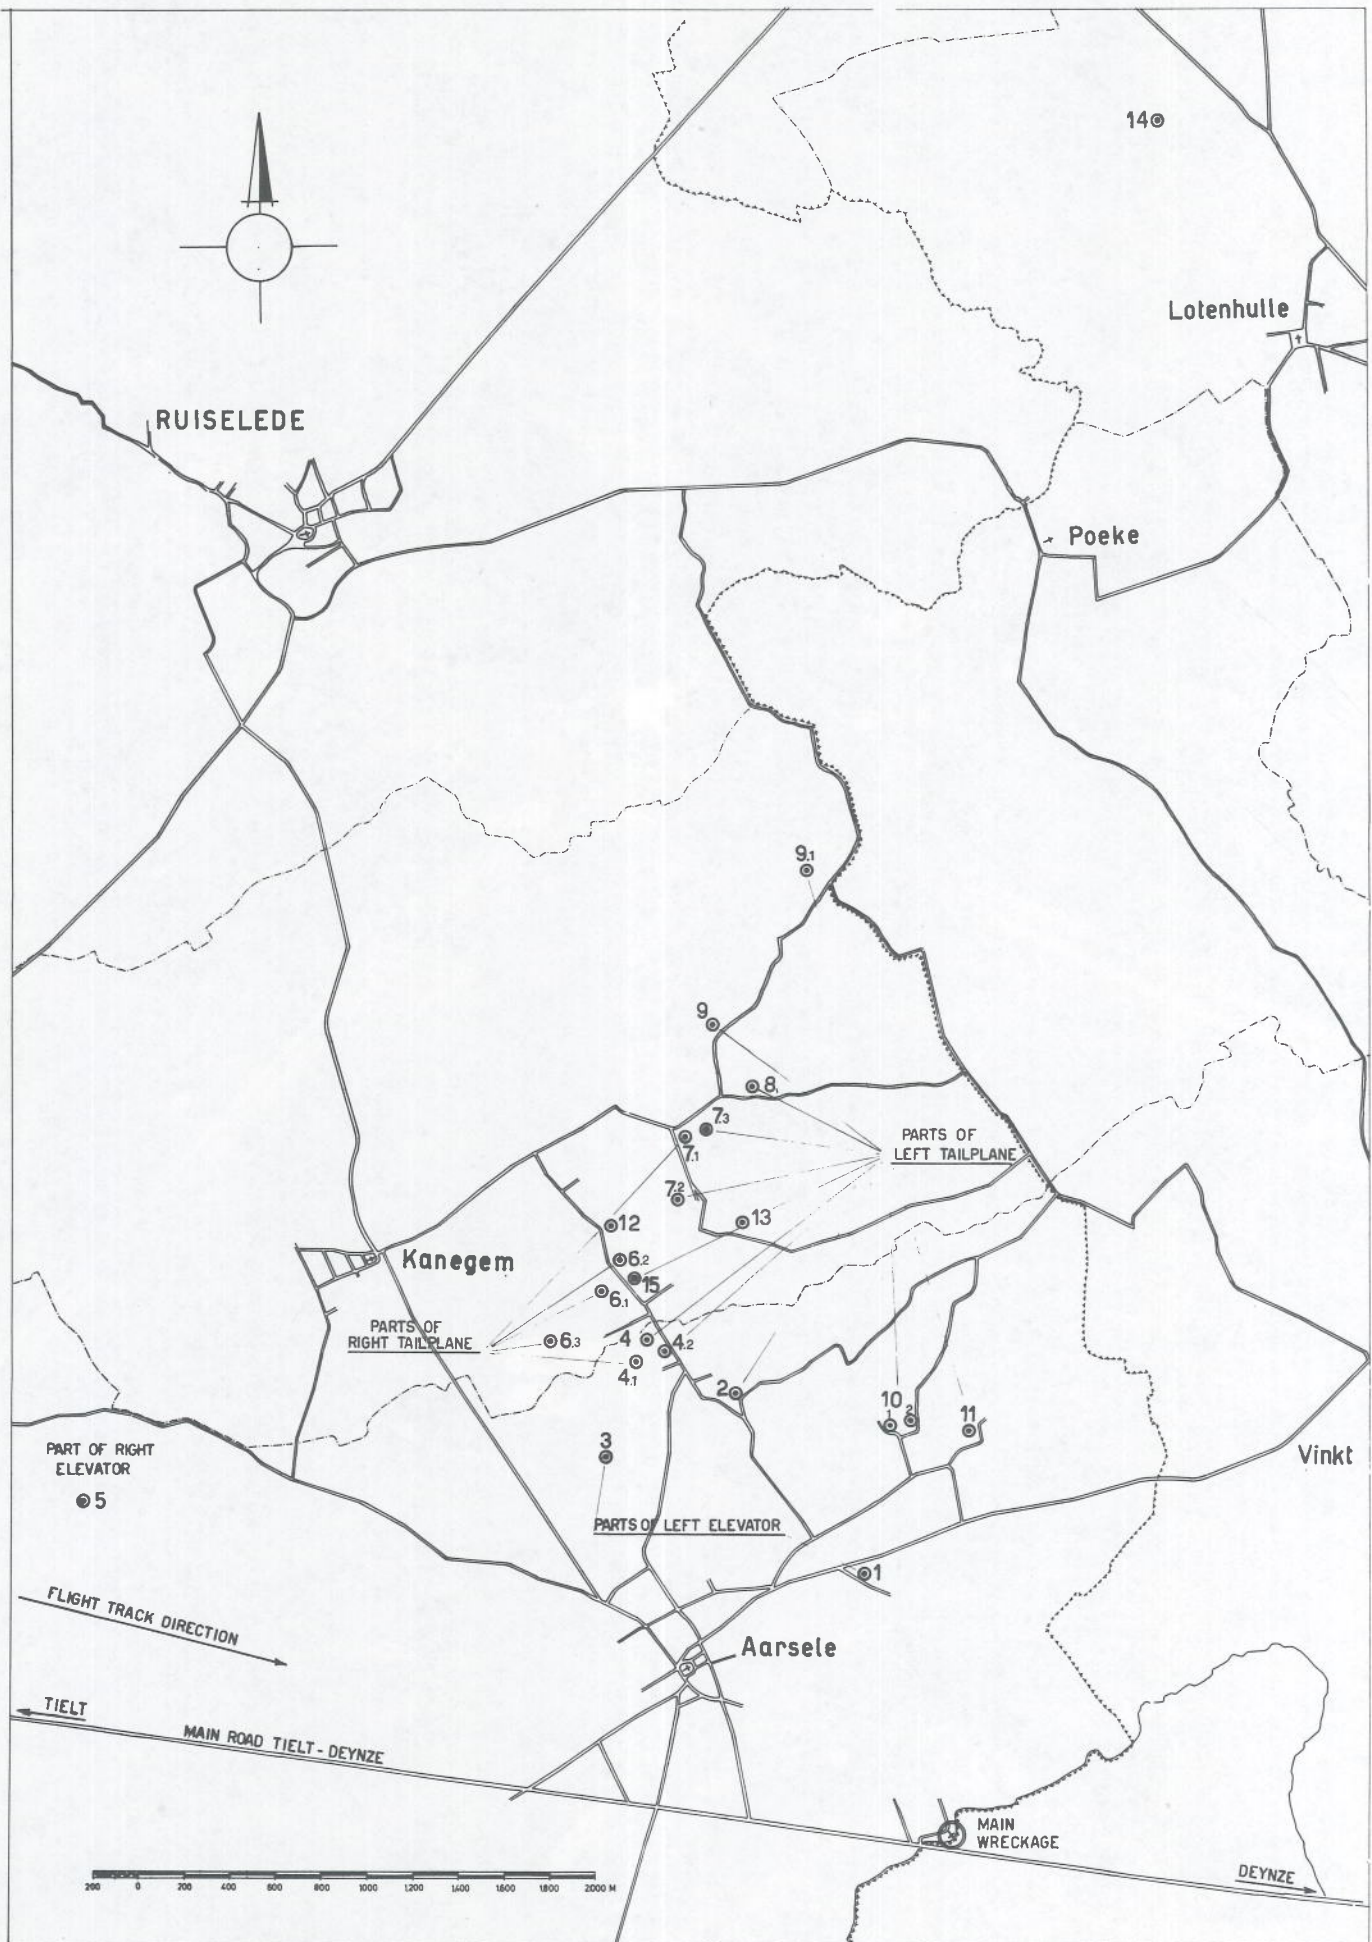
FIGURE N°4 \_ PLOT OF PIECES SEPARATED FROM G-APEC

N°	DESIGNATION.
	<u>Left Elevator.</u>
1.	Left elevator, inboard section, with trim and spring tabs.
3.	Left elevator, outboard section.
	<u>Right Elevator.</u>

5.	Right elevator, outboard section, with part of tab.
	<u>Left Tailplane.</u>
2.	Left tailplane leading edge, centre section.
4.	Left tailplane leading edge, outboard section with tip.

4.2.	Rear spar of centre section of left tailplane, with hinge C.
7.2.	Left tailplane, rear spar, between hinges B and C.
7.3.	Left tailplane, part of upper skin.

8.	Left tailplane, part of lower skin.
	Rib, right tailplane, front to centre spar.
	Two small pieces (skin plate).
9.	Four small pieces of left tailplane.

9.1.	Left tailplane, part of lower skin.
10.	Left tailplane, part of upper skin, between front and centre spars. (10.1. : one large piece and 10.2.: two small pieces).

11.	Left tailplane upper skin, centre section between centre and rear spars.
13.	Nose rib assy and left tailplane rear spar.
15.	Left tailplane centre spar (three pieces).
	<u>Right Tailplane.</u>

4.1.	Right tailplane leading edge, outboard section with tip.
6.1.	Right tailplane rear spar, with hinges C and D.
6.2.	Right tailplane, part of upper skin.

6.3.	Right tailplane leading edge, centre section.
7.1.	Right tailplane, part of upper skin.
12.	Right tailplane, nose rib assy.
14.	Elevator fabric.

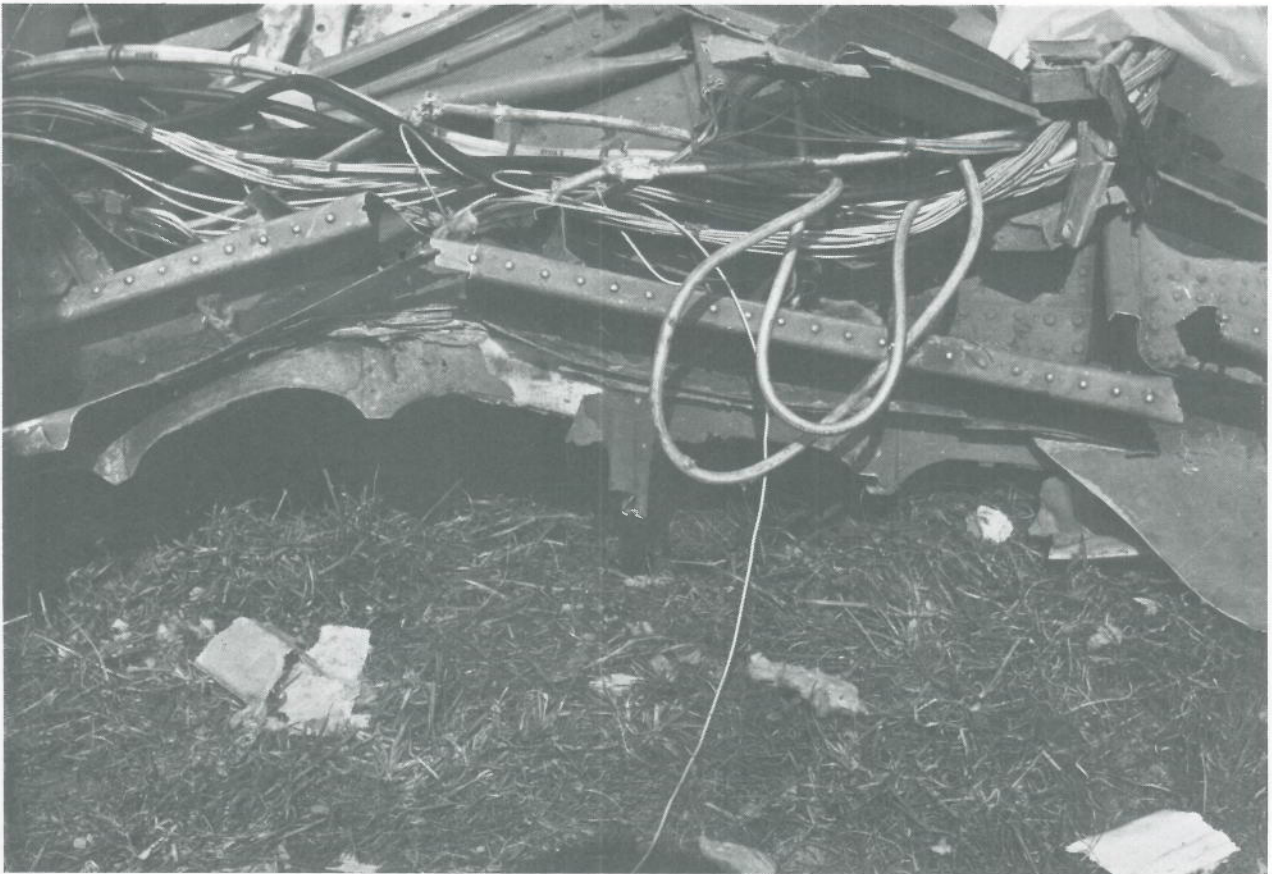
Figure n° 7: Lower portion of fuselage station 1223, showing severe corrosion attack and delamination in the rear pressure bulkhead.

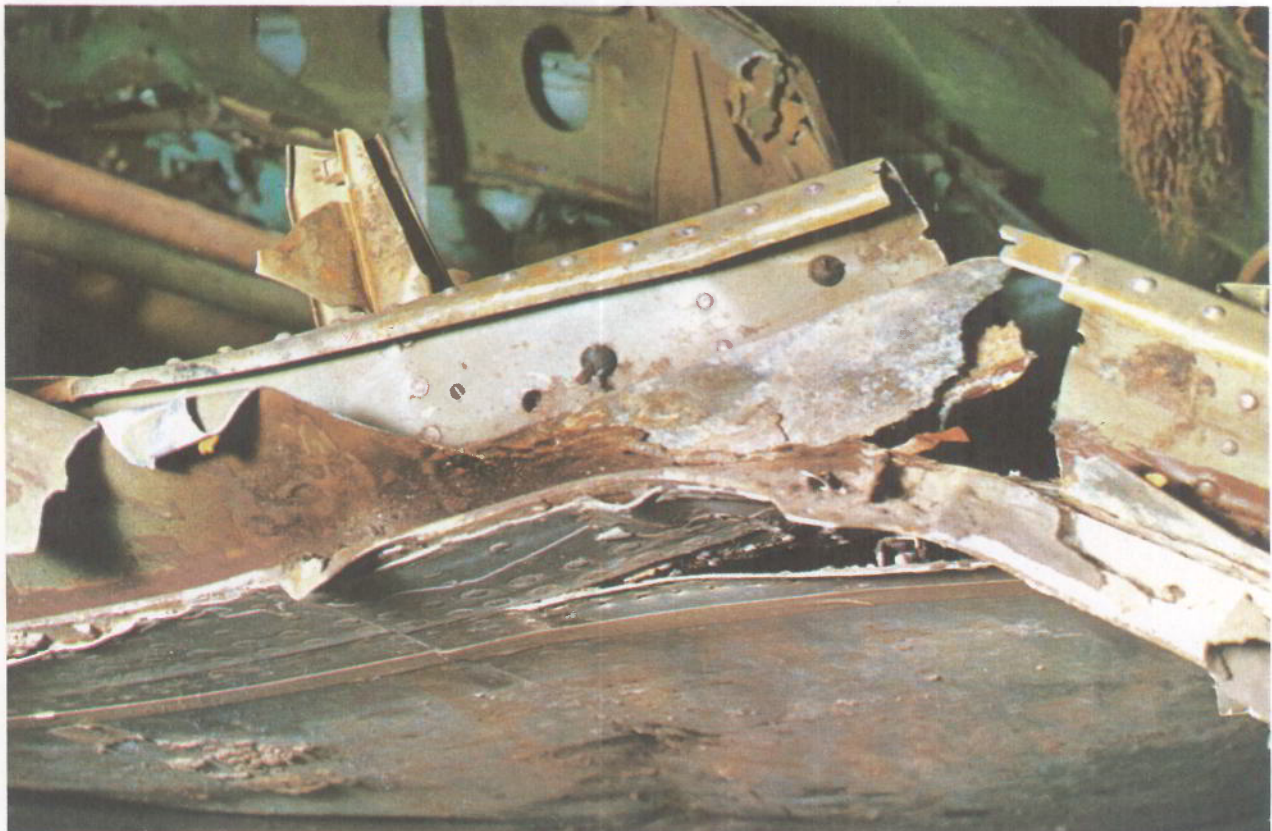
Figure n° 8: Lower portion of frame 1223 and rear pressure bulkhead, showing tar marks.

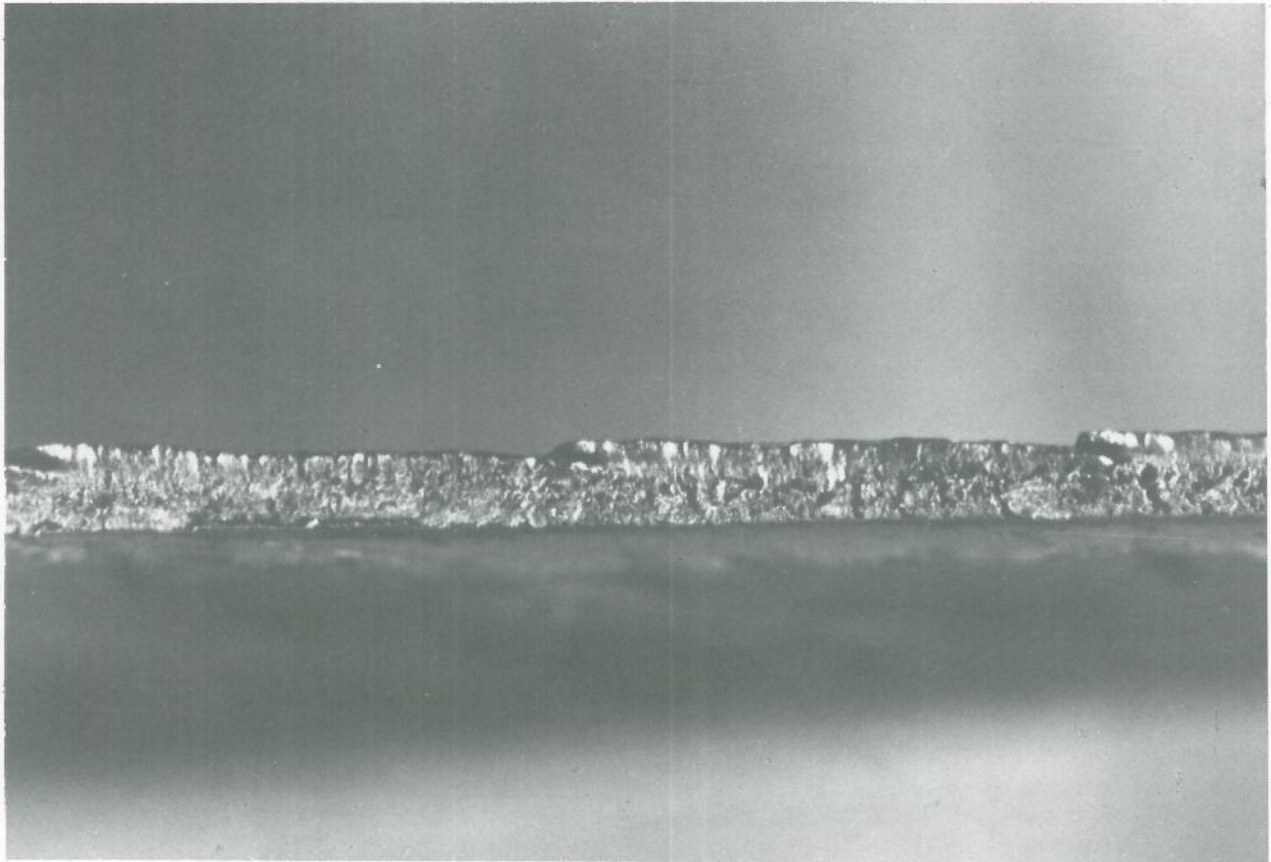
Figure n° 9: Typical "step," marks along tears in the rear pressure bulkhead.

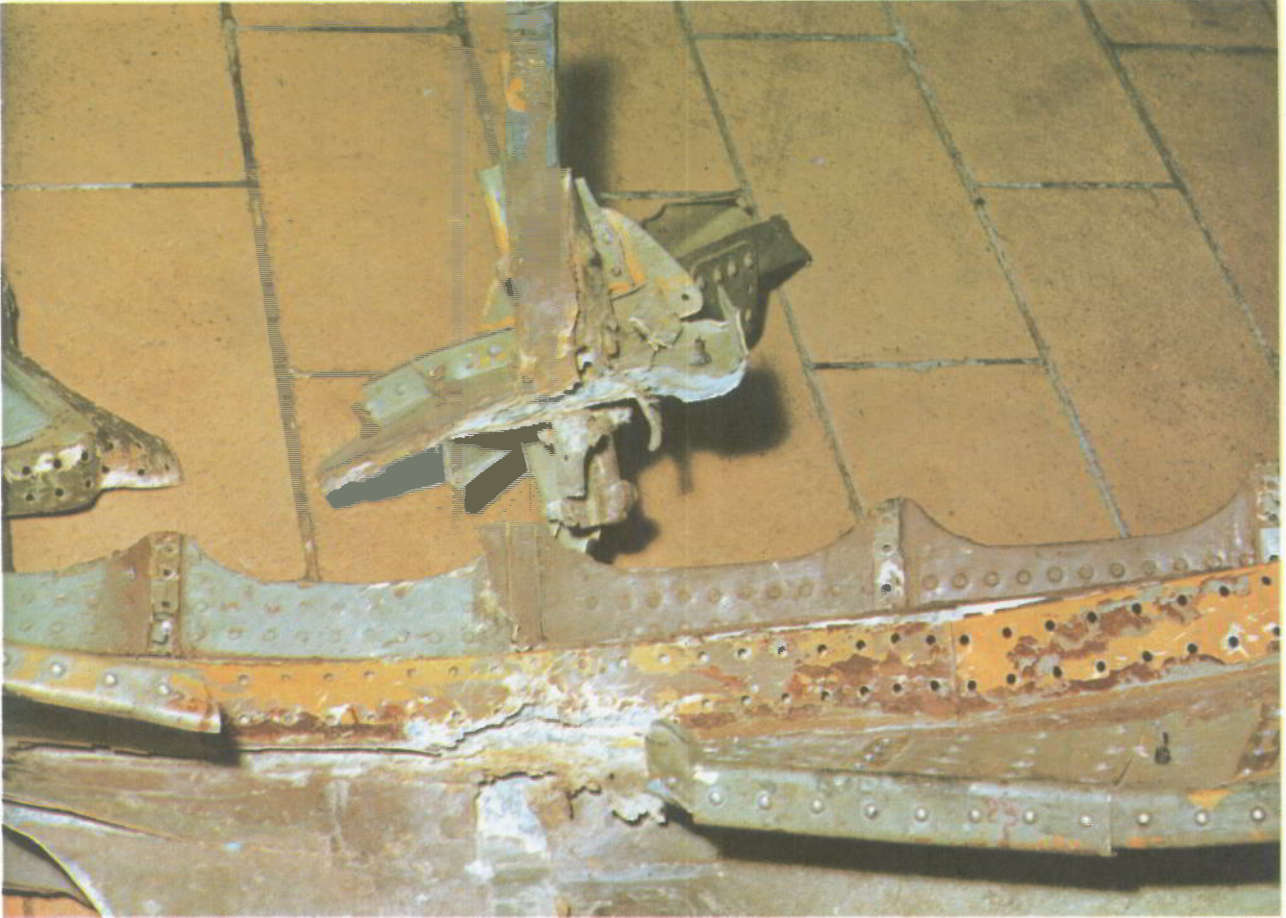
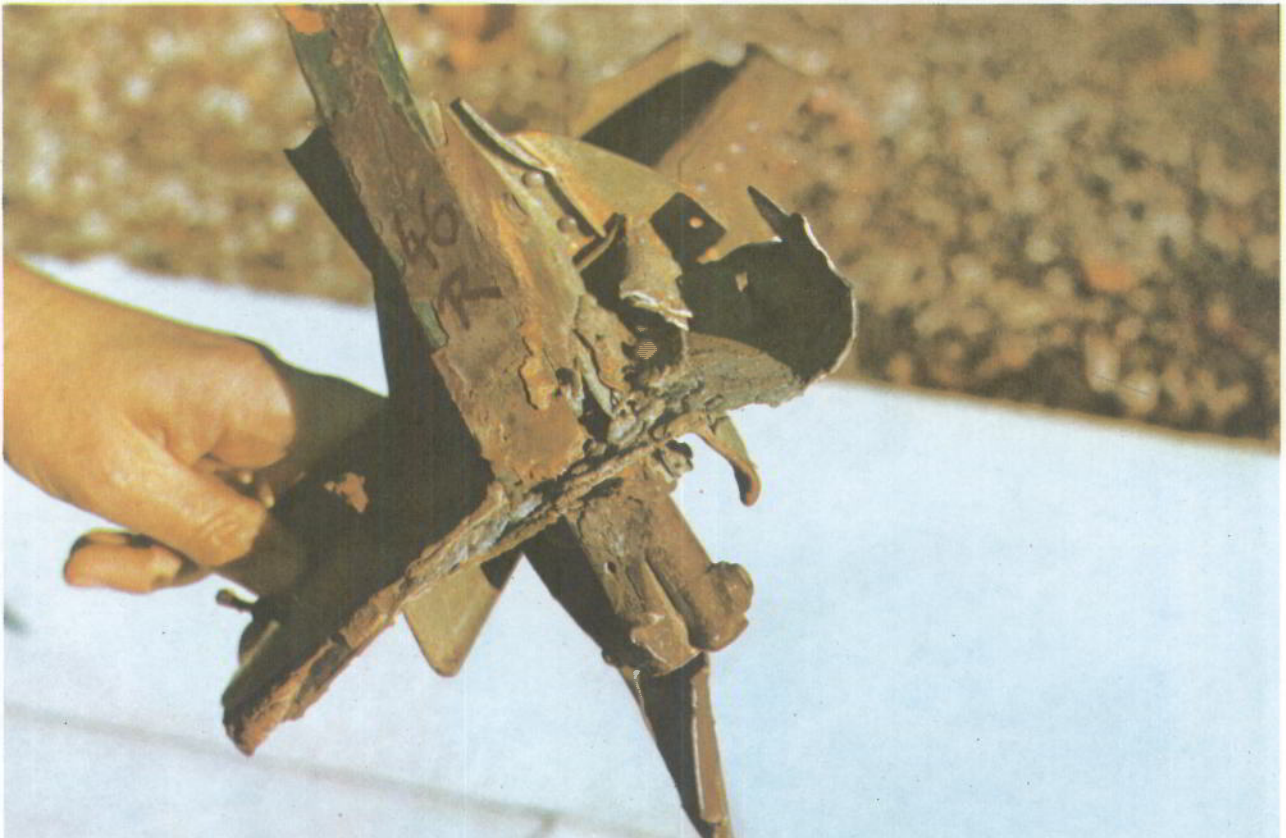
a) Frame 1223.

b) Vertical bracing member.

Figure n° 12: Fuselage station 1223 at stringer 46, showing severe corrosion at vertical bracing member.

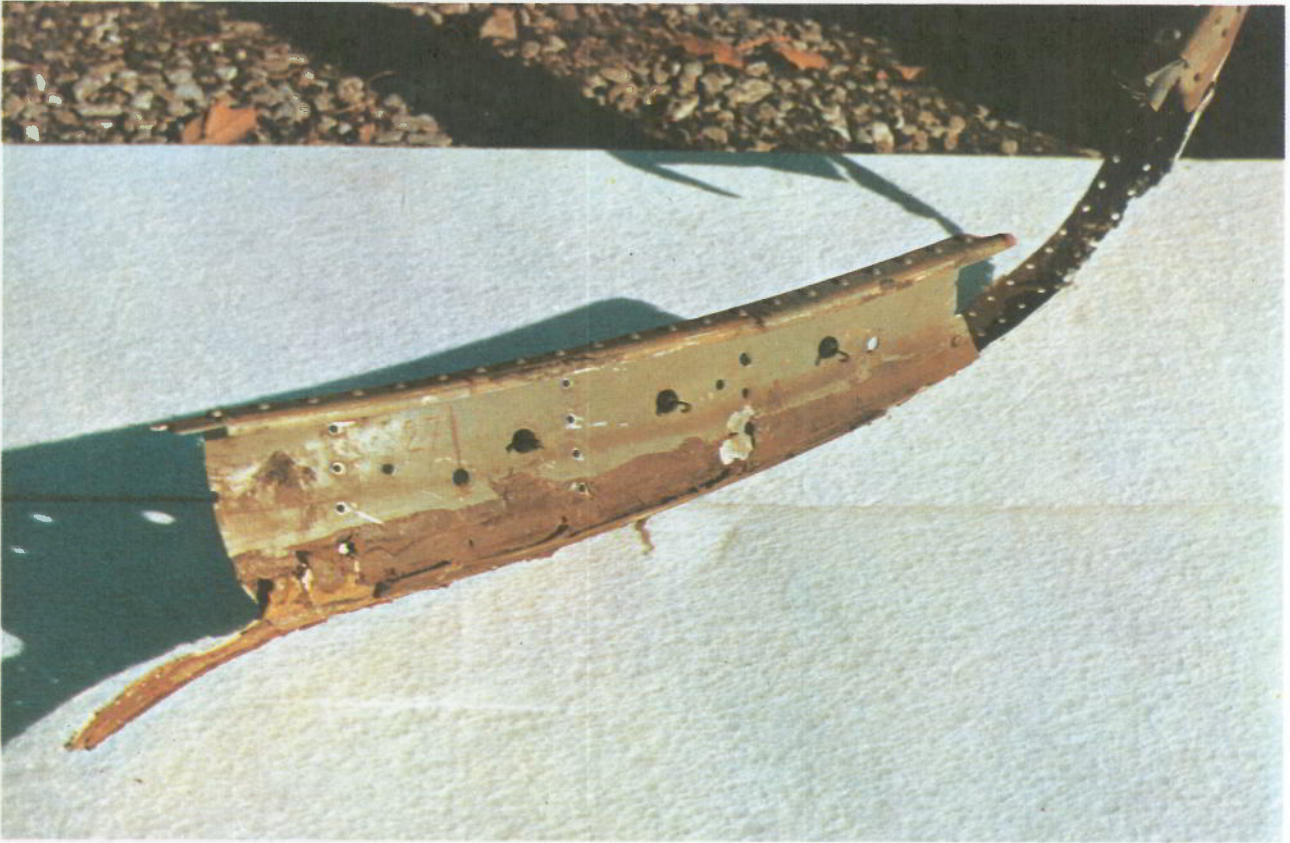
Figure n° 13: Lower portion of frame 1223, rear face, showing polysulphide sealant and blocked drain hole.

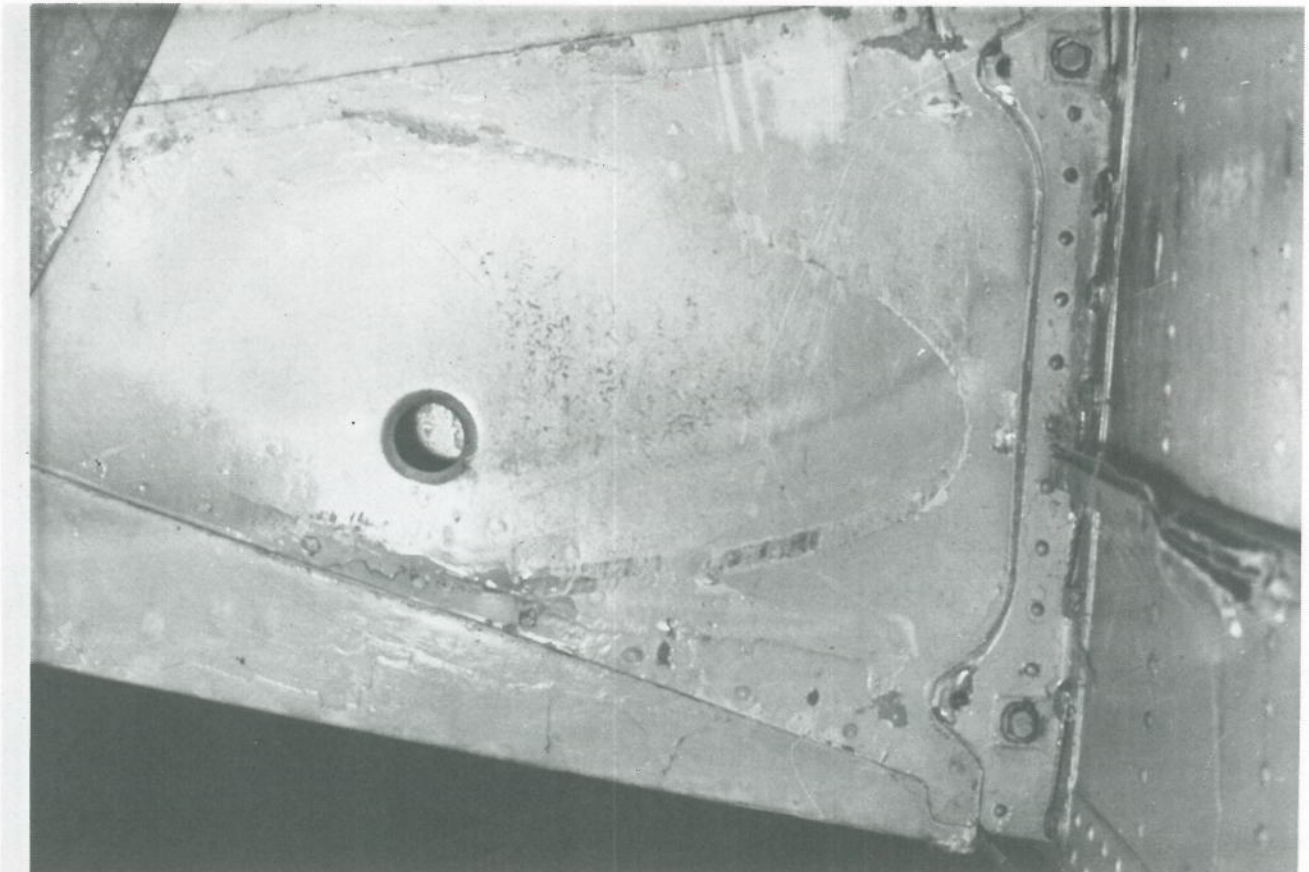
Figure n° 15: Typical hinge beam (Stn 89-LH-inboard face) showing impression of elevator leading edge.

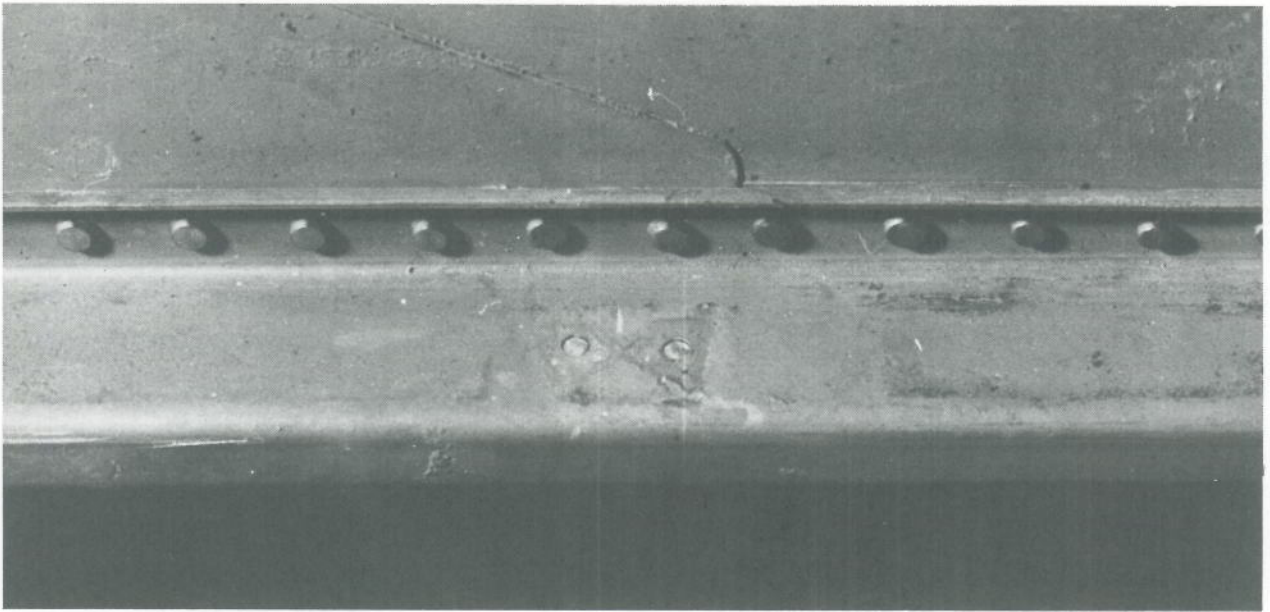
a) Rivets sheared at the stringer and cleat attachment.

Figure 16: Typical failures in tailplanes.

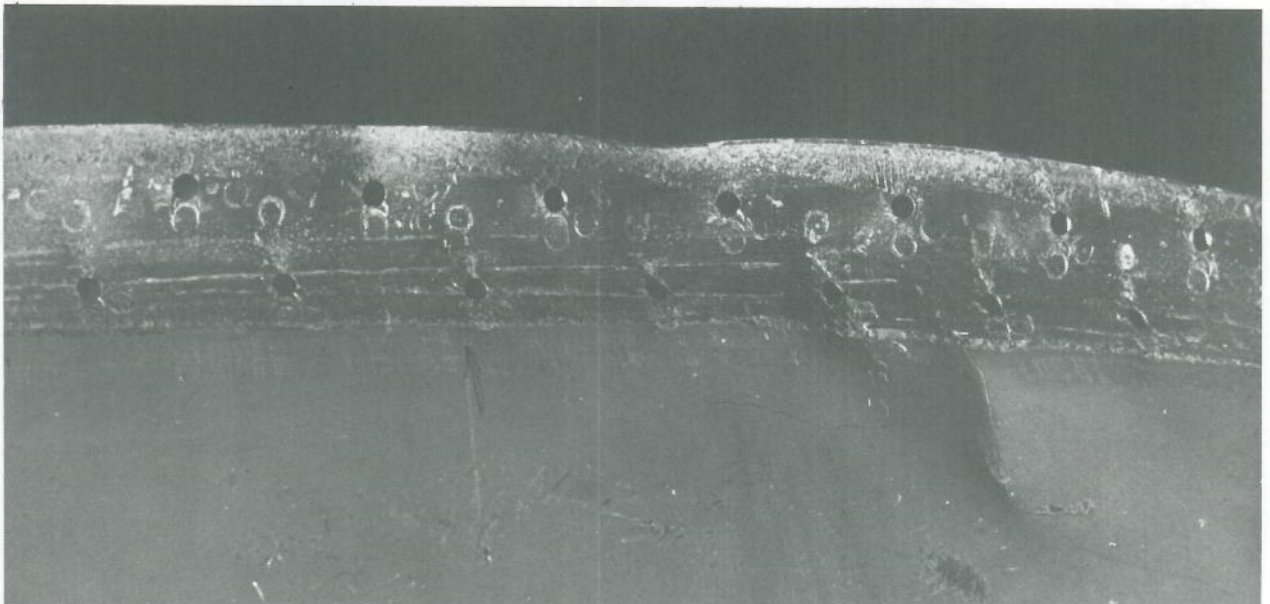
b) Upper skin, inner face, along rear spar near station 143, RH.

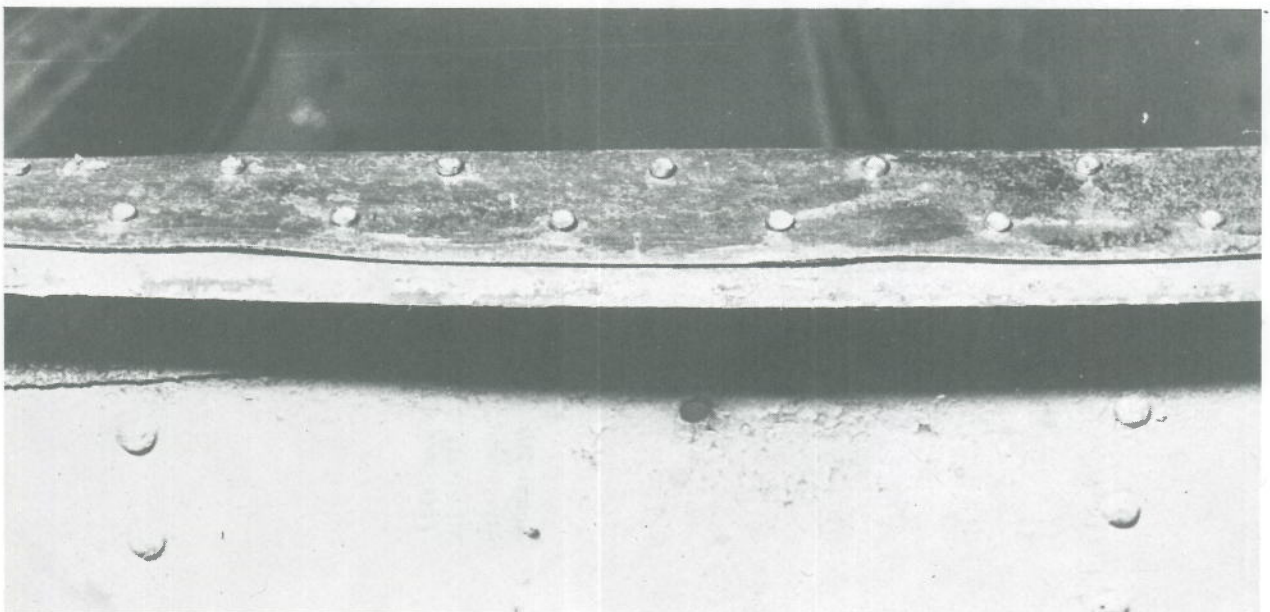
c) Rear spar, upper cap, near station 143, RH

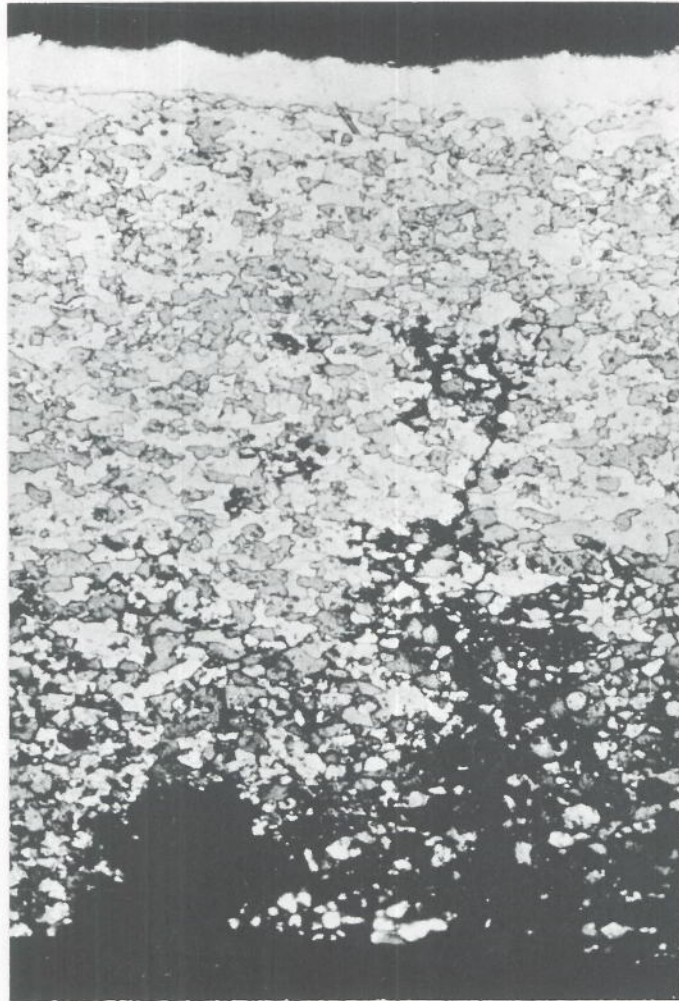
Figure n° 17: Typical micrograph taken in lower portion of rear pressure bulkhead plating showing severe intergranular corrosion at front face.
