## Boeing 767-304, G-OBYB

<b>AAIB Bulletin No: 11/2003</b>	<b>Ref: EW/C2002/10/04</b>	<b>Category: 1.1</b>
<b>INCIDENT</b>		
<b>Aircraft Type and Registration:</b>	Boeing 767-304, G-OBYB	
<b>No &amp; Type of Engines:</b>	2 General Electric CF6-80C2B7F turbofan engines	
<b>Year of Manufacture:</b>	1996	
<b>Date &amp; Time (UTC):</b>	29 October 2002 at 1715 hrs	
<b>Location:</b>	Birmingham International Airport, Birmingham	
<b>Type of Flight:</b>	Public Transport (Positioning)	
<b>Persons on Board:</b>	Crew - 9	Passengers - Nil
<b>Injuries:</b>	Crew - None	Passengers - N/A
<b>Nature of Damage:</b>	None	
<b>Commander's Licence:</b>	Airline Transport Pilot's Licence	
<b>Commander's Age:</b>	Not Relevant	
<b>Commander's Flying Experience:</b>	Not known	
<b>Information Source:</b>	Analysis of Flight recorder information plus further enquiries

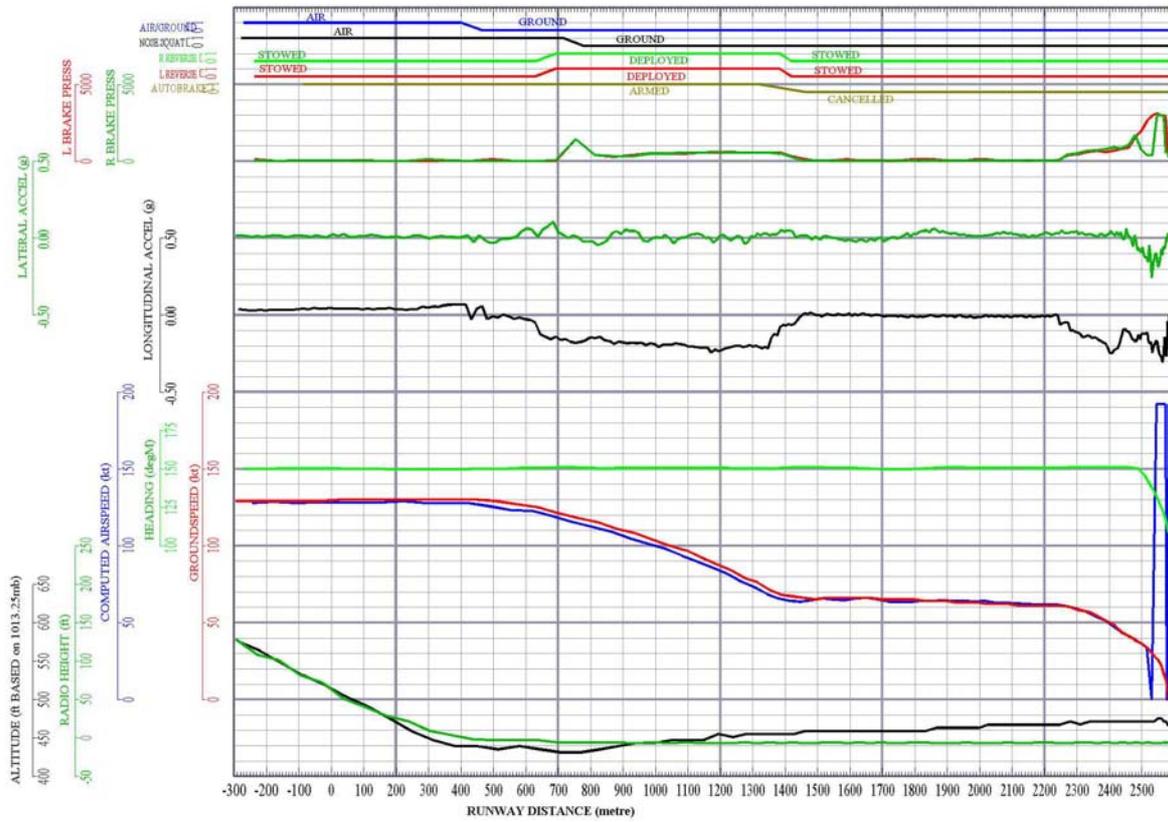
The DFDR yielded good quality information and the aircraft's position along the landing runway was derived from the recorded data. A plot of relevant parameters for the entire landing are shown against runway distance at Figure 1 and an expanded view for the last phase of the landing roll at Figure 2.

SELECTED DFDR PARAMETERS-FINAL APPROACH AND LANDING

The approach and landing were normal with the aircraft touching down on the centreline and well within the normal zone. When the aircraft had slowed to 65 kt, thrust reverse and autobrake were cancelled and the brakes released. At this stage the aircraft was some 1,200 metres from the Runway 33 threshold end of the paved surface. The aircraft was then allowed to 'coast' with the speed slowly reducing to 61 kt until some 30 metres before Runway 33 threshold markers, where the brakes were gradually applied. Brake pressure was slowly increased with a corresponding increase in retardation. Some 120 metres beyond the 33 threshold (175 metres from the end of the paved surface) brake pressures were approximately symmetrical (660 psi left and 880 psi right), and the retardation was about -0.25 g. Over the following 50 metres mean brake pressure increased slightly (770 psi left and 825 psi right), but the retardation dropped to only -0.1 g. At this point the brake pressure increased more rapidly and over a further 20 metres of travel had reached about 1600 psi per side, but retardation only increased to -0.16 g. At this point the speed was about 40 kt and a turn to the left was commenced, using rudder and differential braking. It is not known if nosewheel steering was used as the steering tiller position was not a recorded parameter. At this point the aircraft was some 110 metres from the end of the paved surface. Left brake pressure then increased to maximum (3000 psi) and the right decreased to 400 psi as the turn continued. When the aircraft was 50 metres from the runway end, right brake pressure was increased rapidly also to maximum and the retardation then rose to a peak of -0.3 g with the aircraft continuing to turn left at a similar rate. The symmetric full brake pressure was held for two to three seconds before the nosewheel ran off the end of the paved surface, at about 12 kt, where brake pressure was relaxed, and after a further 6 seconds (10 to 15 metres of travel) the aircraft came to rest. On the CVR towards the end of the ground roll there were sounds possibly consistent with the nosewheel slipping on the surface, but these were after it had run off the paved surface.

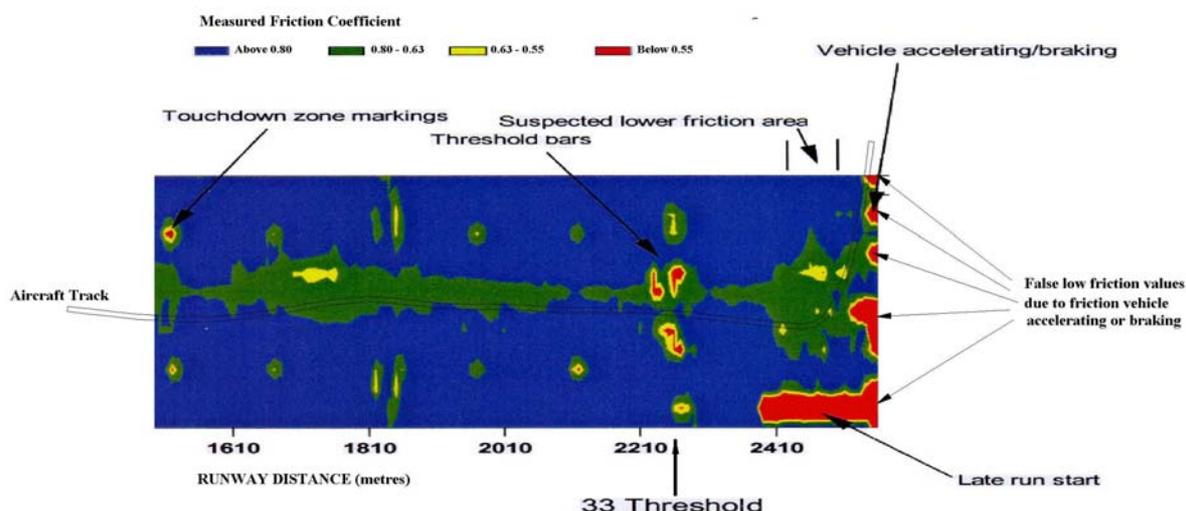
Examining in detail the results for the 33 threshold end of the runway indicated that there were a few areas beyond the threshold markings that were within the maintenance planning band (0.55 to 0.63), and one very small area where it fell to below the minimum friction level. Cranfield produced a friction contour map for the runway and the portion at the 33 end is reproduced at Figure 3 together with the derived aircraft track.

FRICITION LEVEL CONTOUR MAP
