McDonnell-Douglas DC10-30ER, C-GCPH

AAIB Bulletin No: 12/2001	Ref: EW/C99/1/1	Category: 1.1
Aircraft Type and Registration:	McDonnell-Douglas DC10-30ER, C-GCPH	
No & Type of Engines:	3 General Electric CF6-50C2 turbofans	
Year of Manufacture:	Not known	
Date & Time (UTC):	6 January 1999 at 0700 hrs	
Location:	London Heathrow Airport, Block 91	
Type of Flight:	Scheduled passenger	
Persons on Board:	Crew - 11	Passengers - 255
Injuries:	Crew - nil	Passengers - nil
Nature of Damage:	Damage to turbine section of No 1 engine	
Commander's Licence:	Airline Transport Pilot's Licence	
Commander's Age:	Not known	
Commander's Flying Experience:	15,000 hrs total (of which 4,000 were on type)	
	Last 90 days - 180 hrs	
	Last 28 days - 60 hrs	
Information Source:	AAIB Field Investigation

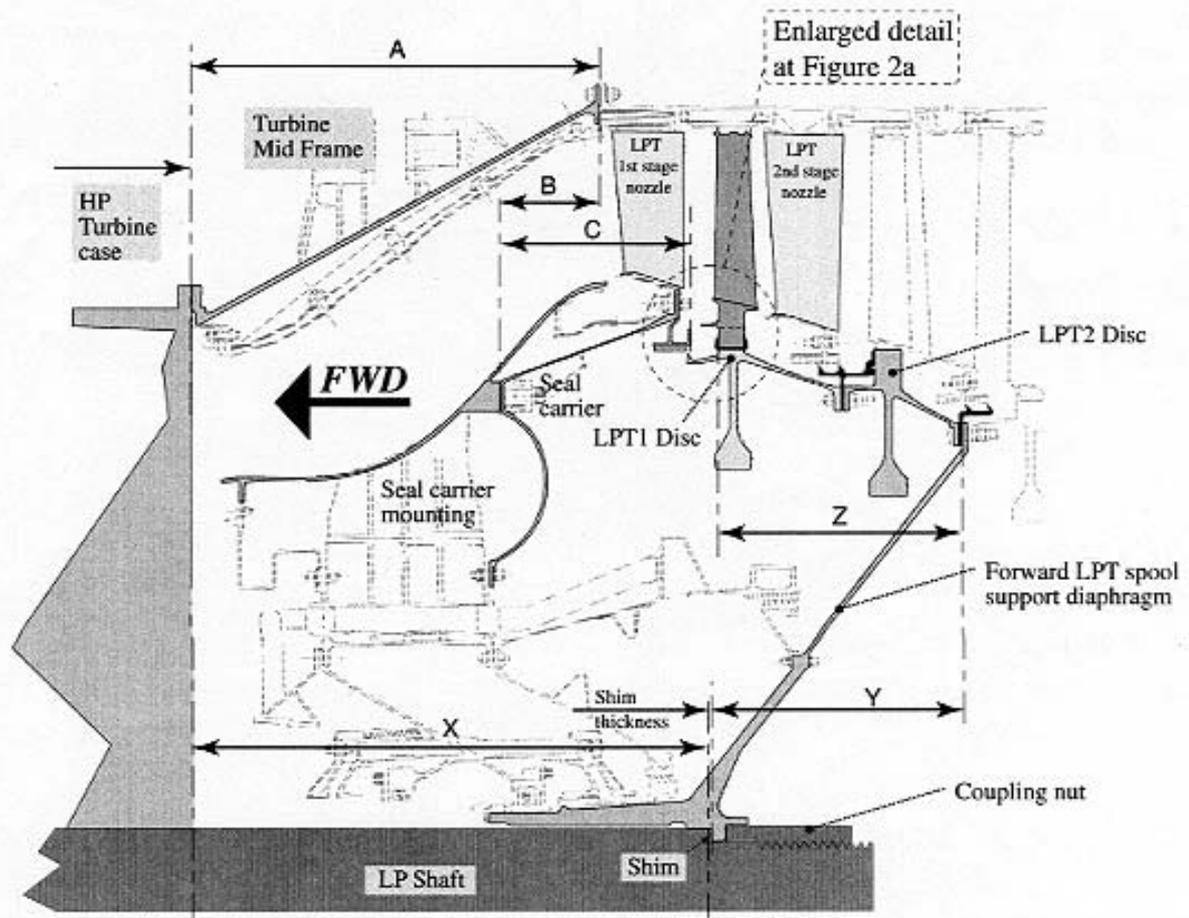
Figure 1a Half section showing general build arrangement of the Turbine Mid-frame and the forward part of LP Turbine Module

Before separating the LP turbine module from the engine, the dimension 'CU' was measured (ie from the rear face of the turbine rear frame to the aft end of the LP shaft assembly). This dimension was found to be 1.812 inches, which was within the required limits of 1.75 to 1.85 inches. The coupling nut (see Figure 1a), which secured the LP turbine rotor to the LP shaft, was removed and visually inspected. The breakaway torque for the nut was measured during removal and found to be approximately 20,000 ft-lbs, which indicated that no looseness had developed in the LP rotor/shaft joint; no damage was observed on the nut. The LP turbine module was then separated from the rest of the engine at the joint between the turbine mid-frame and the rear of the HP turbine case (Figure 1a).

The LP turbine rotor positioning shim (Figure 1a), positioned between the turbine rotor and the shoulder on the LP shaft (dimension 'CU' adjustment), was examined; it was found to be undistorted and within the permitted dimension range at 0.163 inch thick. After removing the turbine rear frame, which exhibited only minor signs of distress, the LP turbine case halves were separated from each other and the turbine mid-frame, and removed from around the rotor with considerable difficulty. Severe damage was then revealed throughout all 4 stages of the LP turbine. There had been damage to the casing, which had caused the penetrations apparent before strip, and secondary damage to the nozzle guide vanes and shrouds of all stages, but the degree of damage diminished towards the aft end of the turbine.

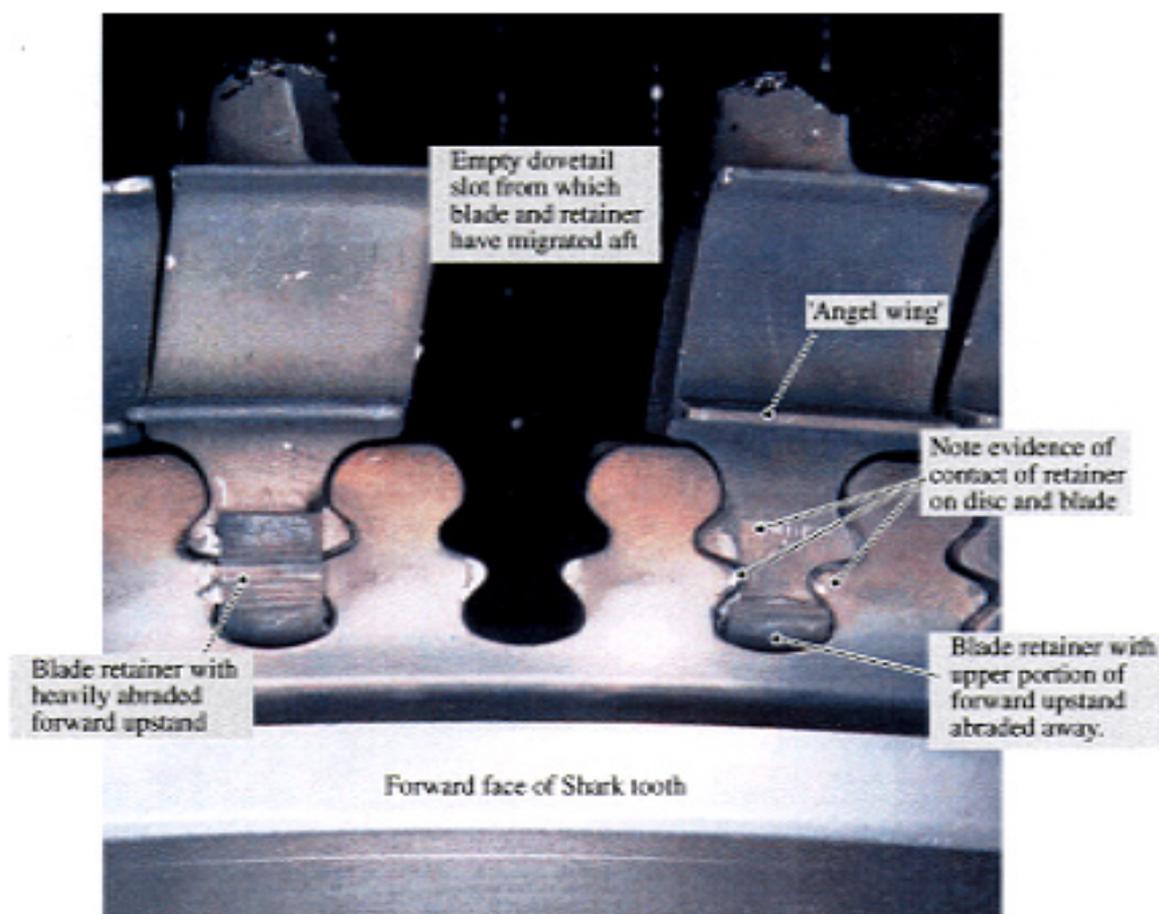
Figure 2 Sector of LPT1 disc rim as found during strip examination

The four LP turbine rotor discs were then separated. Examination of these revealed that the blades of the 2nd, 3rd and 4th stages had suffered secondary damage as a result of debris travelling aftwards, but no evidence of primary failure was observed on any of these blades. The severity of the damage reduced from the 2nd stage aft, there being 2 complete blades missing from this stage but only aerofoil damage to the turbine blades of the 3rd and 4th stages, with stage 4 blades less damaged than stage 3. The LPT 1 rotor, however, was very severely damaged. A large proportion (75 out of 128) of the blade roots were missing from their slots in the LP 1 disc and several of the remaining blade roots had moved aft from their normal position, to varying extents. The aerofoil of every blade root remaining in the disc had been sheared off at the level of the blade platform.

Examination of the stage 1 LP turbine blade retainers showed that all of those remaining in position exhibited varying degrees of abrasion damage to their forward 'upstand', as illustrated in the photograph at [Figure 2](#), and depicted in the diagram at Figure 2a. The shape of this abrasion damage to the forward faces of these retainer upstands was consistent with it having been made by circumferential rubbing contact against the aft corner of the LPT1 nozzle air seal 'discourager leg' (see Figure 2a). In those cases where the forward upstand had not been completely worn through and was still in its intended position, the turbine blade roots had been retained in their correct positions. However, where the forward upstand of retainers had been abraded right through, approximately 0.175 inch of the upstand height had been lost in every case and, as a result, the residual height of the upstands had become short enough to allow the associated blade roots and retainers to slide axially aft. However, this reduced height of the upstands had been sufficiently long to restrain affected blades from moving forward relative to the retainer. The majority of those turbine blades, where the forward upstand of the retainers had abraded through, had moved aft by varying amounts and carried the remainder of their retainers with them. However, in no circumferential position had the interference between the seal and the LPT1 disc assembly been sufficiently severe as to affect the forward face of the turbine disc.

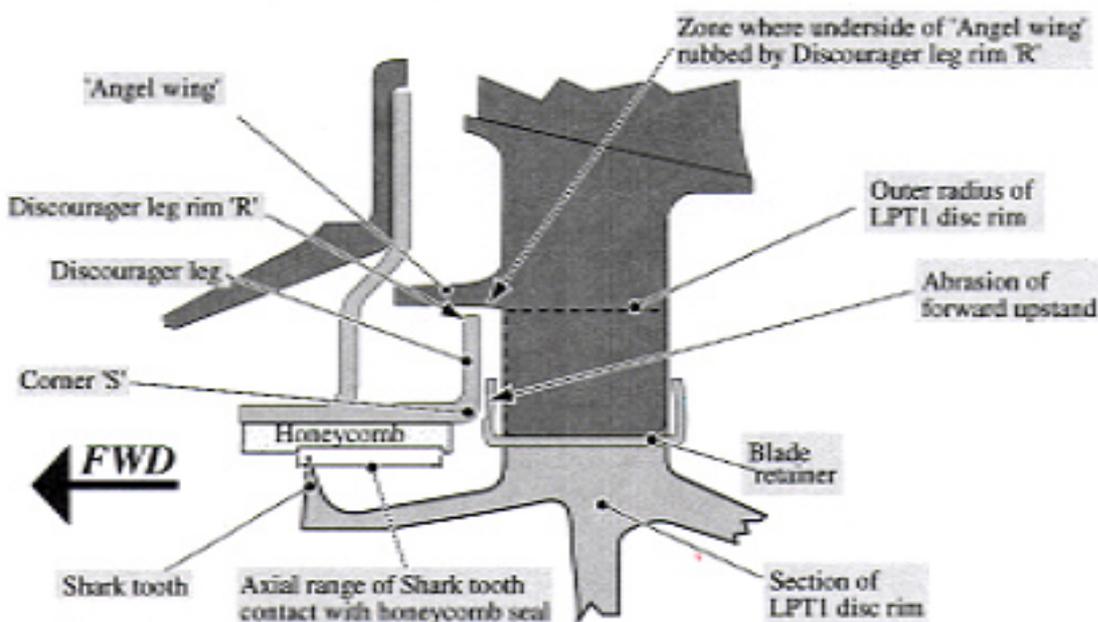
Figure 2a Detail cross section showing arrangement of LPT 1st stage nozzle seal

It was noted that there were two standards of stage 1 LP turbine blades with different thickness 'Angel wings' (Figure 2a). It was also observed on the blade roots remaining in the disc that those with the thicker Angel wings had evidence of rubs on the underside of their platforms; this rubbing was consistent with it having been made by the outer rim ('R' in Figure 2a) of the stage 1 nozzle air seal discourager leg.

The stage 1 nozzle air seal was visually inspected while still attached to the turbine mid-frame. The internal diameter surface of the seal was observed to have two areas where the seal honeycomb material had been rubbed away by the LP 1 turbine disc 'Shark tooth' knife seal edge (see Figure 2a). The more clearly defined rub was across an arc at the bottom of the engine and the second, lighter, rub was at the top of the engine, just to the left of the centreline. The lower rub was 0.75 inch wide and 0.030 inch deep, but the upper rub had minimal depth, about 0.003 inch, and was the same width as the lower rub. No evidence of hard particle impact damage was observed on either the internal diameter surface of the honeycomb or the knife seal.

It was therefore apparent that the primary cause of the aft displacement and release of stage 1 LP turbine blades had been the loss of a critical portion of the forward upstands on a large number of their blade retainers. This loss had been caused by rotational rubbing contact and erosive wear between the forward faces of the retainer upstands and the aft face of the stage 1 LP turbine nozzle seal assembly. This had worn a groove part way up the upstands, thereby weakening them and, in many cases, causing the upper part of the upstand to separate completely (see Figure 2a).

It appears that, in this case, the position of the LP turbine rotor was further forward, relative to the LPT1 Nozzle assembly, than the design allowed for and as a consequence contact occurred between the LPT1 blade retainers and the base of the discourager lip at corner S in Figure 2a. This abrasion resulted in the loss of a critical portion of the blade retainer upstands of a large proportion of the LPT1 blades, which allowed those blades to displace aft and disengage from their dovetail retaining slots in the disc. These liberated blades then destroyed the LP turbine module.
