Robinson R22 Beta, G-IORG

AAIB Bulletin No: 9/2003	Ref: EW/C2002/05/04	Category: 2.3
Aircraft Type and Registration:	Robinson R22 Beta, G-IORG	
No & Type of Engines:	1 Lycoming O-320-B2C piston engine	
Year of Manufacture:	1991	
Date & Time (UTC):	14 May 2002 at 0855 hrs	
Location:	Sywell Aerodrome, Northamptonshire	
Type of Flight:	Aerial work	
Persons on Board:	Crew - 1	Passengers - 1
Injuries:	Crew - None	Passengers - None
Nature of Damage:	Main rotor blade cracked	
Commander's Licence:	Commercial Pilot's Licence	
Commander's Age:	57 years	
Commander's Flying Experience:	13,500 hours (of which 8,000 were on type)	
	Last 90 days - 250 hours	
	Last 28 days - 64 hours	
Information Source:	AAIB Field Investigation

Synopsis

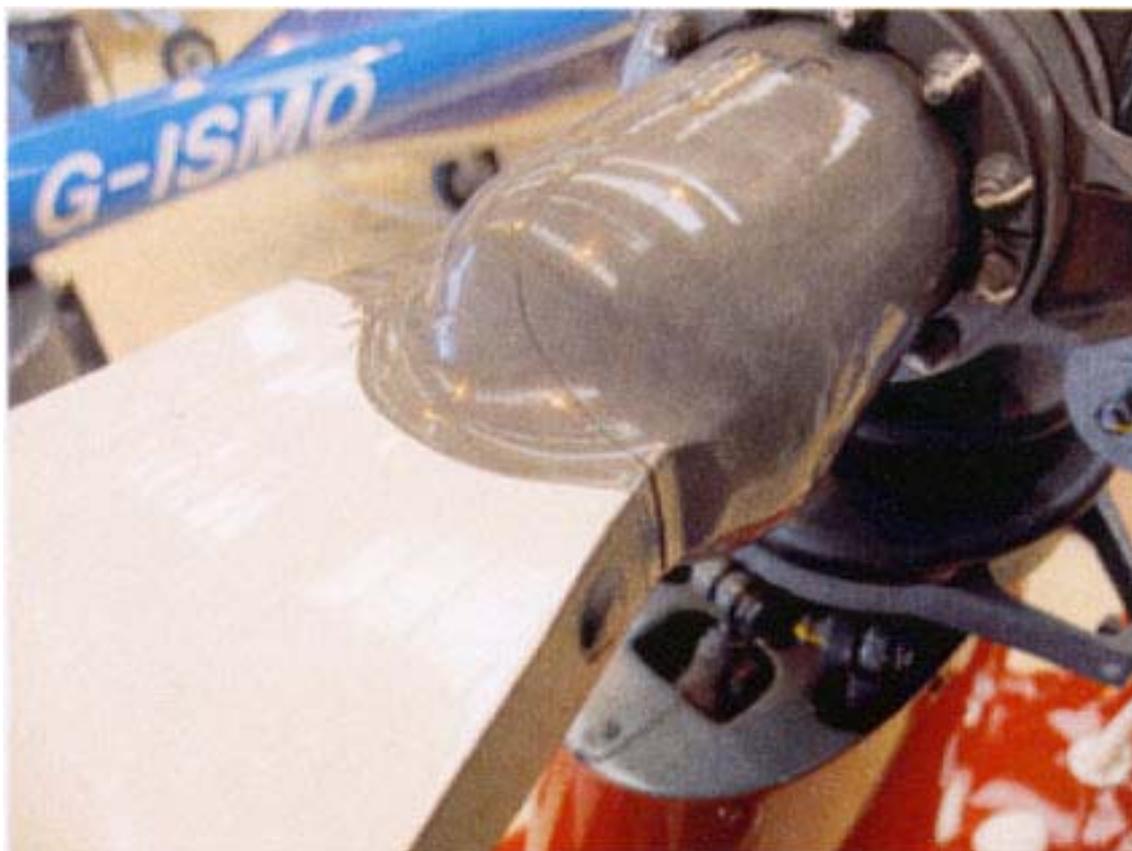
After landing, a test pilot from the maintenance organisation went out to carry out an assessment. During his preliminary walk-round inspection, oil contamination was noted around the rotor head area. After climbing up to investigate the source of this oil, he was examining the spindle bearing oil retention boots for damage which from experience he considered a likely source, when he saw a large crack in one of the main rotor blades close to the root end, see Figure 1. The test pilot was appalled at the extent of the crack, and immediately quarantined the aircraft pending the AAIB investigation.

Figure 1
Crack in root fitting of main rotor blade

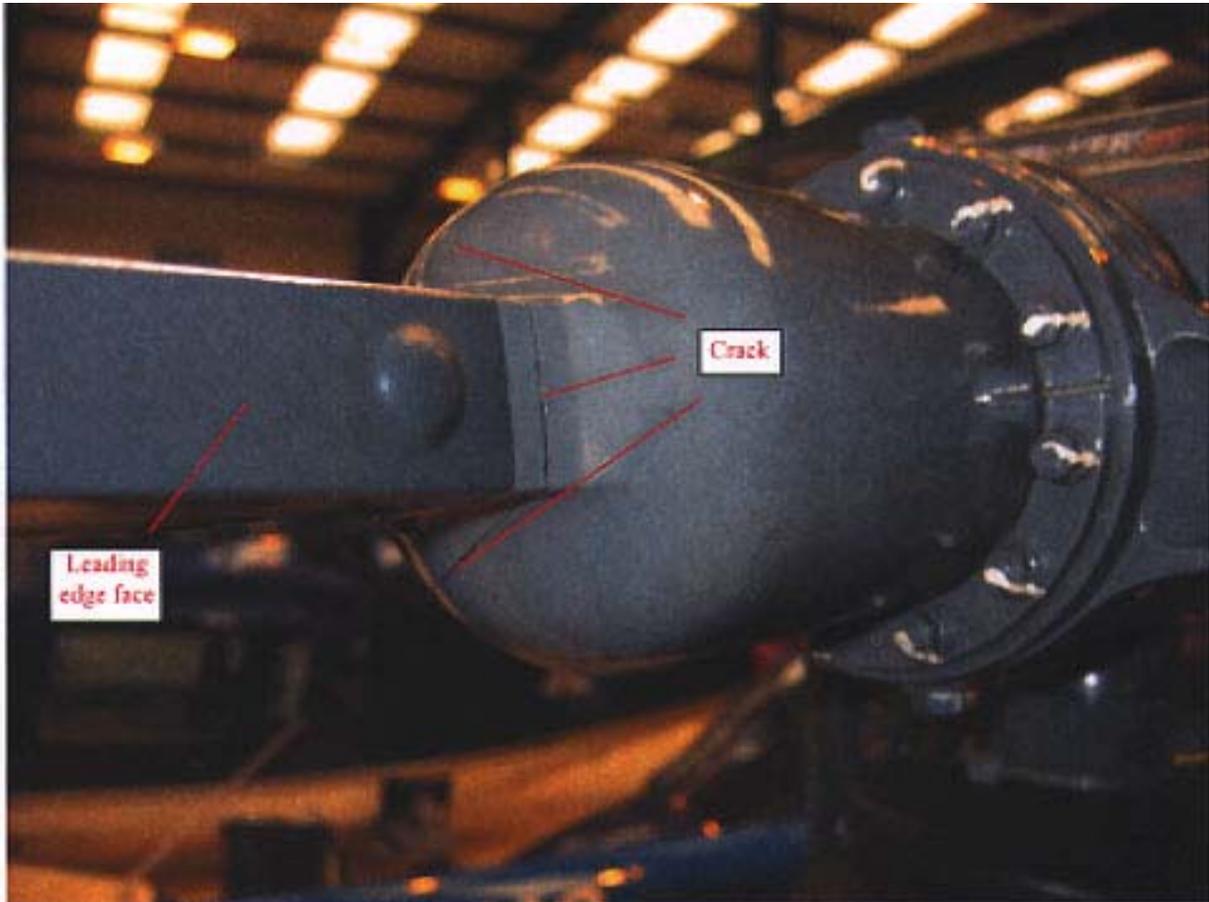
The crack, which was confined to the blade root fitting, had apparently initiated at the leading edge and propagated back towards the trailing edge, turning progressively inboard as the crack developed, Figure 3.

Figure 3
Main rotor blade in situ, showing the crack extending from the leading edge face across both top and bottom surfaces of root fitting

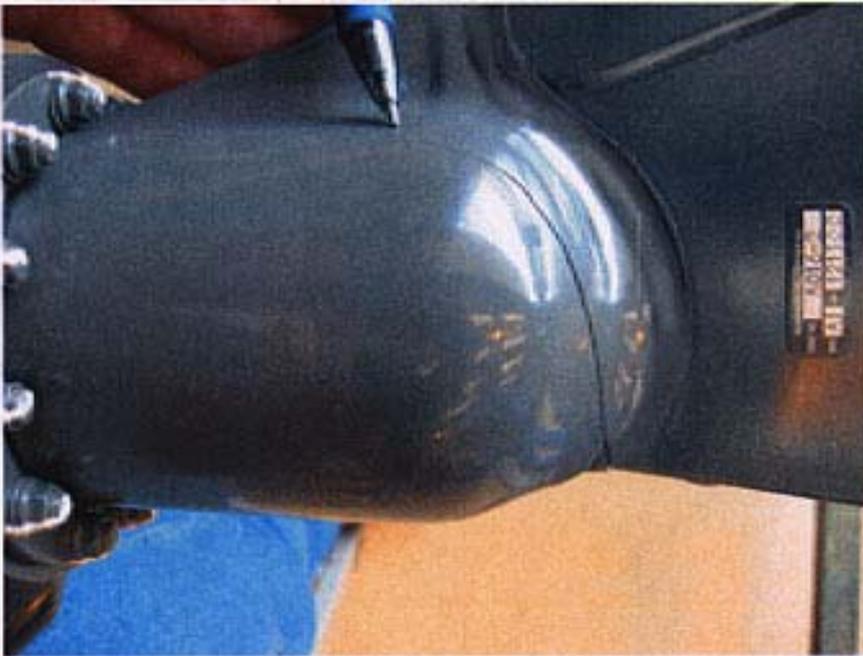
In total, the crack had extended a distance of approximately 9 cm beyond the leading edge on the lower surface of the fitting and approximately 7 cm on the upper surface, Figures 4 and 5. The crack had evidently penetrated through the full thickness of the forging over a significant proportion of the cross-section, and had opened up sufficiently to produce a discernible step-like discontinuity across the fracture at the leading edge. Localised distortions were also visible in the surface of the forging in the vicinity of the crack fronts, particularly on the upper half of the fitting (Figure 5), suggested that the crack, which was considered at this time to probably be associated with a fatigue mechanism, had reached an advanced stage involving low cycle rapid growth and that the blade had been very close to catastrophic failure.

Figure 4
Undersurface crack (length approximately 9 cm)

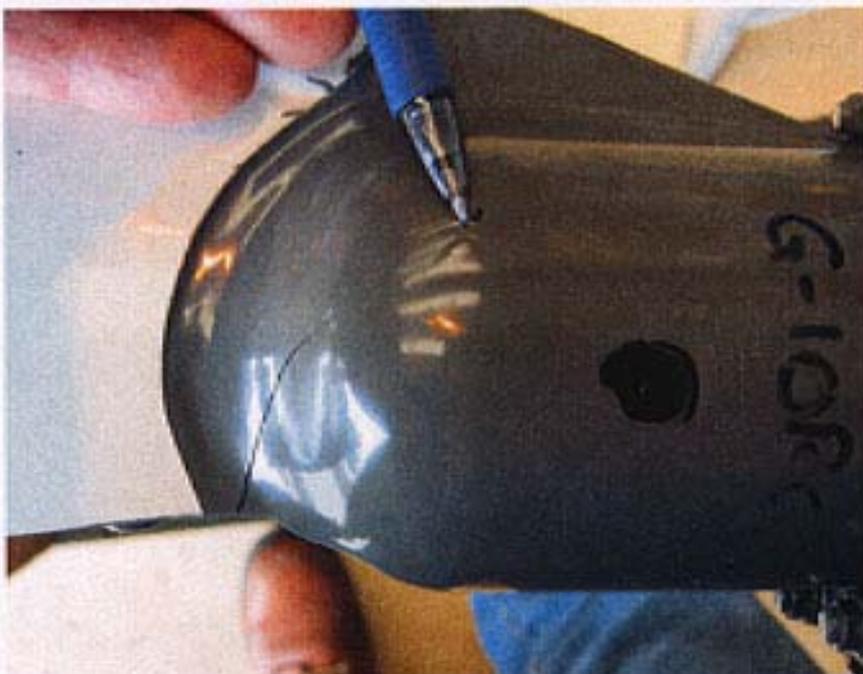
Figure 5
Topsurface crack (length approximately 7 cm)

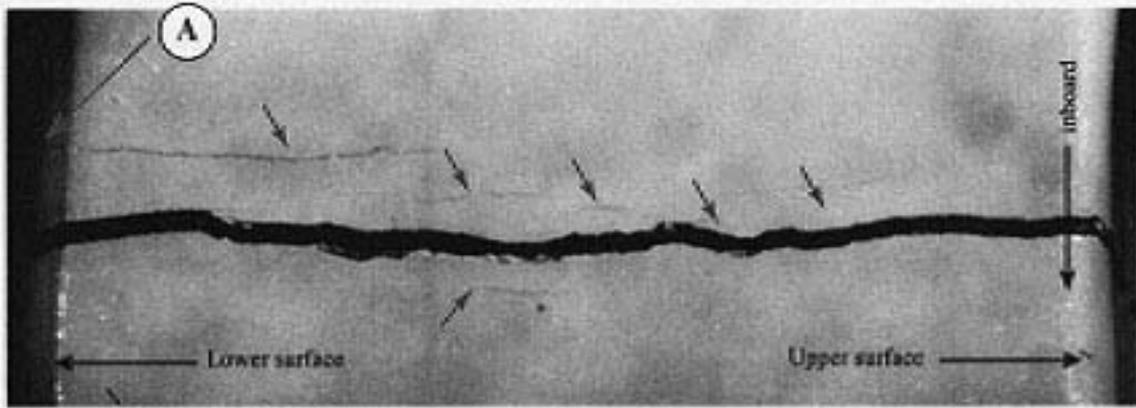
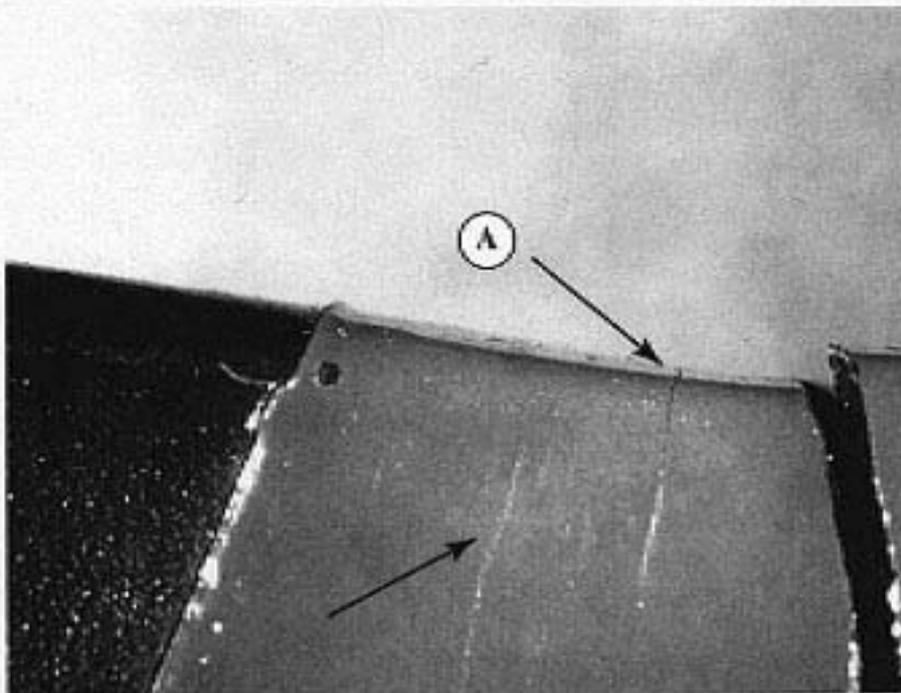
Preliminary optical microscopy of the leading edge surface confirmed the presence of the numerous secondary cracks adjoining the main crack noted previously, Figures 6a and 6b. Their appearance was consistent with abnormally high strain in the surface material, but it was not apparent whether they had proceeded, or were symptomatic of, the main crack.

Figure 6a and 6b
Secondary cracking in the filler/paint of the leading edge and lower surfaces.
Note: Crack labelled 'A' extends around lower corner onto lower surface

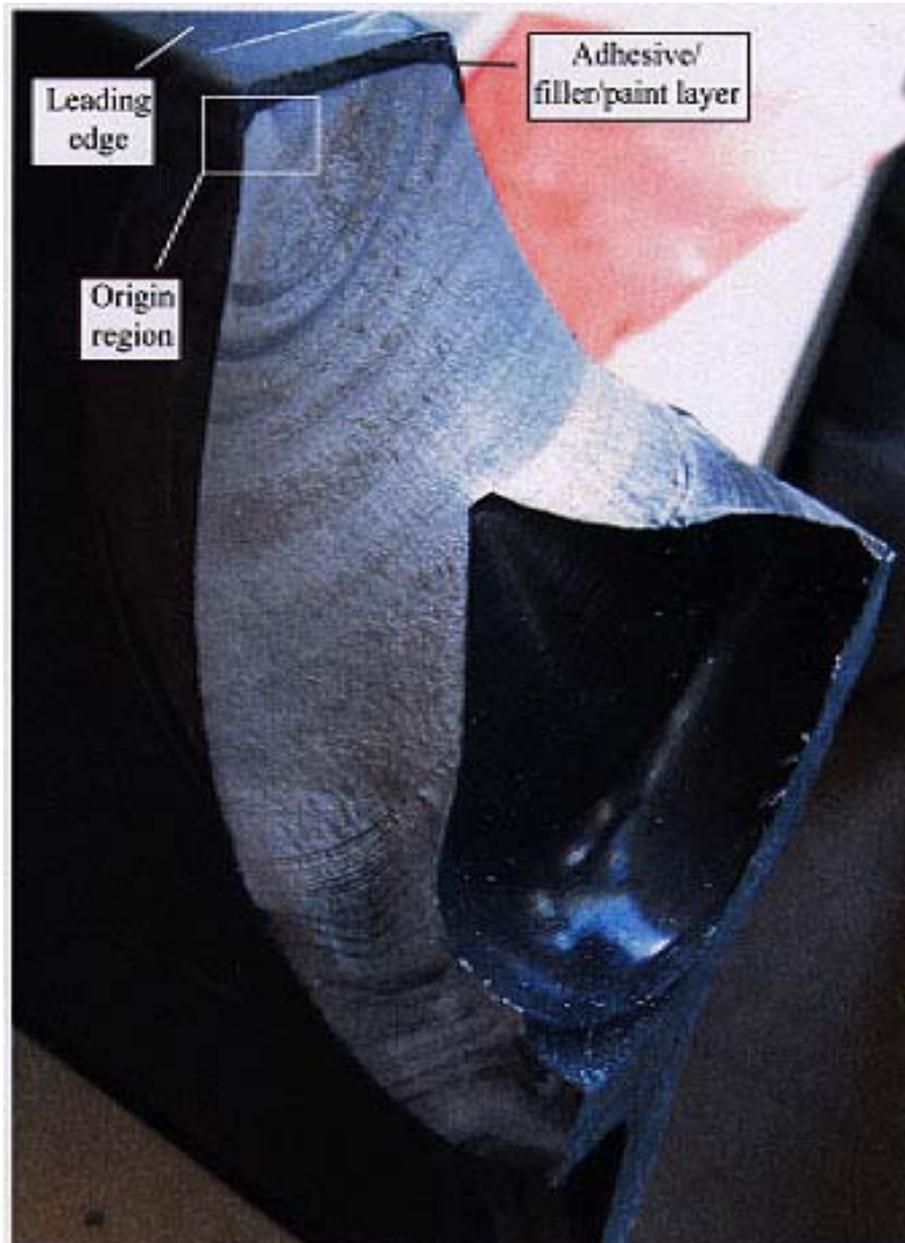
Figure 7
Outboard half of fracture

The fracture originated at the leading edge lower corner of the section in the region identified in Figure 7, and shown in detail in Figure 8. There was no single-point origin; rather, the crack initiated over an approximately 1 mm length of surface coinciding with a facet adjacent to the bottom corner of the leading edge; this was consistent with stress-induced cracking. No evidence was found of any

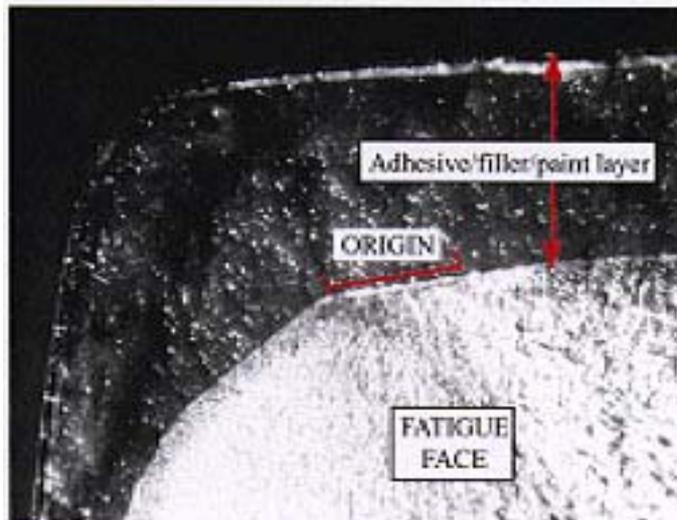
Figure 8
Close up of origin region

corrosion or pitting of the surface in the origin region; nor of any inclusions or other metallurgical defects within the material.

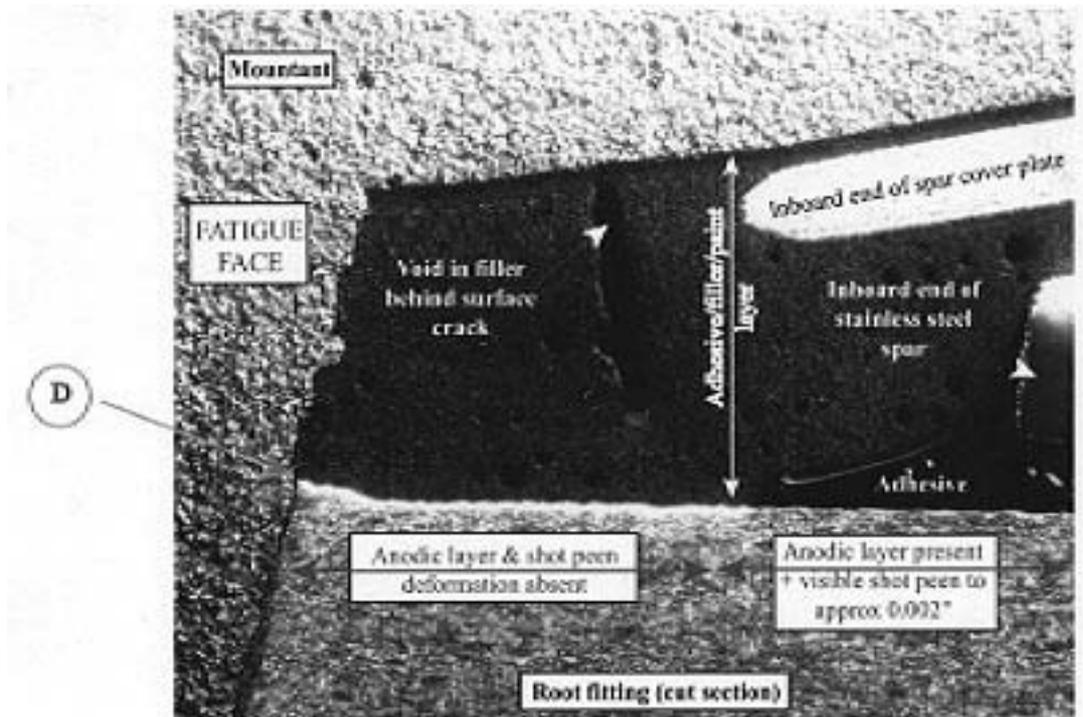
- a thin anodic layer was visible in the region beneath the spar/adhesive fillet, but absent inboard of the fillet, except over a small band approximately 0.5 mm wide located approximately mid way between the end of the spar and the fracture, and
- deformation of the grain structure consistent with that produced by shot peening was visible in the region beneath the spar/adhesive fillet, but absent inboard of the fillet; except in the narrow 0.5 mm band where the anodic layer was present (see above).

Where evidence of grain deformation characteristic of shot peening was present, the visible depth of the deformation layer was typically 0.002". Figure 9 shows the mounted and etched section, labelled to show the features referred to above.

Mounted and etched spanwise section, cut normal to chordwise axis in a plane approximately 4 mm back from the lower corner of the leading edge

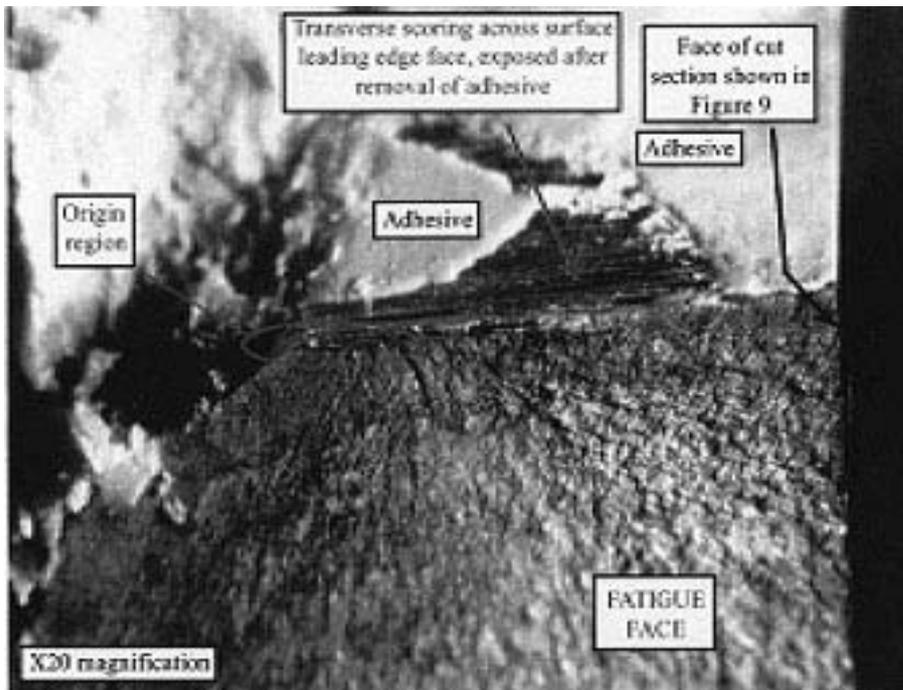
Figure 10 shows the region thus exposed, looking obliquely down in a spanwise direction onto the fracture and leading edge faces. The exposed leading edge surface was characterised by a series of closely spaced scores, running transversely across the leading edge and parallel to the plane of the

fracture, which appeared to have been produced by an abrasive process. These features are highlighted in Figure 10.

Transverse surface scoring of leading edge face in vicinity of origin, exposed after localised removal of filler/adhesive layers (Oblique view, looking spanwise onto outboard fracture face and leading edge surface - in direction of arrow 'D' in Figure 9)

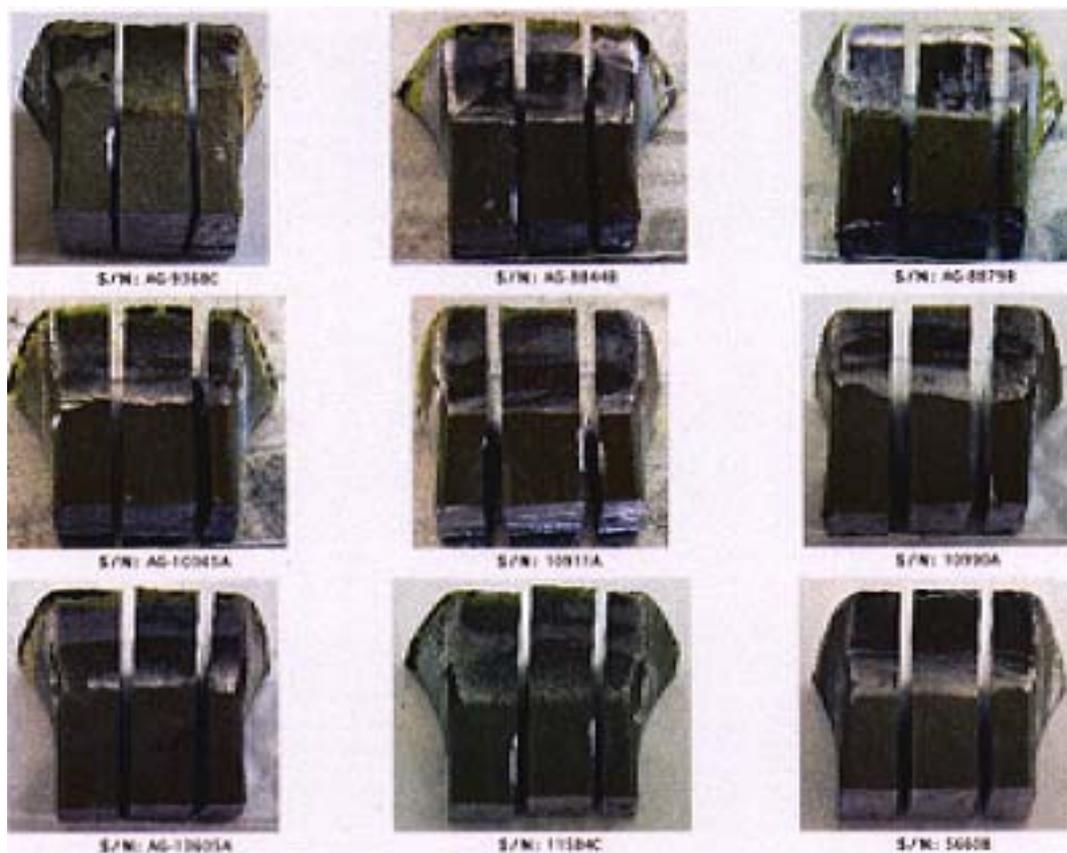
Removal of the filler and adhesive layers from the opposing intact blade from both G-IORG, and the range of sample blades revealed a broadly consistent pattern of transverse abrasion across the leading edge face just inboard of the spar, and around the corners. This was similar to that noted on the cracked blade from G-IORG. Figure 13 shows the opposing blade from G-IORG, and Figure 14 shows these characteristics on the other sample blades examined by the AAIB.

Figure 14
Surface condition of sample blades obtained by AAIB for comparison with the blades from G-IORG

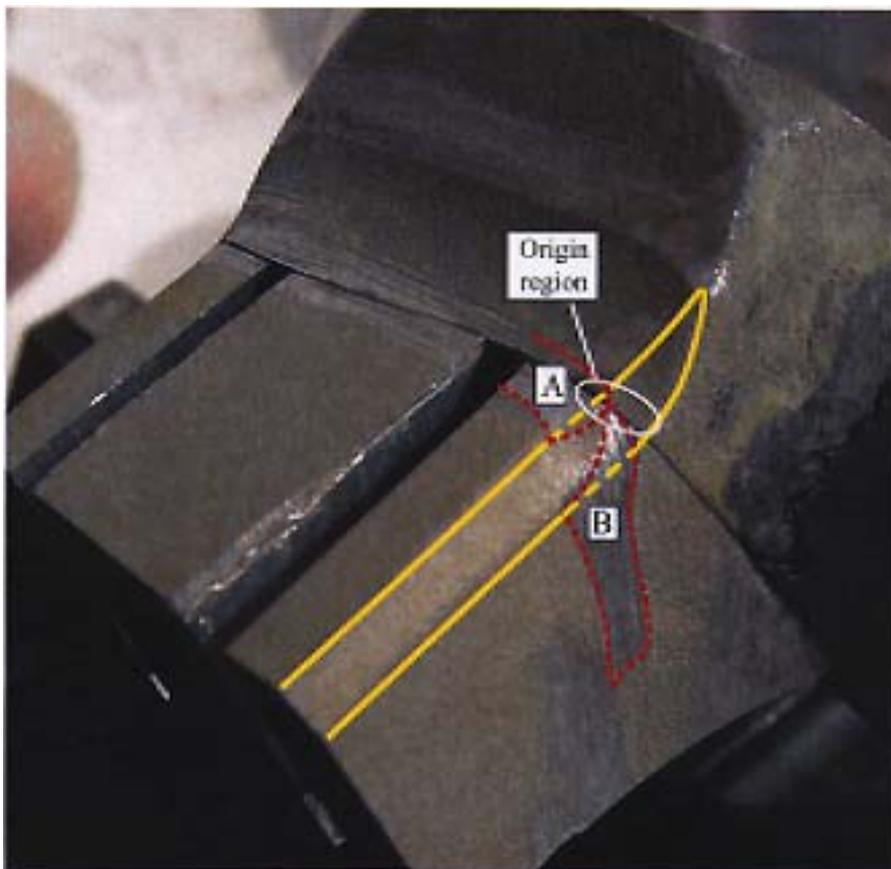
Figure 16 illustrates how the excavated valleys (red boundary) intersect the manufactured chamfer (yellow boundary) to form a particularly complex 3D surface geometry in the crack initiation region. It also shows that the origin of the fatigue fracture lies very close to the point where two separate regions of surface excavation, labelled A & B in Figure 16, conjoin.

Figure 16
Modifications to the surface topography in the origin region,
due to the abrasion damage

In this same area, deep score lines, running around the chamfer, create a series of small but distinct steps, forming a terrace-like surface which further adds to the complexity of the macro surface topography in the region of the crack origin.

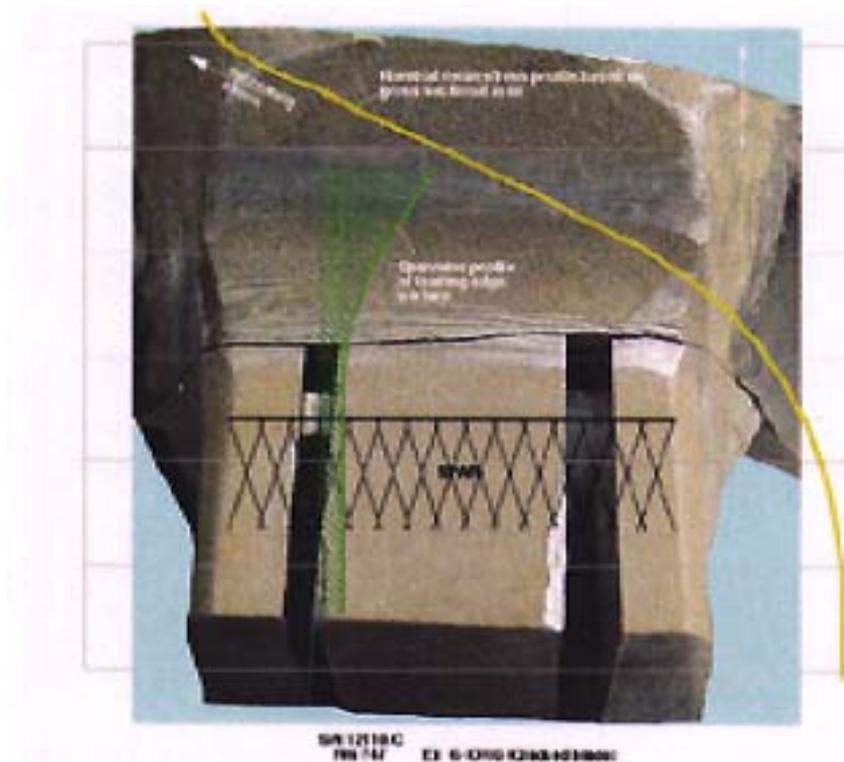
- ii) The most significant stress concentration occurred at a critical spanwise position, ie, just inboard of the spar, where the cross-sectional form of the fitting did not benefit from the increase in section-area as the fitting changes shape from an aerofoil to a hemispherical form. Figure 17 shows the nominal mean stress profile, based on CF tensile loading, acting upon sectional area-changes across the affected region. From this it can be seen that the stress concentration produced around the conjoined/stepped region is located outboard of the region where the nominal background stress starts to decrease due to the increase in sectional area.

- iii) A thinner than normal overall shot peened layer on the leading edge, and the consequent probability that the abrasion process would remove the peened layer totally in the areas affected, thus depriving the high stress region of the mitigating effect of a fatigue suppressing compressive surface layer.

Figure 17
Correlation between surface damage and mean stress profile (yellow)
and surface profile (green)

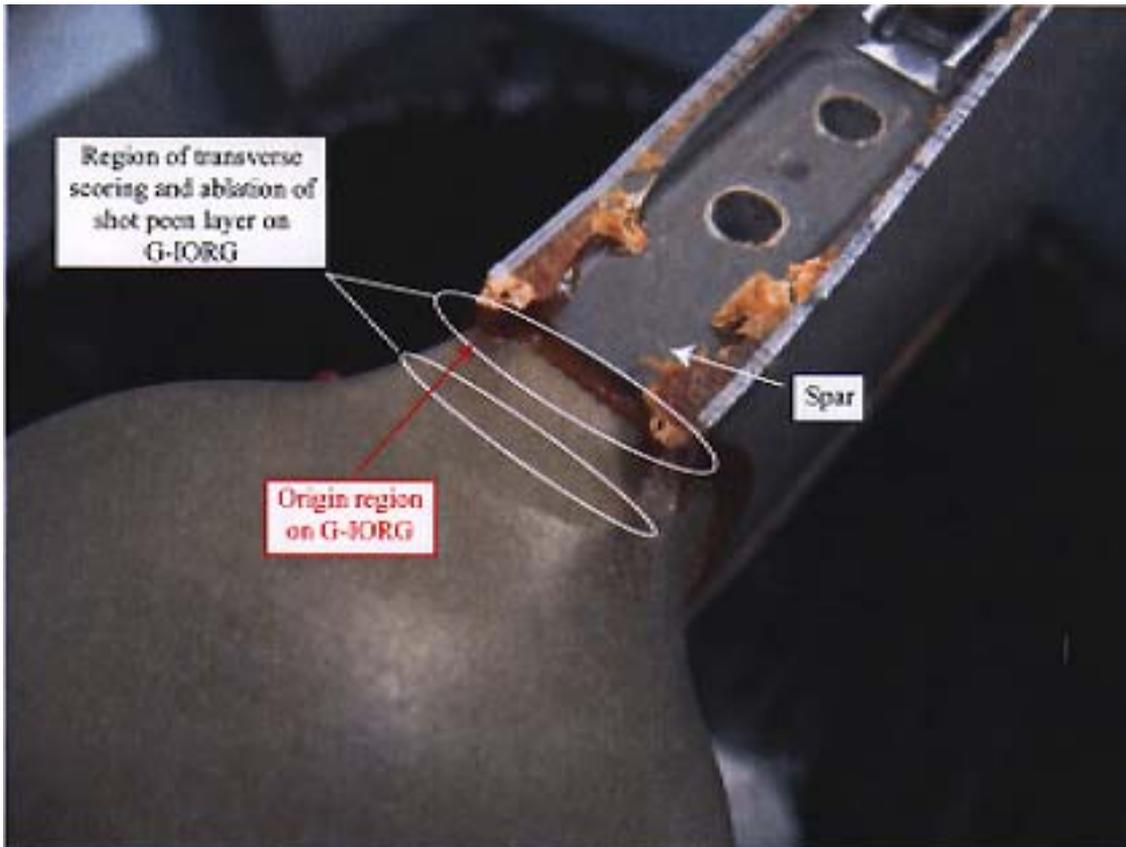
During the bond-cure process, excess adhesive squeezes out in significant quantities from the various joint lines between components. Prior to this investigation, this excess was removed by use of a die grinder fitted with a small grit-loaded rubber wheel. Figure 18 shows a typical blade prior to removal of the excess adhesive, with the areas of the leading edge damaged during grinding operations to remove this excess adhesive identified.

Figure 18
Blade root at inboard end of spar,
before clean-up of excess adhesive and final dressing of blade

Whilst considerable effort had clearly been invested in maintenance of quality control of the bond process, relatively little consideration appears to have been given to controlling the quality of surface finish. The lack of any positive form of control over the use of power grinders on the root fitting, especially for operations which were essentially of a cosmetic nature, was inappropriate, given that this is a stress-critical area where both surface finish and macro geometry are critically important factors in relation to fatigue sensitivity. This shortcoming was compounded by:
