AIRCRAFT ACCIDENT REPORT 1/2010

Air Accidents Investigation Branch

**Report on the accident to
Boeing 777-236ER, G-YMMM,
at London Heathrow Airport
on 17 January 2008**

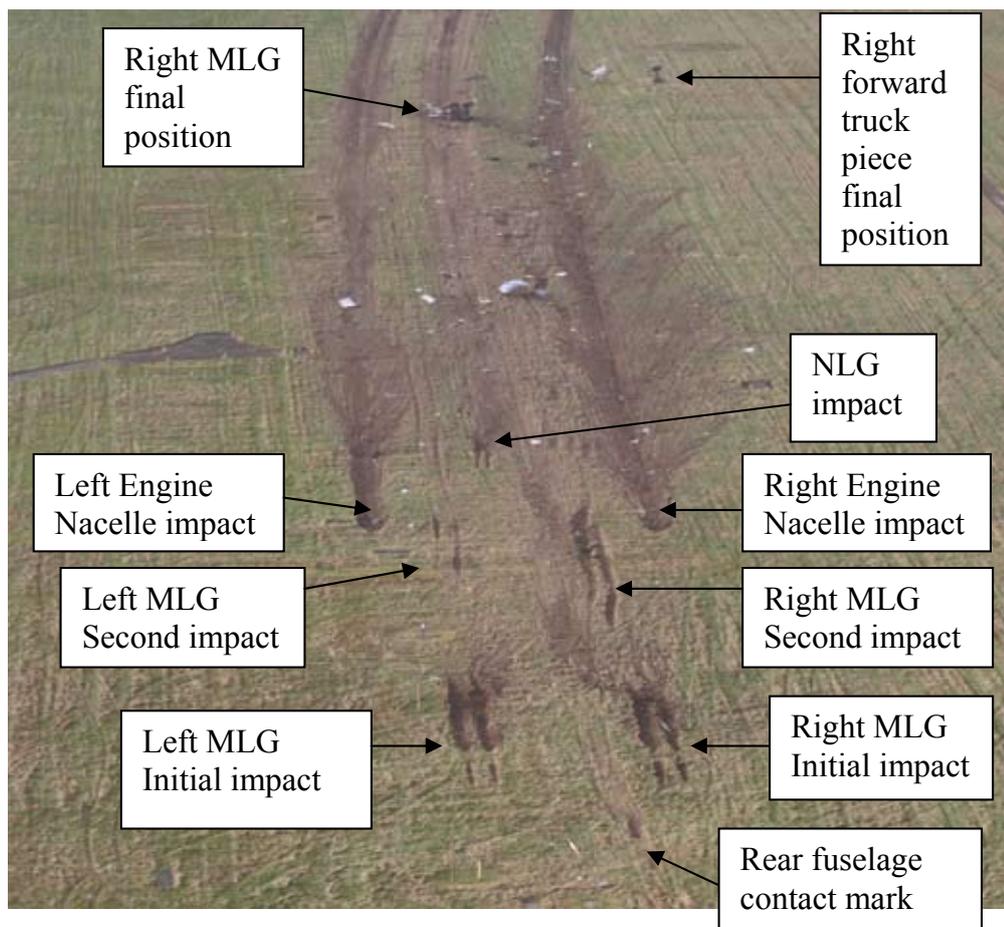
Approximately 40 m beyond its initial contact, the left engine struck the concrete cover of the southern inspection pit, which caused severe disruption to the front and lower engine area and the failure of the majority of its fan blades.

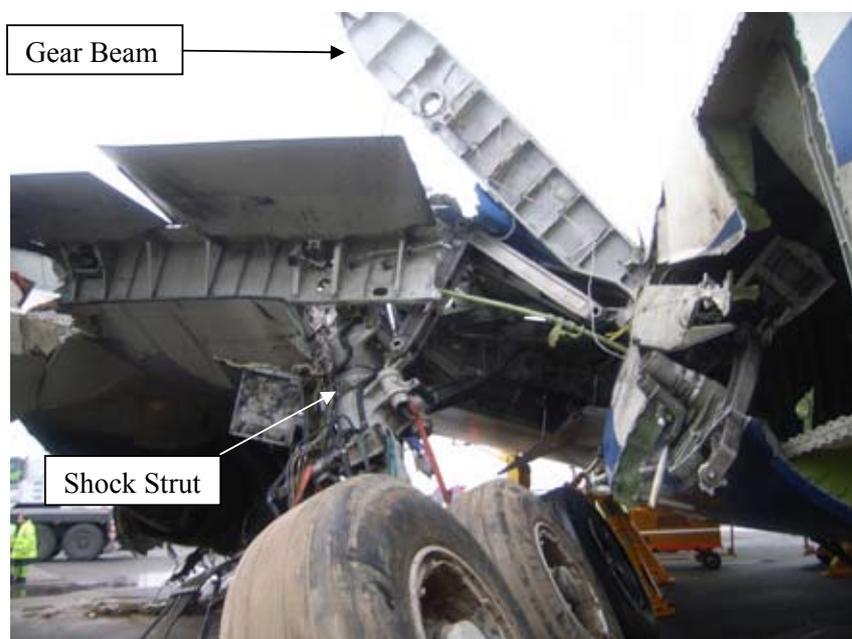
Figure 25

The truck beam had evidence of damage due to over-travel in the truck pitch-up direction. There was no visible damage to the shock strut or centre axle

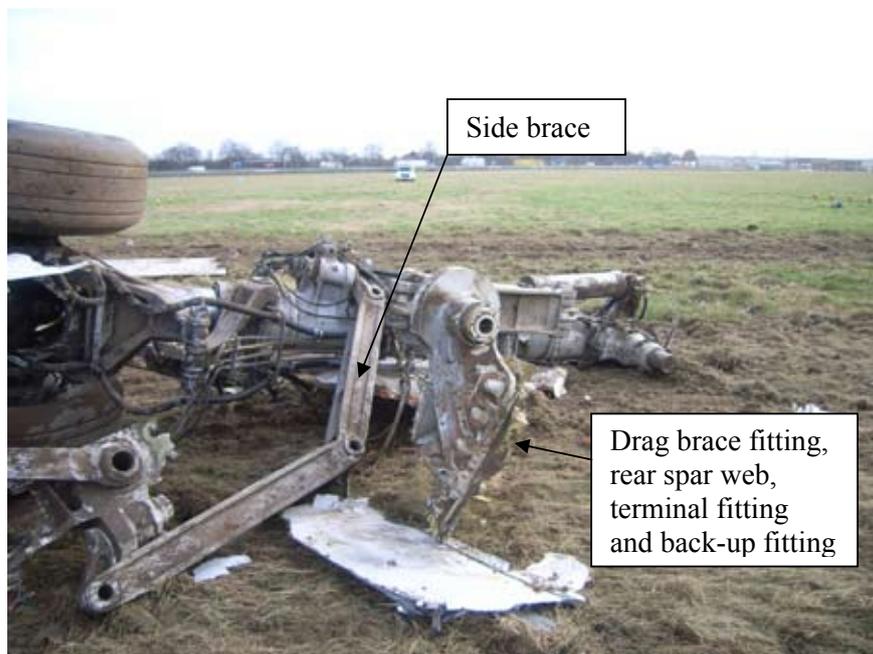
Figure 26

During the subsequent ground slide the right MLG had separated from the aircraft, rupturing the rear wing spar web. The drag brace support fitting, together with portions of the rear spar web, rear terminal fitting and the internal back-up fitting remained attached to the right main landing gear around the drag brace fitting. Examination of the fracture surfaces indicated an overload in the aft direction.

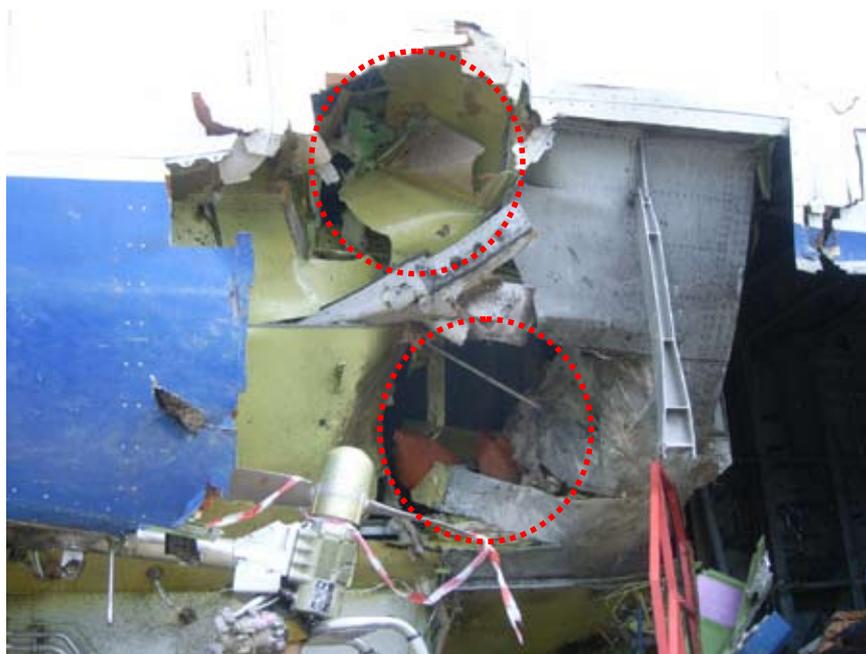
Figure 29

The two front wheels of the right MLG, together with the forward section of the truck beam ahead of the centre axle became detached and impacted the right side of the fuselage.

View showing damage to right fuselage aft of the MLG bay.
(Dotted lines indicate impact marks from the rear two wheels of
the truck beam)

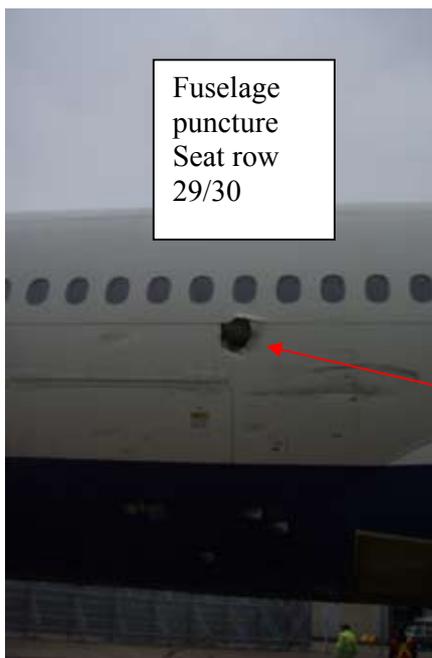
Figure 30

Right side of fuselage showing damage at seat rows 29/30

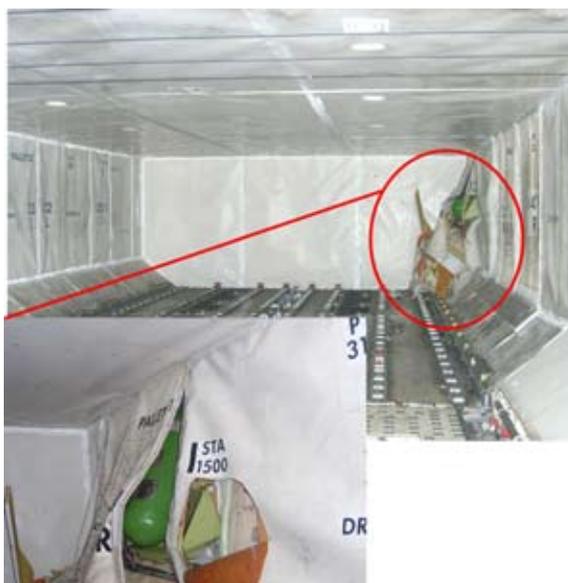
Figure 32

The impact and penetration of the forward right side of the rear cargo bay by the right landing gear tore one of the oxygen cylinders from the cabin oxygen supply manifold, rupturing the manifold pipe (Figure 32). This allowed all the remaining cabin oxygen cylinders to vent to atmosphere.

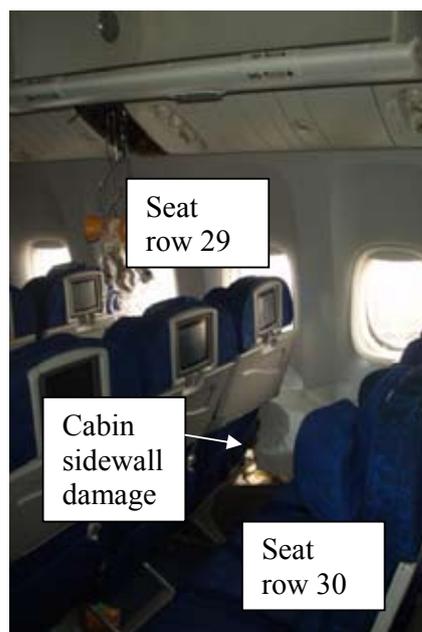
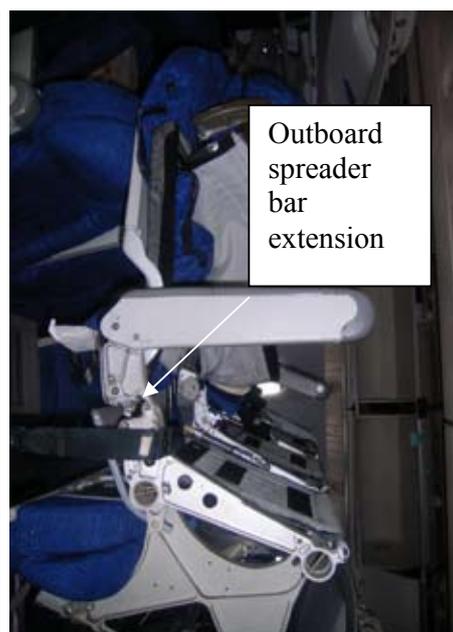
Figure 33

The right MLG forward truck beam and its wheels had punctured the right side of the fuselage adjacent to seat rows 29-30, at the height of the seat armrest (Figures 33 and 34). This had breached the fuselage outer skin, insulation blankets and the cabin lining panel. The sidewall lining had been pushed into the cabin, resulting in the injury to the passenger seated in 30K and the failure of the outboard spreader bar extension of seat 29K.

Cabin damage at rows 29/30

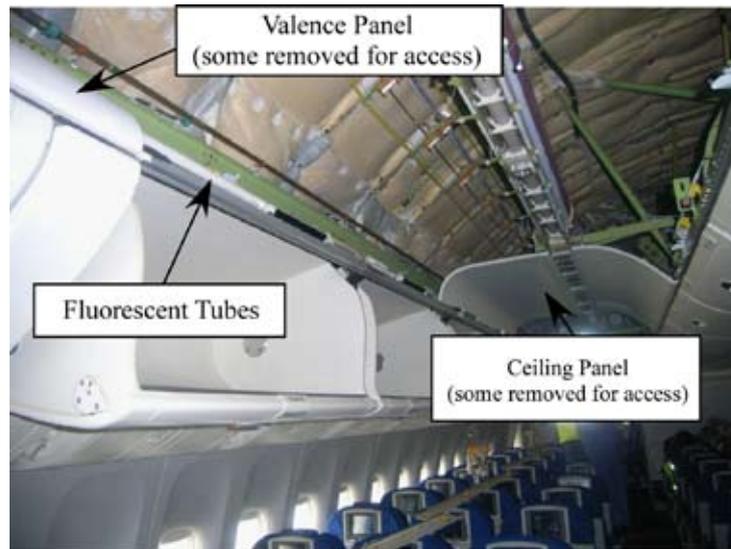
Figure 36

A further, detailed examination showed that on the right side there were eight fluorescent tubes missing. Of these, five had separated from the fixtures but were intact and were lodged above the overhead bins behind the valence panels. Three fluorescent tubes had broken. On the left side there were ten fluorescent tubes missing; five tubes had separated but were intact and five had broken. Three of the fixtures were damaged but the tube retaining end fittings were still functional. The gap between the ceiling panel and the valence panel contained numerous fragments from the fluorescent tubes.

Overhead lighting, showing loose fluorescent tubes

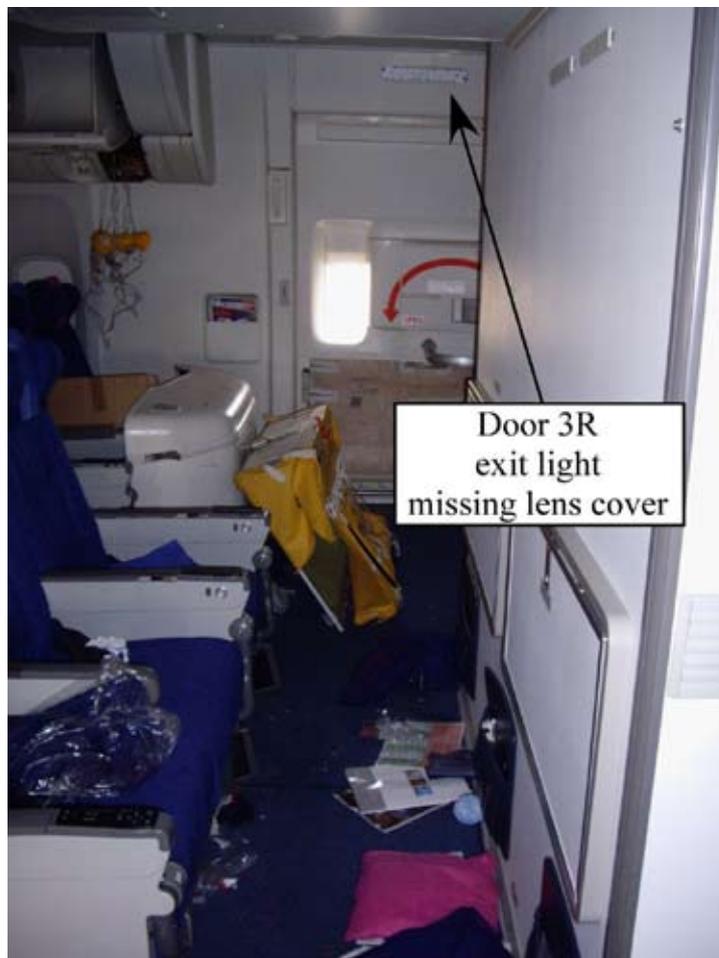
Figure 38

The exit signs light lenses were found to have detached from Door 3L and 3R (Figure 38) and it was evident that any misalignment of the plastic door mouldings resulted in difficulty in engaging all four of the mounting clips.

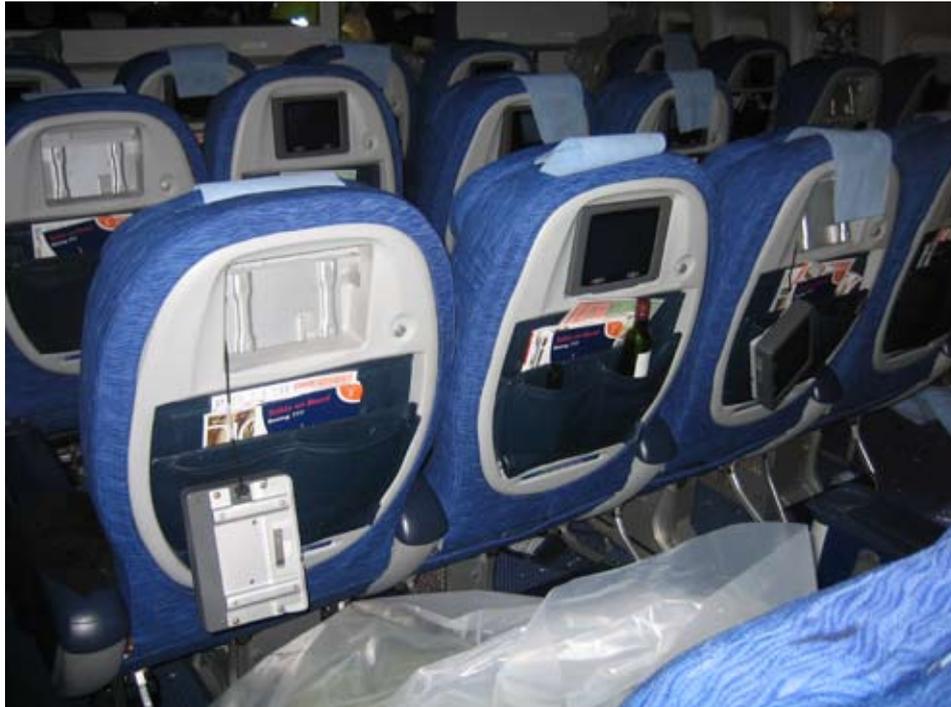
Figure 39

Further examination revealed that by exerting a downward force by hand, it was possible to detach one of the monitors which otherwise appeared to be correctly located. The spring clip attachments were found to be loose, allowing movement of the clip and preventing correct engagement in the detent.

Business Economy section showing video monitors detached from the seat backs

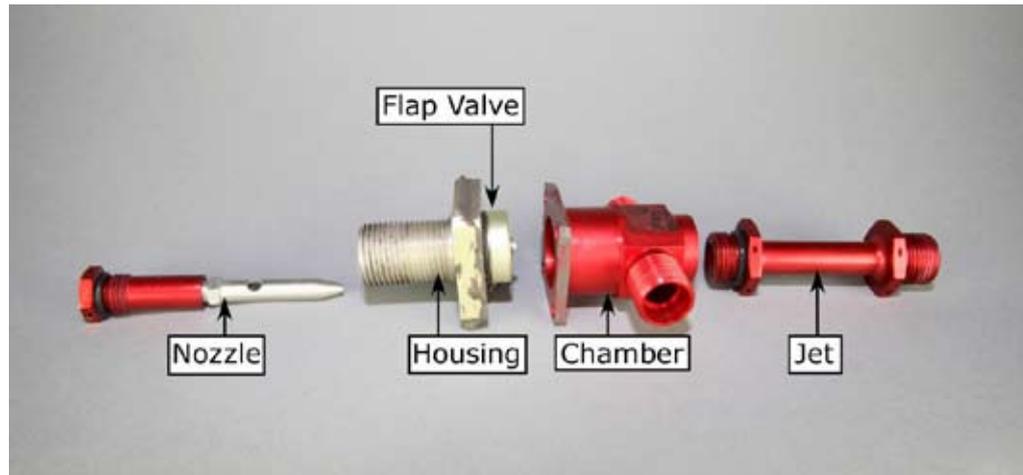
Figure 44

When the nozzle from the right main scavenge jet pump was removed from its housing half a teaspoon of a 'jelly-like' substance, later identified in a laboratory as "water", was found in the housing. It is not known if this water was originally lodged in the nozzle and was pulled through the flap valve into the housing, or whether the water had been introduced into the housing during a previous maintenance activity. The water was tested for microbiological contamination and the quantity of contamination was assessed as negligible.

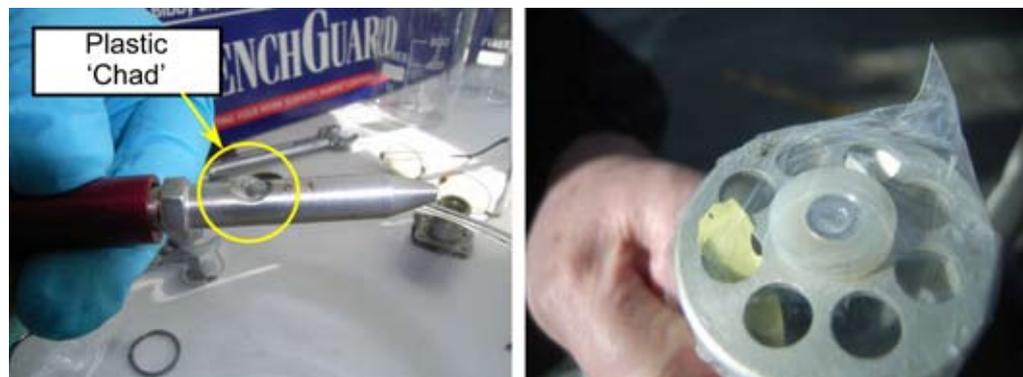
Figure 45

A 6 mm plastic disc (chad) was found in the chamber of the right main scavenge jet pump, which was large enough to block one of the ports in the nozzle, Figure 45. A flake of paint was found trapped in the pipe between the scavenge inlet and the chamber (Figure 45). From a swab taken from the inside of the chamber, it was established that there was a moderate amount of microbiological contamination on the internal surfaces of the chamber.

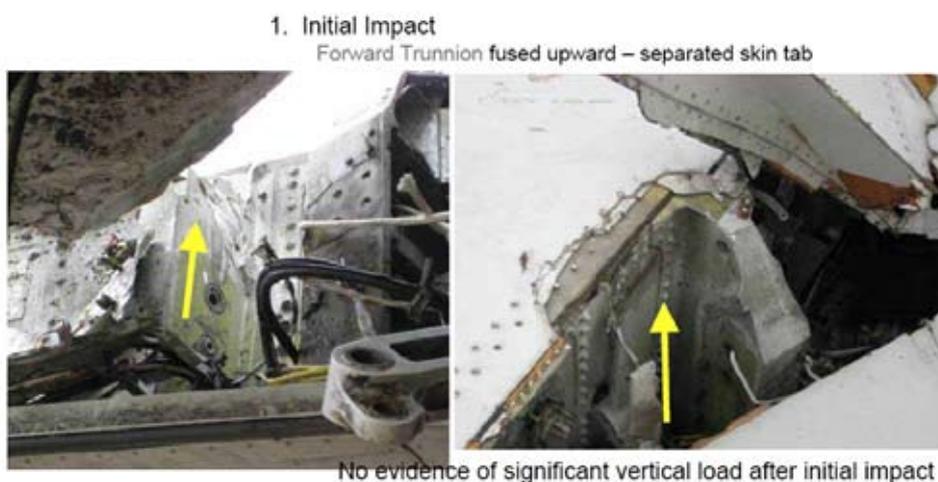
1. Initial impact: Gear beam outboard attachment fuse pins failed
Forward trunnion upper and lower housing fuse pins failed
Drag brace fuse pin 'crankshafted'

Note the piece of upper wing skin removed by the separation of the upper and lower housings. This impact had pried open the wing tank.

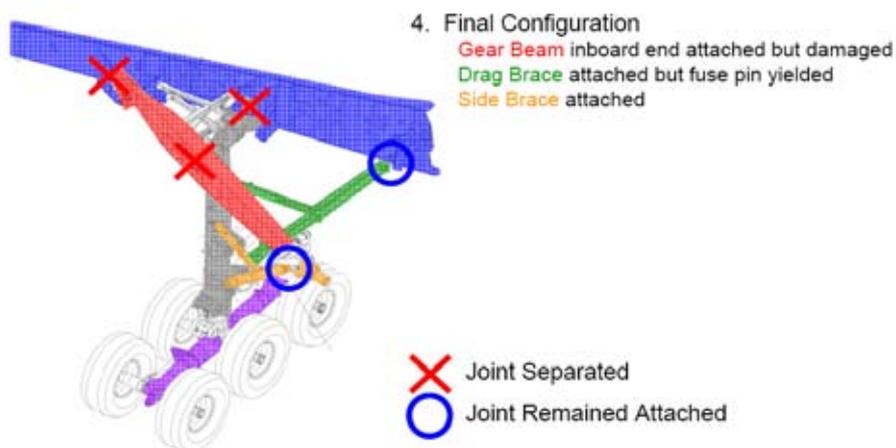
4. Final Configuration: Gear beam inboard end damaged but still attached, drag and side brace both folded but still attached.

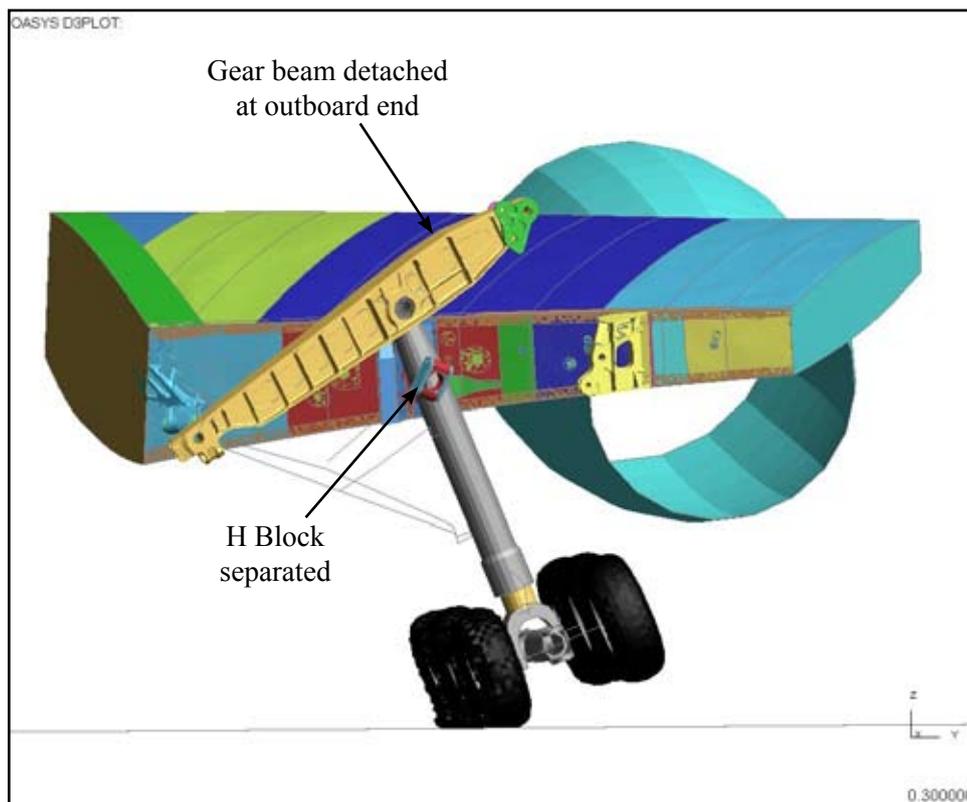
Figure 66 shows a view from behind the right wing during the impact sequence, at the point when the outboard end of the gear beam and the lower and upper housings have failed.
