No: 8/92

Ref: EW/A92/5/1

Aircraft Type and Registration: Boeing 747-212B, G-TKYO

Nature of Damage: Damage to left inboard flaps and wing trailing edge upper fixed panel

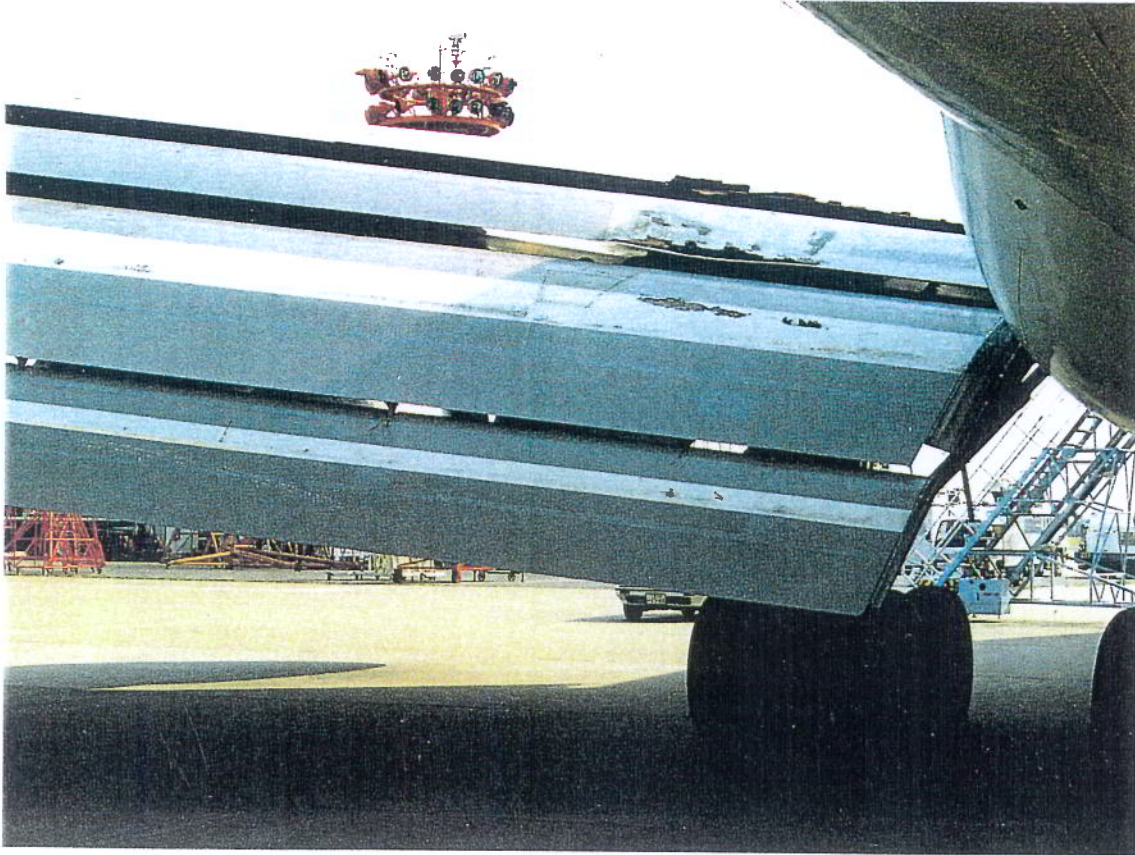
Figure 1

The aircraft was examined prior to, and during, the repairs which were carried out at Narita airport. This revealed that damage had occurred to the top surfaces of the inboard fore and mid-flaps and that the whole trailing edge of the upper wing surface fixed panel, which abuts the fuselage fairing, had broken away (Figures 1 and 2), to leave a ragged and disbonded edge. At the outboard end, approximately the aftmost 60 inches of this panel were missing, together with a similar length of the aft portion of rib No 3, and approximately 20 inches of panel at the inboard end. The fractured surfaces of rib No 3 indicated that this had failed under overload conditions. The Configuration Deviation List for the aircraft allows for flight, subject to various limitations, with up to 112 x 36 inches of the aft portion of this panel missing, but makes no mention of possible damage to the flaps, or vibration. The upper surface of the fore-flap had been severely 'pounded' such that an area of its honeycomb structure towards the trailing edge, and several sections of upper skin, were missing. Similarly, crushing damage and a hole were present in the upper surface of the mid-flap. Upon considering the relative positions of the fixed panel trailing edge and this flap damage, it became apparent that the damage to the flaps had occurred as a result of the break-up of the panel's trailing edge whilst the flap had been in the range between 5° and fully retracted. Most of this damage was associated with the outboard half of the fixed panel. This panel is of composite construction with a honeycomb core and an examination showed no evidence of pre-existing delamination, disbonding or water contamination. No assessment of the detached sections could be made since these were not recovered.

General view of flap damage

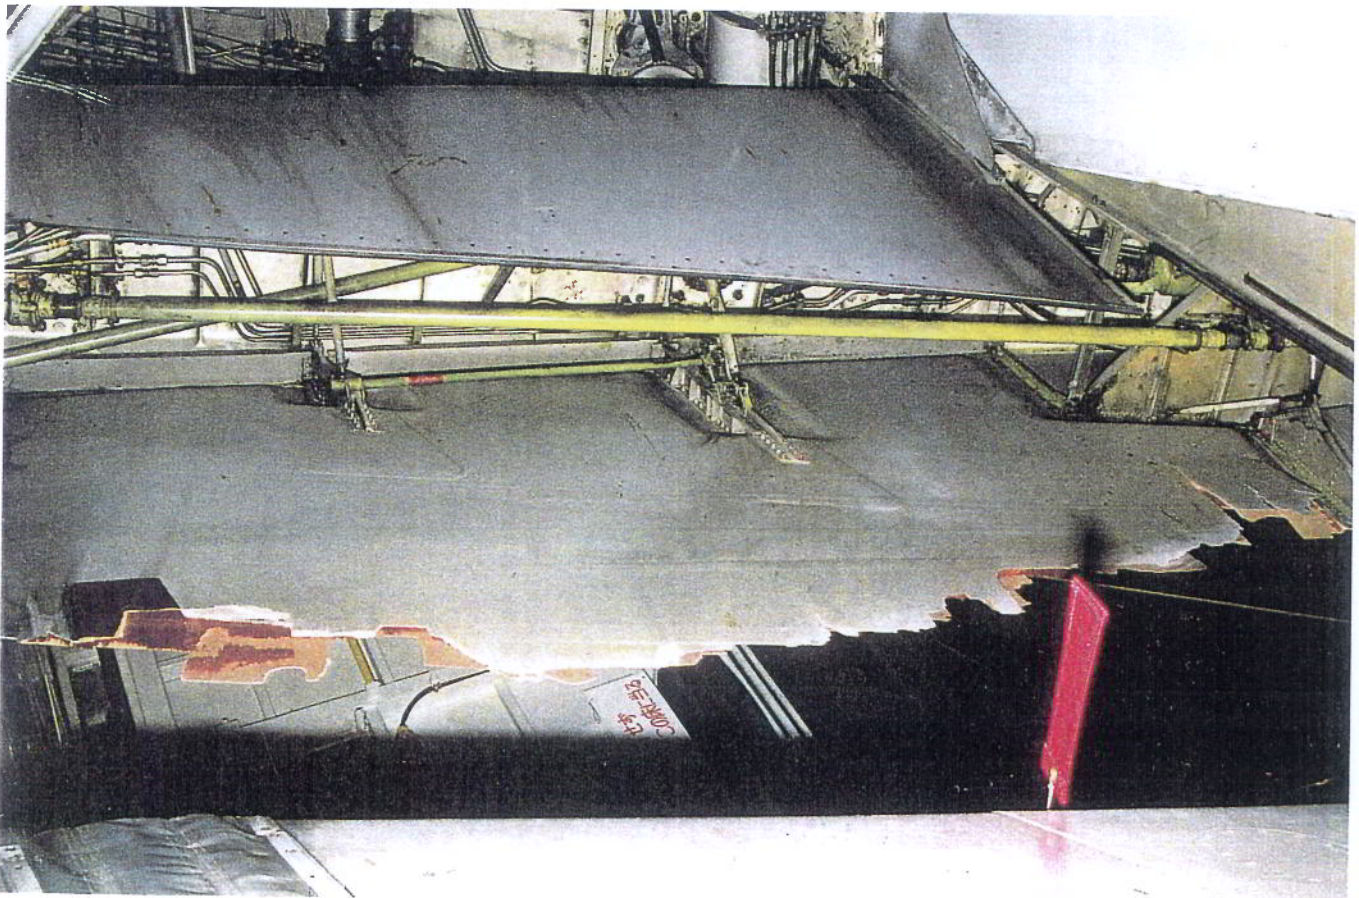
Figure 2

The trailing edge of the fixed upper panel is designed so that it is deflected upwards, by a maximum amount of 1.75" at its trailing edge in line with the inboard rib, by the upper surface of the mid-flap at its inboard end when the flaps are fully retracted. It is intended that the outboard end of the upper panel should remain clear of the flaps. Rubbing strips and low friction paint are employed between these surfaces to minimise wear, the areas of contact being evident from witness marks on the paint. Wear patterns were apparent on the low friction paint of the affected area of the left fore-flap and, when compared with the right side of G-TKYO and several other aircraft examined, appeared abnormal in that a triangular shaped area of 'dirty' paint was coincident with the damage to the fore-flap. Close inspection of this area revealed it to have been caused by

the lower surface of the fixed panel 'hammering' the top surface of the flap as the panel trailing edge disintegrated.

Lower view of damage to fixed upper panel

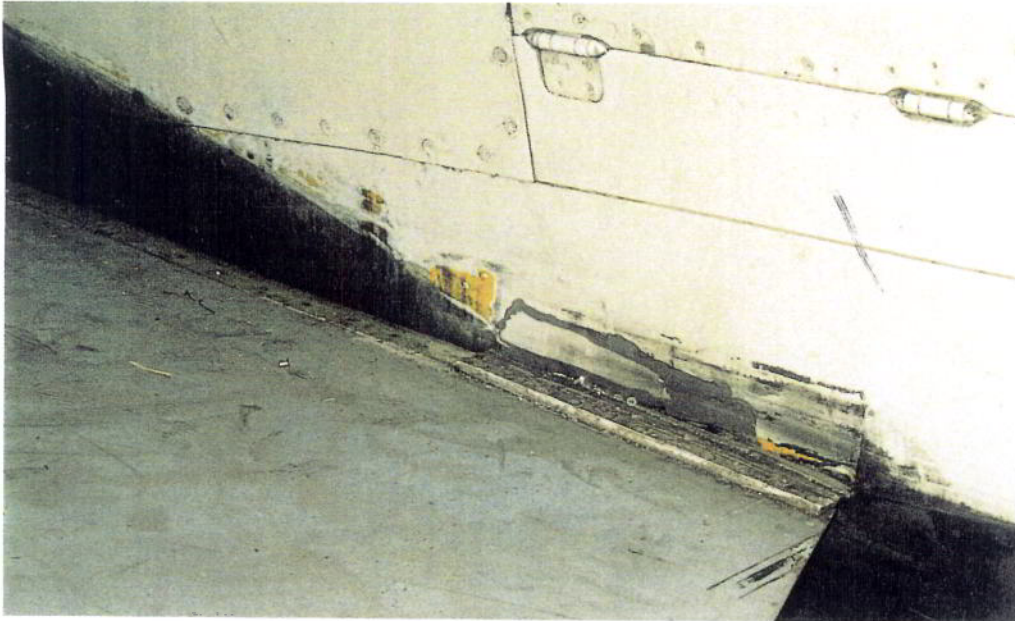
Figure 3

A more significant area of witness marking was present on the fuselage side, in the region of the aft inboard edge of the fixed panel. At this location, marks from the rubber edge seal showed the extent to which the inboard aft edge of the panel had been flexed upwards, this marking being present on all other Boeing 747's examined. However, the extent to which the panel had been flexed upwards during normal operation was not conclusively established from these marks as some of the marking had undoubtedly resulted from the break-up of the panel. Nevertheless, the upper limit of the area of heavier witness marks suggested that this panel had been flexed in excess of the quoted maximum and certainly to a slightly higher level than panels on other aircraft, or that on the right side of the same aircraft. These witness marks are compared in Figures 3 and 4 with those from another aircraft.

Comparison of fixed panel witness marks against fuselage side

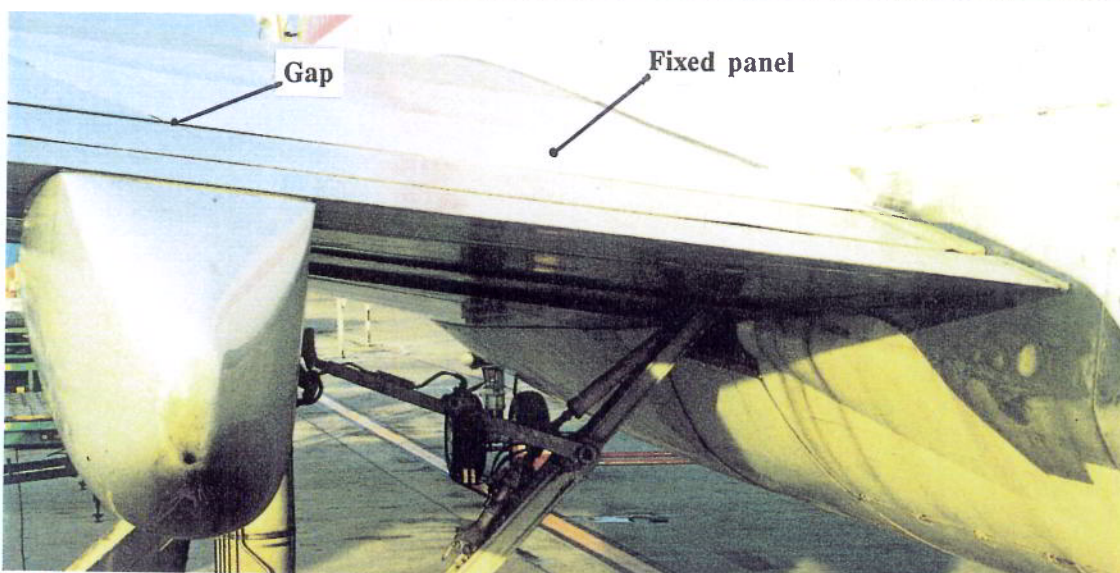
Figure 5 shows the left side panel, after the aircraft had been repaired, rigged in accordance with the revised Service Bulletin and flown back to London Heathrow, with the flaps in the fully retracted position. A measure of contact is evident between the inboard end of the fixed panel and fore-flap but little, if any, at its outboard end (as required). Figure 6 illustrates the rigging requirements.

Flaps fully in, after repair/re-rig
