INCIDENT

Aircraft Type and Registration:	Avro 146-RJ100, G-CFAA
No & Type of Engines:	4 Lycoming LF507-1F turbofan engines
Year of Manufacture:	2000
Date & Time (UTC):	7 January 2005 at 1335 hrs
Location:	London City Airport, London
Type of Flight:	Public Transport (Passenger)
Persons on Board:	Crew - 5 Passengers - 53
Injuries:	Crew - None Passengers - None
Nature of Damage:	Damage to Ground Strike Indicator
Commander's Licence:	Airline Transport Pilots Licence
Commander's Age:	35 years
Commander's Flying Experience:	7,100 hours (of which 880 were on type) Last 90 days - 133 hours Last 28 days - 33 hours
Information Source:	AAIB Field Investigation

During a landing in blustery conditions on Runway 28 at London City Airport, the aircraft's tail struck the ground, causing damage limited to the Ground Strike Indicator.

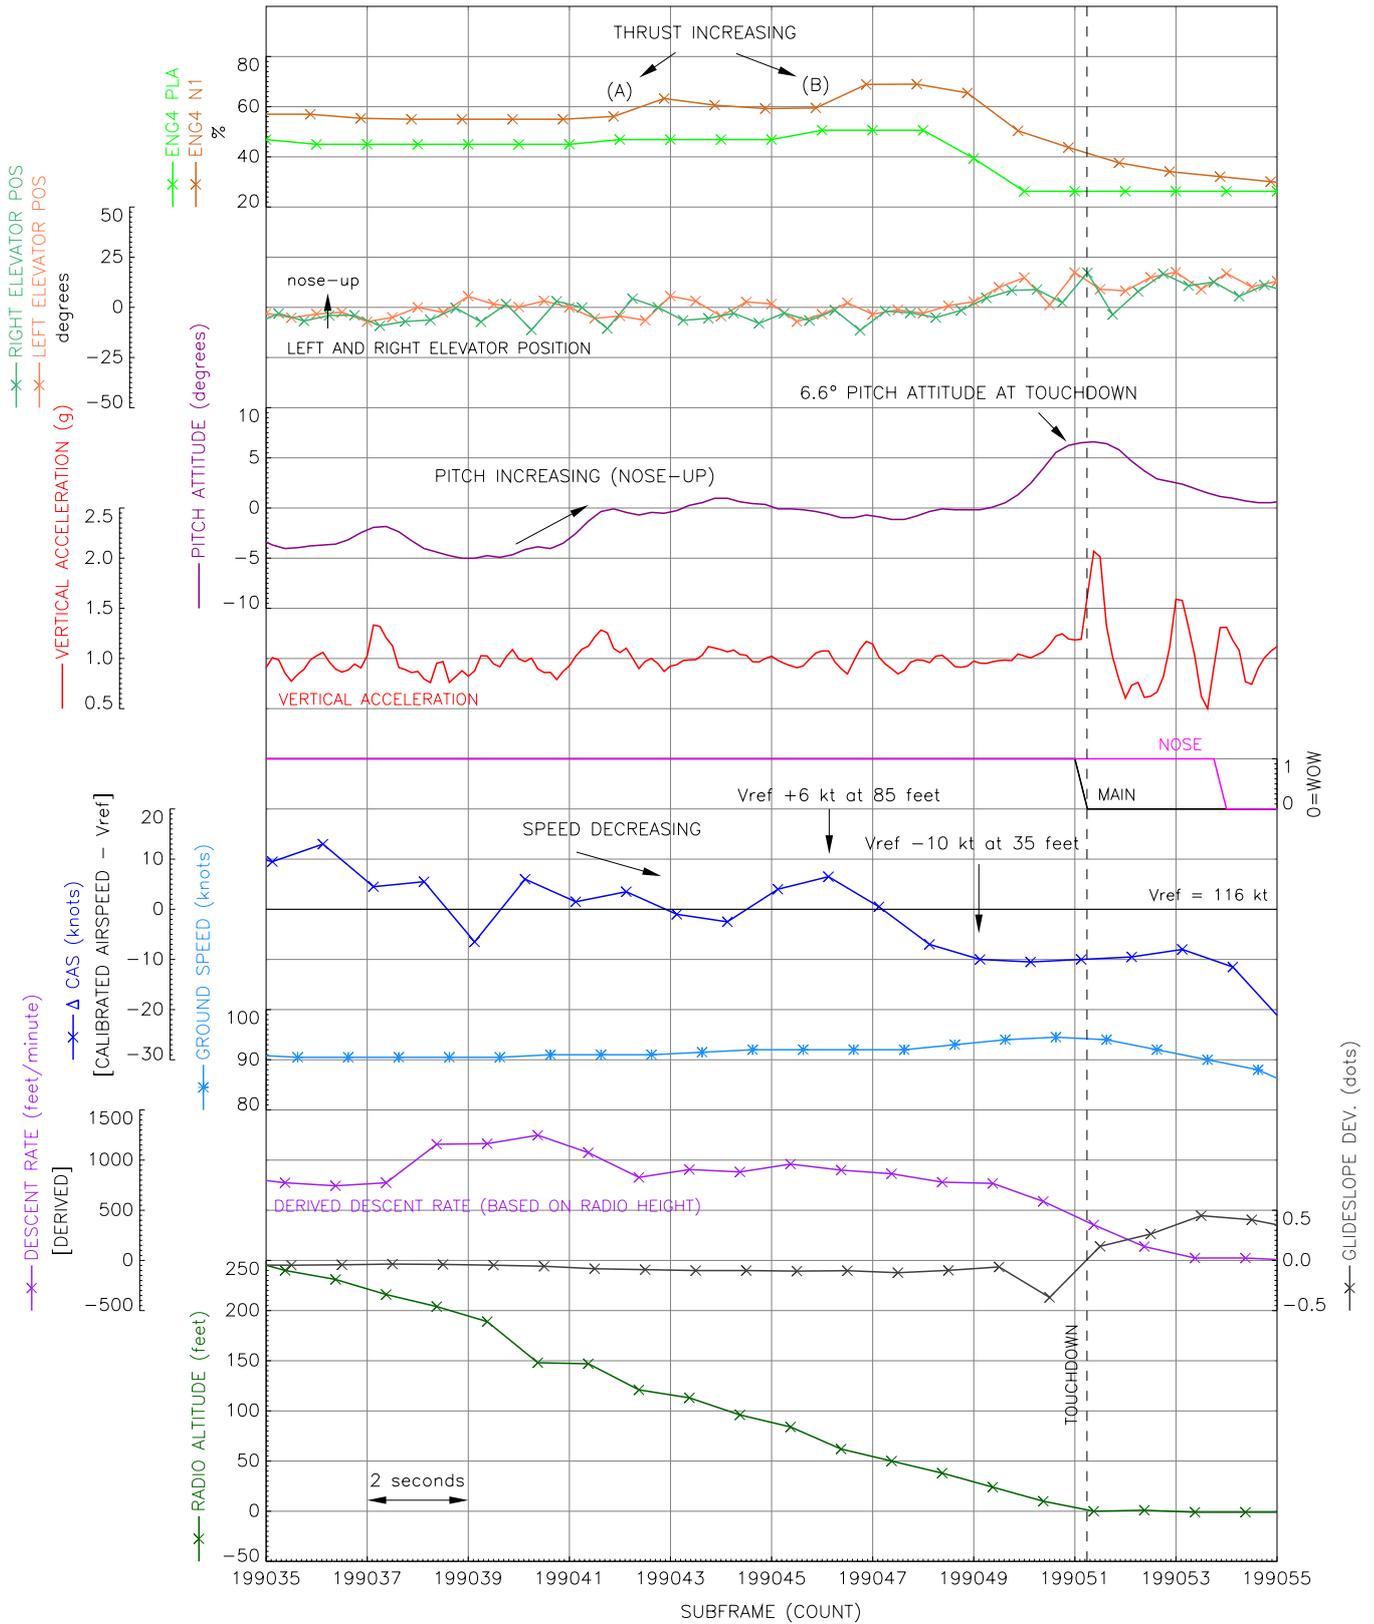
Figure 1
 Salient FDR Parameters
 (Incident to G-CFAA on 7 January 2005)

A time-history of the relevant parameters during the incident is shown in Figure 1.

The data presented for the incident landing starts just over 16 seconds before the touchdown with the aircraft on the glideslope; 245 ft above the ground; at 125 kt (ie $V_{ref} + 9$ kt); with a descent rate of about 750 ft/min and a fan speed (N1) of about 57% on each of the engines. For clarity, the Power Lever Angle (PLA) and N1 are shown for engine No 4 only; these are, however, representative of those of the other three engines.

The figure shows two points during the descent (Points A and B of Figure 1) at which additional thrust was applied. The first thrust increase was from 57% to 63% N1, at about 150 ft and 9 seconds before touchdown. This increase in thrust followed an increase in aircraft pitch attitude from -5° to 0° and coincided with a decrease in airspeed from $V_{ref} + 6$ kt to $V_{ref} - 2$ kt.

The second thrust increase was from 60% to 69% N1, at about 85 ft and 5 seconds before touchdown. This occurred as the aircraft pitch decreased slightly and the airspeed increased from $V_{ref} - 2$ kt to $V_{ref} + 6$ kt. As the N1 began to increase, the airspeed reduced by 16 kt to $V_{ref} - 10$ kt over 3 seconds, at a peak deceleration of 7 kt per second; the aircraft pitch attitude remained nominally level and the ground speed only increased by 2 kt to 94 kt. The aircraft height when the airspeed reached $V_{ref} - 10$ kt was 35 ft and the airspeed remained at $V_{ref} - 10$ kt until touchdown.

At touchdown the recorded pitch attitude peaked at 6.6° and the descent rate was 600 ft/min (10 ft/sec).

As the aircraft approached, at about 85 ft, the commander increased thrust from 60% to 69% N1 and decreased the pitch attitude slightly. Both of these actions should, in still air, have resulted in an increase in airspeed. However, the airspeed decreased by 16 kt over 3 seconds, although the ground speed increased slightly. By 35 ft, the speed was 10 kt below V_{ref} making a normal touchdown difficult to achieve, with any attempt to flare the aircraft for touchdown causing a further reduction in speed. During the flare, the pitch attitude increased to 6.6° nose up and the tail contacted the runway. This evidence is consistent with an encounter with significant negative windshear immediately prior to touchdown.
