# Bell 206L-1, N206DD

**AAIB Bulletin No:** 7/2001    **Ref:** EW/G2001/01/06    **Category:** 2.3

**Aircraft Type and Registration:** Bell 206L-1, N206DD

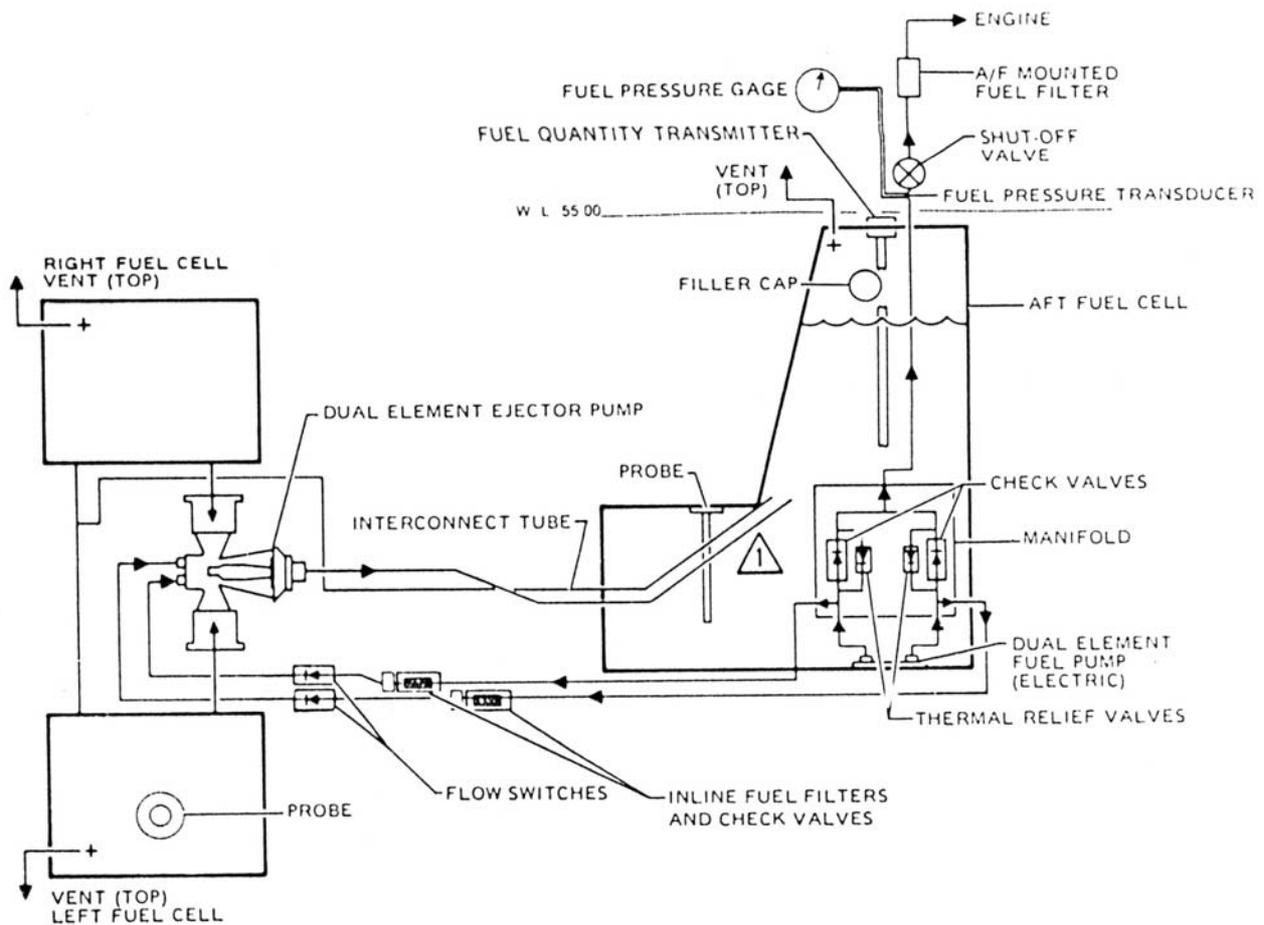
"Examination of the dynamic components of the helicopter did not disclose evidence of pre-impact problems. Water was found in the engine nozzle fuel line and airframe filter. Also, the airframe fuel filter was found only 20% full of liquid but is typically found full of fuel under normal circumstances. Whether the water ingress into the fuel line was as a result of the mishap is unknown; however, no breaks were seen in the lines and fittings attached to these components. A significant amount of contamination was found in the left side inline fuel transfer filter. The nature of this contamination indicates it was present in the filter before the mishap occurred. The amount of debris on the filter screen likely resulted in fuel bypassing the screen at some point; however, no debris was seen in the ejector pumps downstream of the filters. The presence of debris in other areas of the fuel system was not determined"

The debris referred to above took the form of paint flakes, white with a green primer backing up to .25 inches by .25 inches, and fragments of a thin transparent plastic-like sheet material, approximately .001" thick, the largest fragment being some .3 inches by .25 inches, Figure 1. The method by which this helicopter was being refuelled was not established

The examination of N206DD by the manufacturer's representative failed to reveal any pre-accident defects, other than the presence of concentrated debris in left jet pump supply fuel filter. In the absence of any reports of electrical supply failure, the fact that both fuel boost pumps failure lights illuminated within a short time of each other strongly suggests that the fuel in the main tank became exhausted, and this view is supported by the stoppage of the engine shortly afterwards. The indication of some 150 lbs of fuel remaining on the cockpit gauge would also suggest that the forward left fuel tank was nearly full, i.e. that this fuel had not been transferred to the main tank. In the opinion of the investigator from the manufacturer who examined the helicopter, sufficient debris was obscuring the filter mesh to cause fuel to flow through the by-pass, although the by-pass opening was reported to have been uncontaminated, as was the left filter when examined. Thus, although no debris was found in the jet pumps when the helicopter was examined, it seems likely

that debris had indeed obstructed the left side of the dual element jet pump interrupting the transfer of fuel. If the main tank had become exhausted due to a problem with the fuel transfer system the low fuel warning light should have illuminated when some 10 gallons remained. The pilot reported that he did not see this warning and no explanation could be found for its absence.
