**INCIDENT**

**Aircraft Type and Registration:** DC-9-32, G-PKBM

**Date & Time (UTC):** 16 November 1993 at 1718 hrs

**Location:** Stand B4, London Heathrow Airport

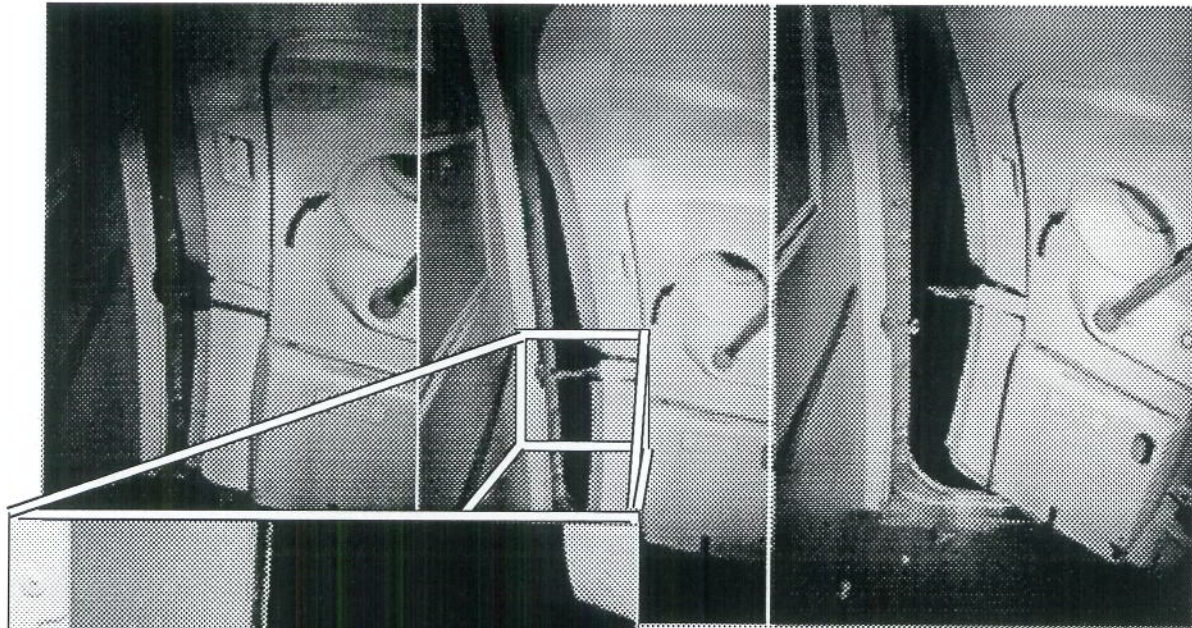
Close-up of cam follower and bayonet showing correct relative positions before separation.

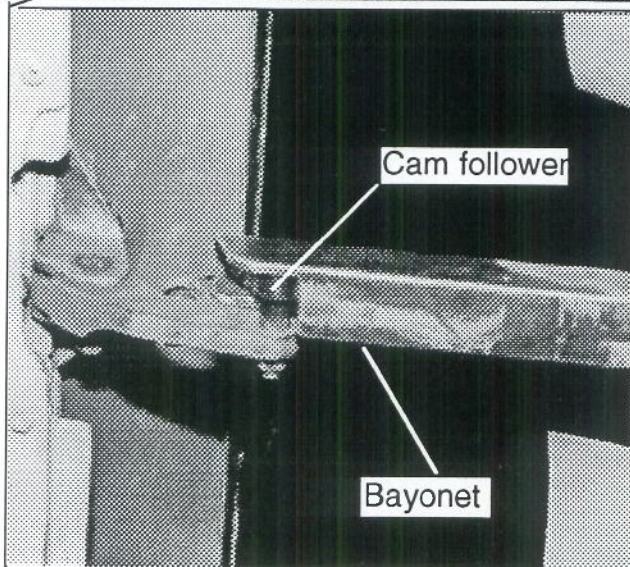
Operation of the door mechanism demonstrated that if the door were opened quickly it was possible to achieve slight overtravel at the end of the forward travel. This could result in the door bouncing back and cause the bayonet bar to end up with its blind side against the spigot, thus preventing the door opening further.

Bayonet positioned on the wrong side of the cam follower, preventing door from opening.
