AAIB Bulletin No: 2/95

Ref: EW/C94/8/3

INCIDENT

Aircraft Type and Registration: Boeing 747-236B, G-BDXH

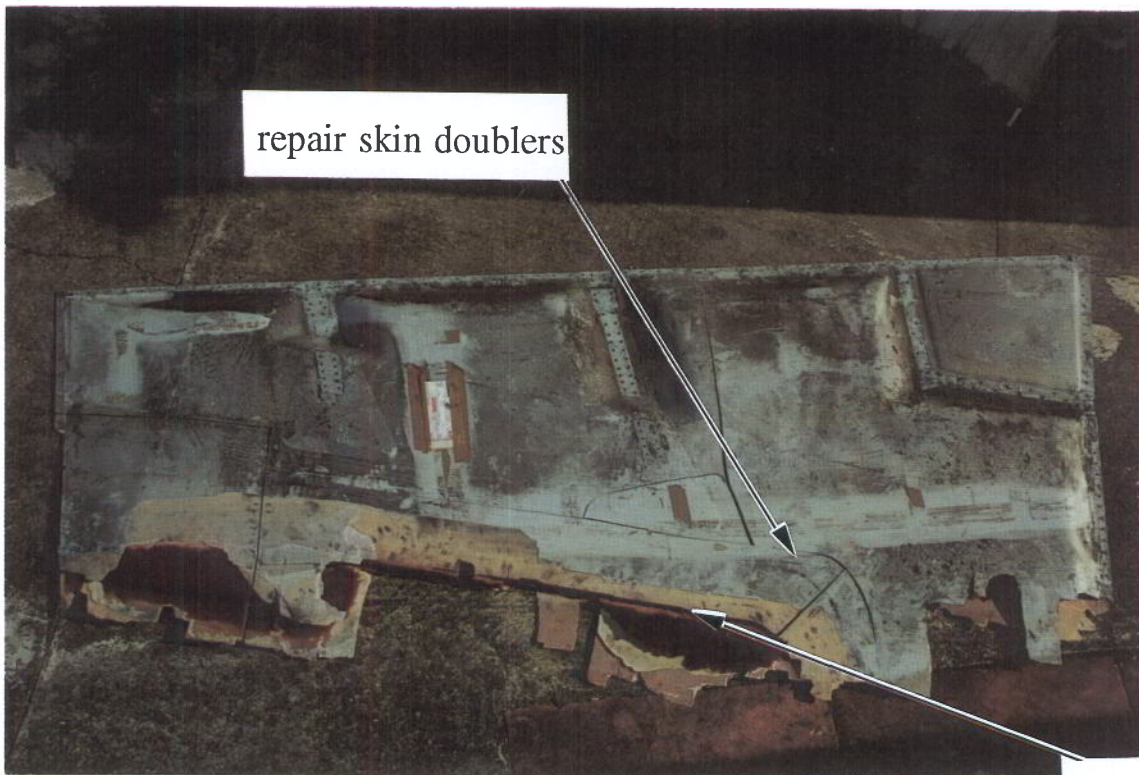
The subsequent examination showed that the panel from G-BDXH had been the subject of a sizeable repair covering about 18 inches of the trailing edge chordwise and extending over about two-thirds of the span from the inboard end. The honeycomb core had been replaced in this region, the interface with the old core being filled with a foaming adhesive. The inner skin had also been replaced and several overlapping plies applied where it met the original skin. The operator's records showed that this repair had been done in February 1991 due to the discovery of extensive delamination following a

The AAIB examination of the failed panel noted that the fracture surface largely followed the repair splice but there was no evidence of substandard workmanship involved with the repaired areas which remained. The examination report concluded that the panel had probably failed due to the nature and size of the repair, which increased the stiffness locally and transferred bending and torsional loads into that area, leading to cracking and disbonding.

core splice

G-BDXH - View of failed wing trailing edge panel showing repaired area

In August 1994 the SRM was revised to restrict the maximum area of a repair to 288 square inches, even using the most stringent methods.

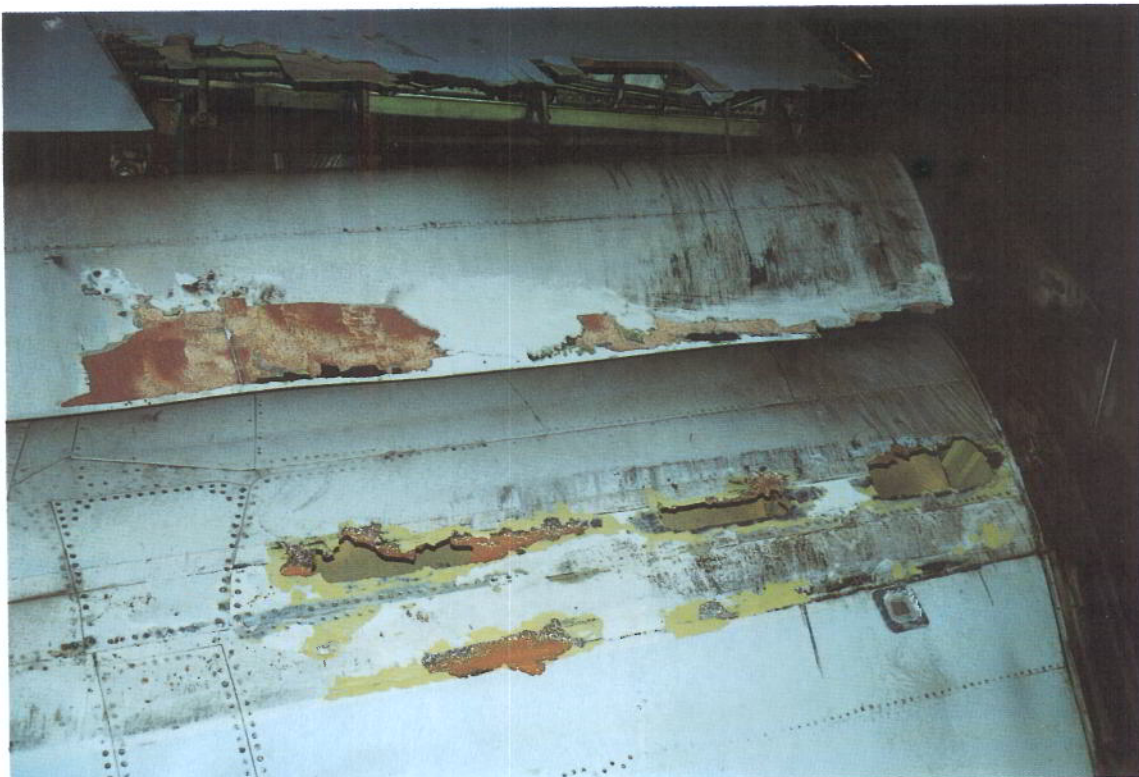
Nature of Damage: Disintegration of a left wing trailing edge panel and consequent damage to the upper surfaces of the mid- and fore-flaps

G-BDXH - Damage to mid-and fore-flap due to break-up of trailing edge panel
