No: 12/91

Ref: EW/A343

Aircraft Type and Registration: Sikorsky S-61N, G-BCLD

Date & Time (UTC): 9 October 1990 at 1626 hrs

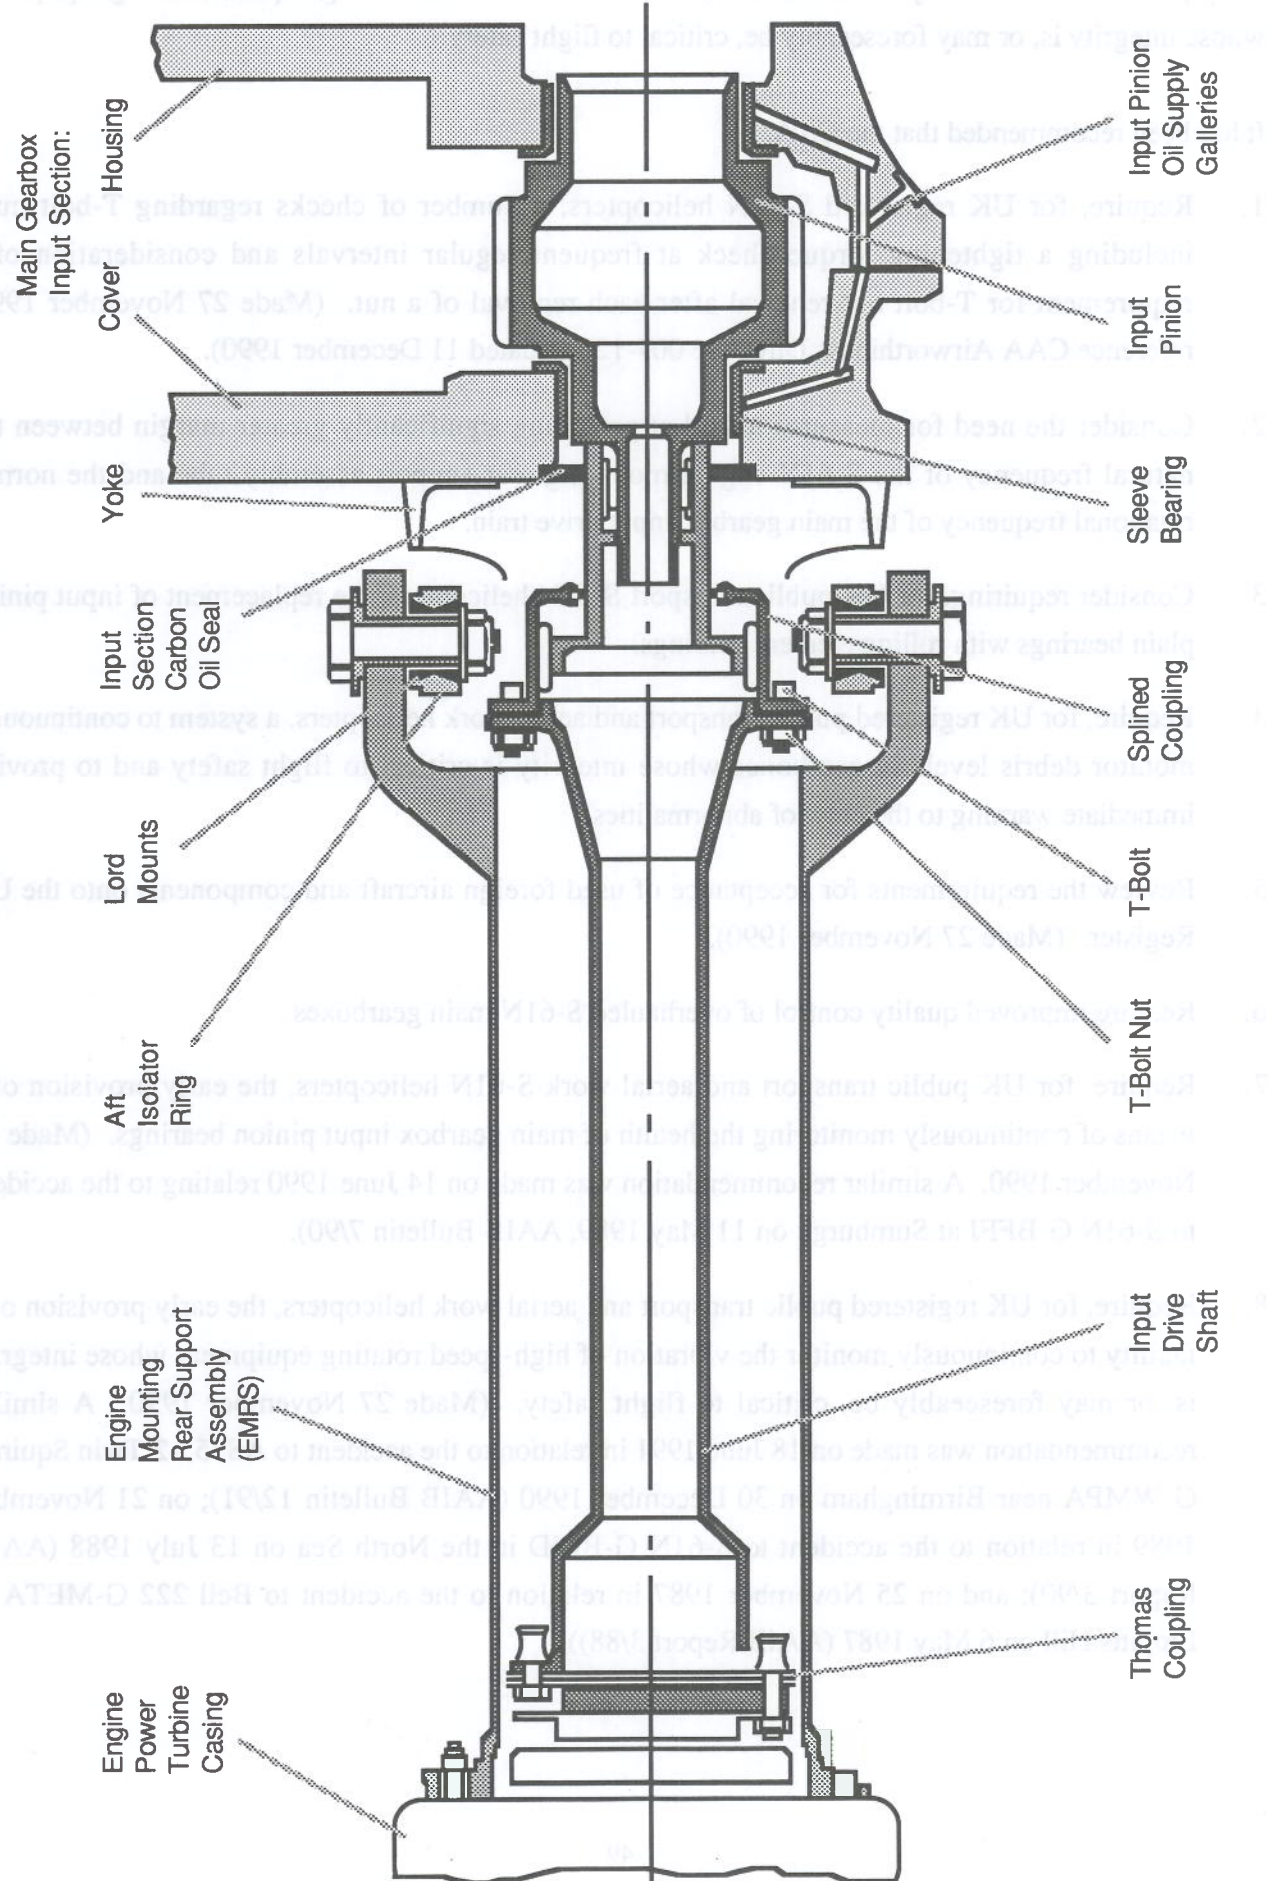
Fig 1

DRIVE TRAIN SCHEMATIC

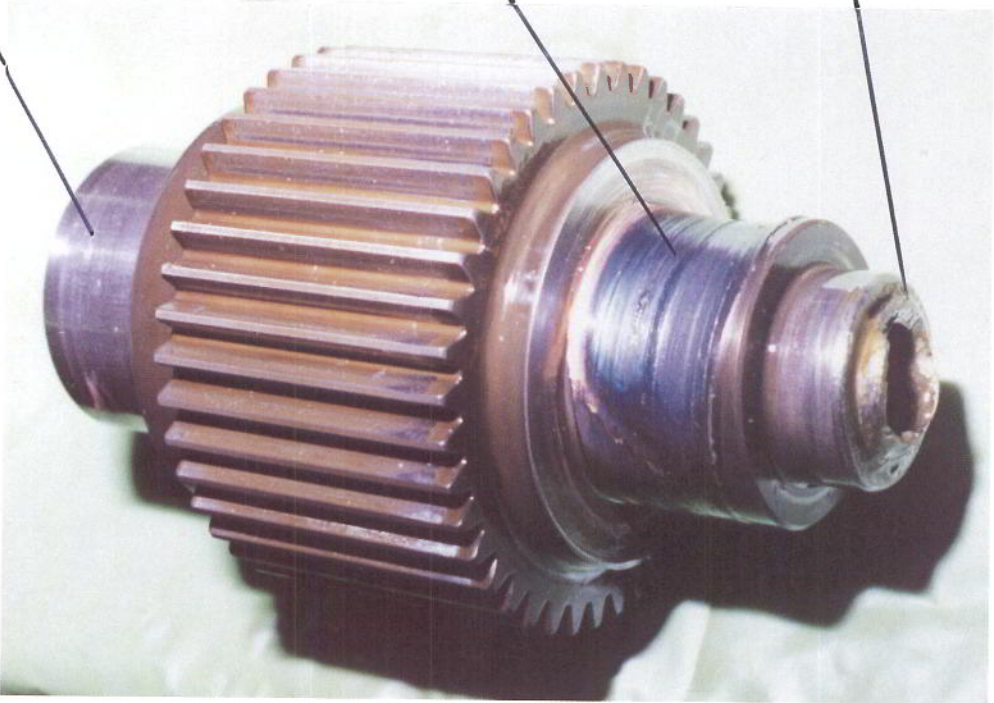
Fig 2

The No. 1 input pinion had fractured transversely through the integral shaft forward of the forward journal (Fig 2). The forward journal exhibited gross rotational wear, deformation and overheat over an approximately 170° arc, with a number of extensive circumferential cracks. Opposite this arc the forward thrust bearing face was overheated and plastically deformed. The aft journal and thrust bearing faces had lesser rotational damage at circumferential positions opposite to those of the forward journal and thrust bearing face damage. Damage characteristics were indicative of the effects of a severe imbalance force applied to the forward end of the input pinion, in a direction consistent with a reduction of mass at around the No. 2 T-bolt position. The forward sleeve bearing had severe

INPUT PINION

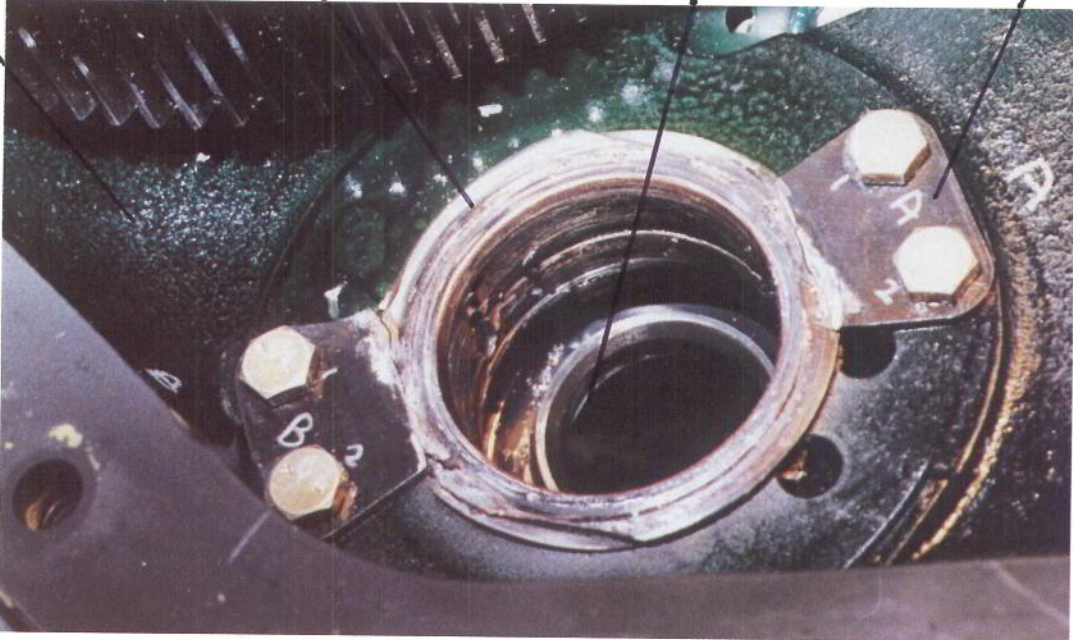
rotational and overheat damage, had distorted and had jumped its restraining clips and turned in its bore in the MGB input section cover. This bore had signs of severe overheat and possibly wear or battering damage, giving approx 1 mm diametric clearance between it and the sleeve bearing. The carbon oil seal housing had rotated in its bore in the input section cover and the seal had been obliterated.

FORWARD SLEEVE BEARING
