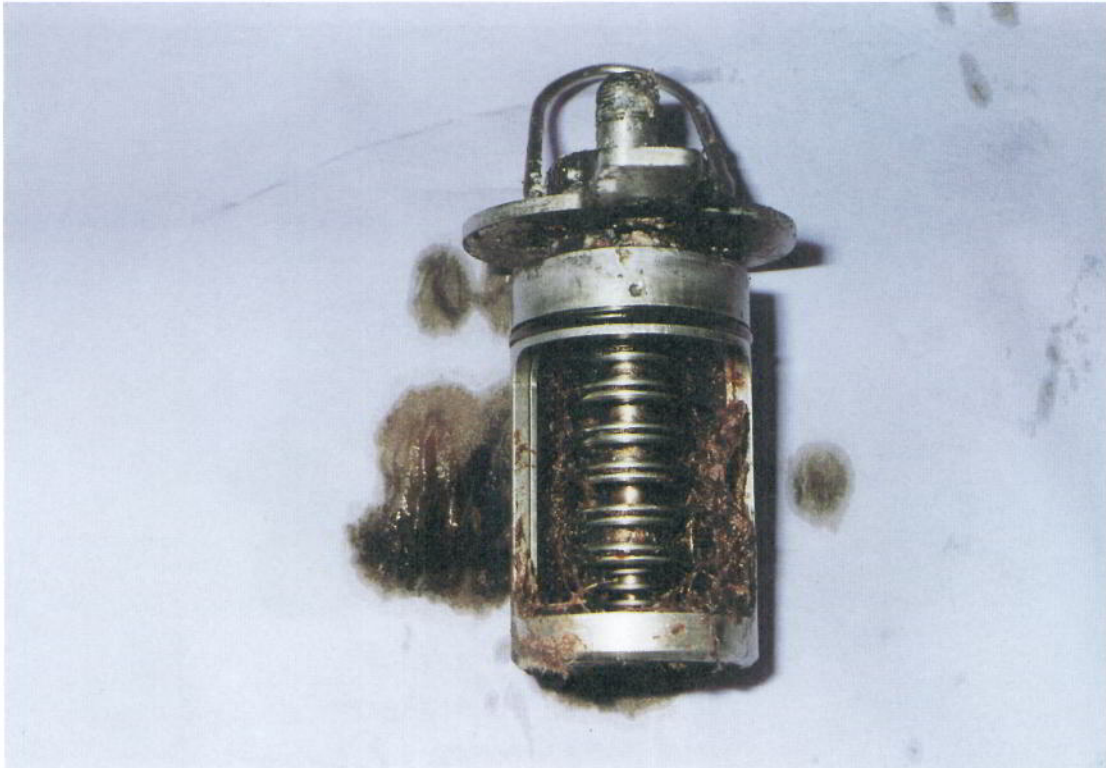
Photograph A

**MAIN GEARBOX SCAVENGE STRAINER
AND MAGNETIC CHIP DETECTOR**

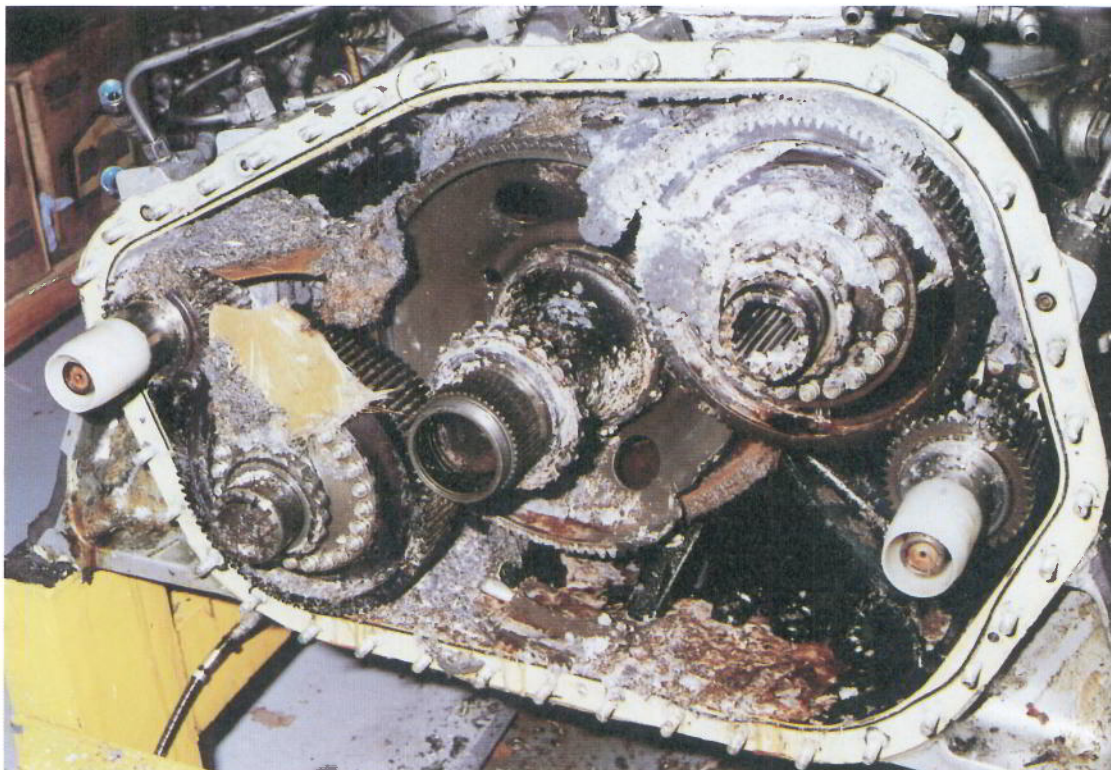
Photograph B

MAIN GEARBOX INPUT SECTION

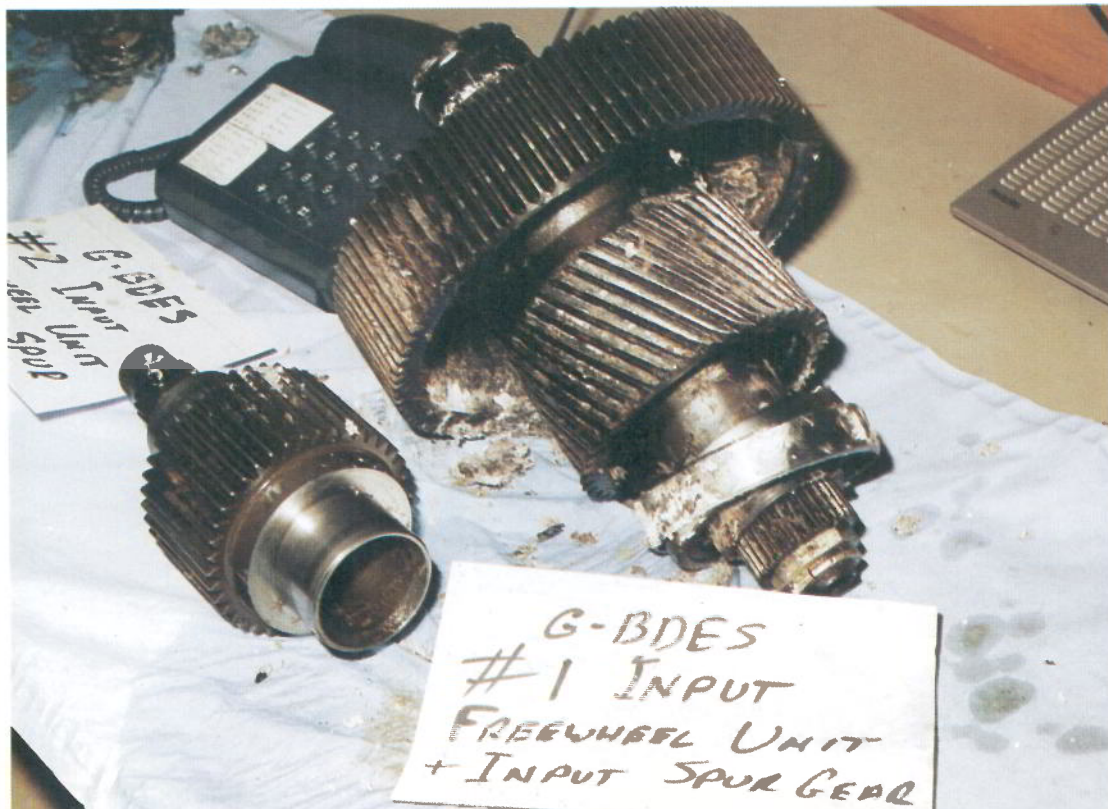
Photograph C

**NO 1 CAMSHAFT ASSEMBLY
AND INPUT SPUR GEAR**

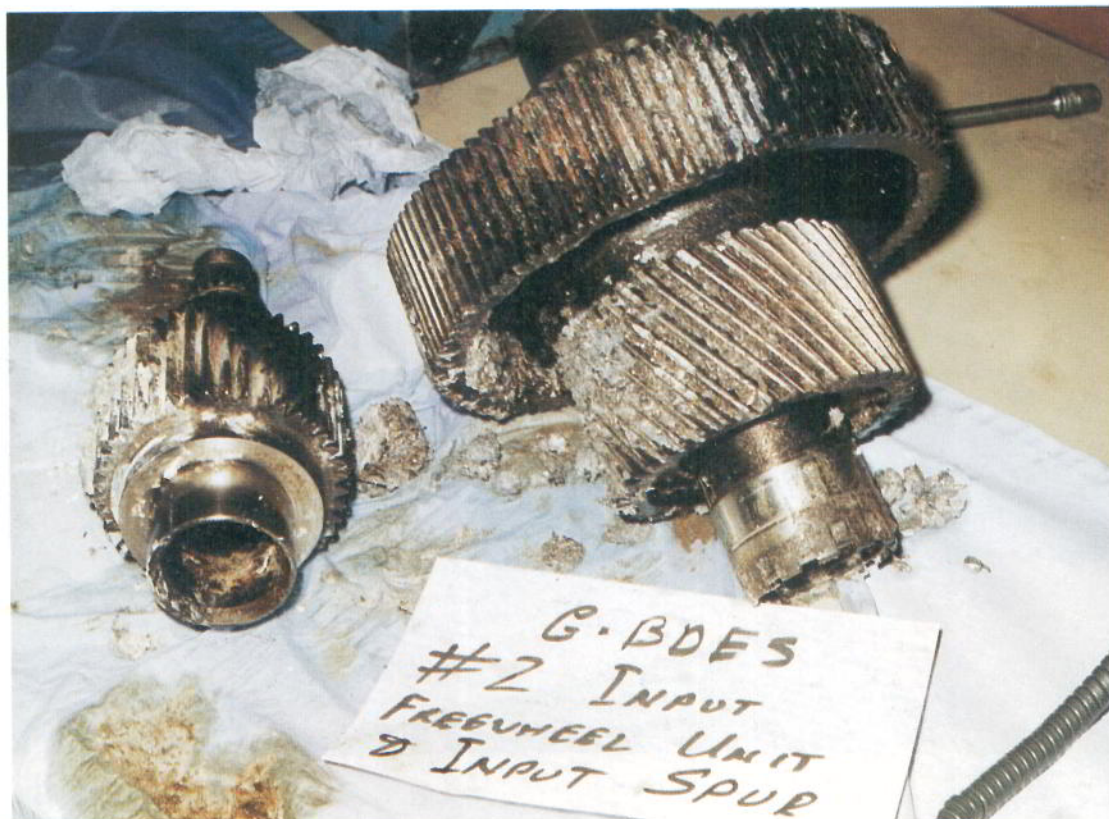
Photograph D

**NO 2 CAMSHAFT ASSEMBLY
AND INPUT SPUR GEAR**

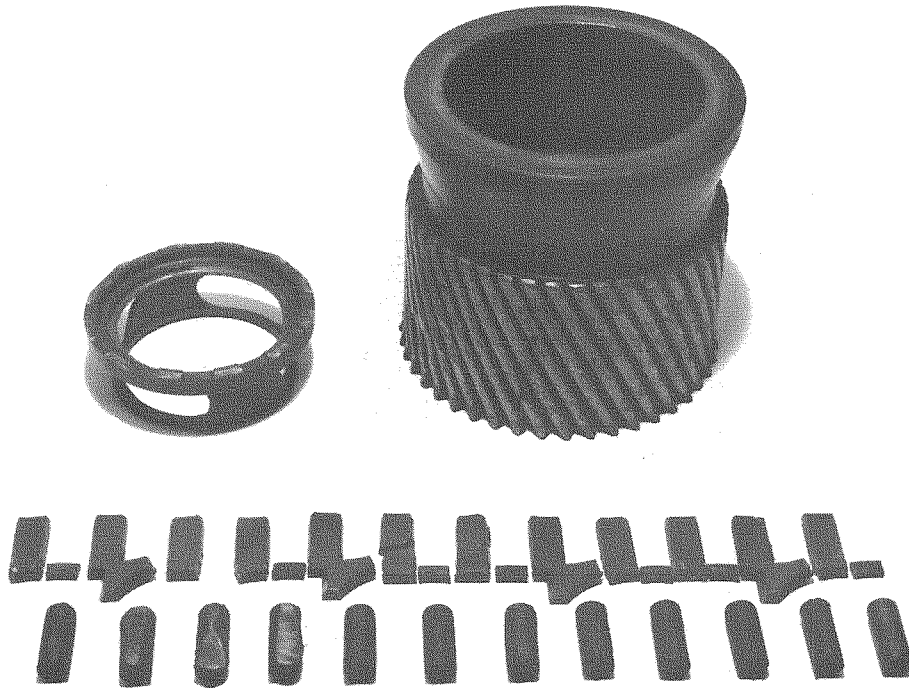
Photograph A

NO 1 FREEWHEEL UNIT

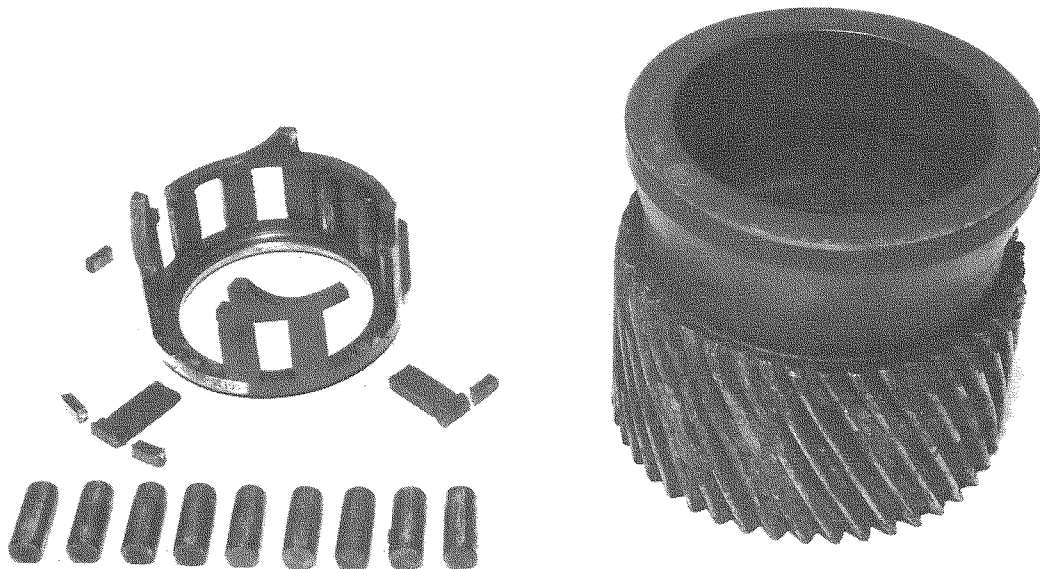
Photograph B

NO 2 FREEWHEEL UNIT

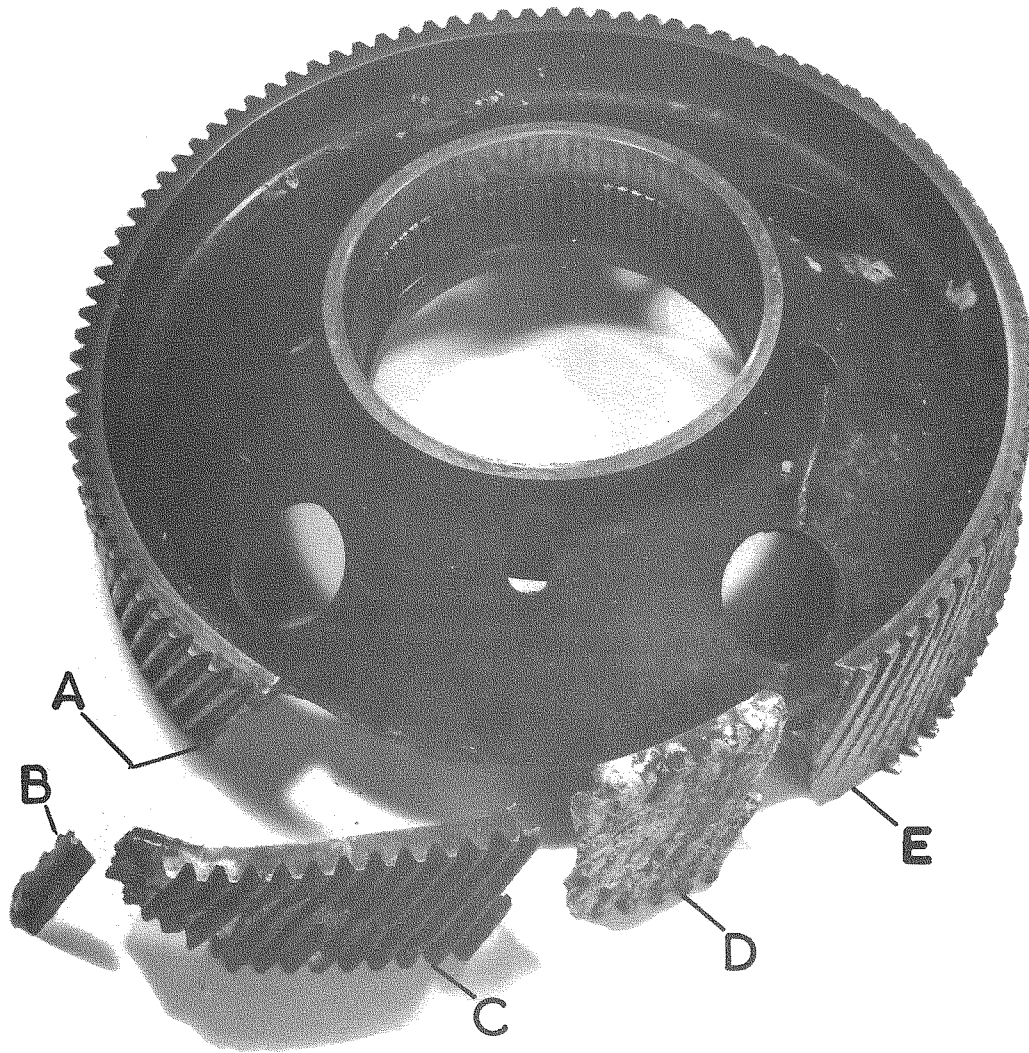
HELICAL COMBINER GEAR WITH PRINCIPAL
FRAGMENTS

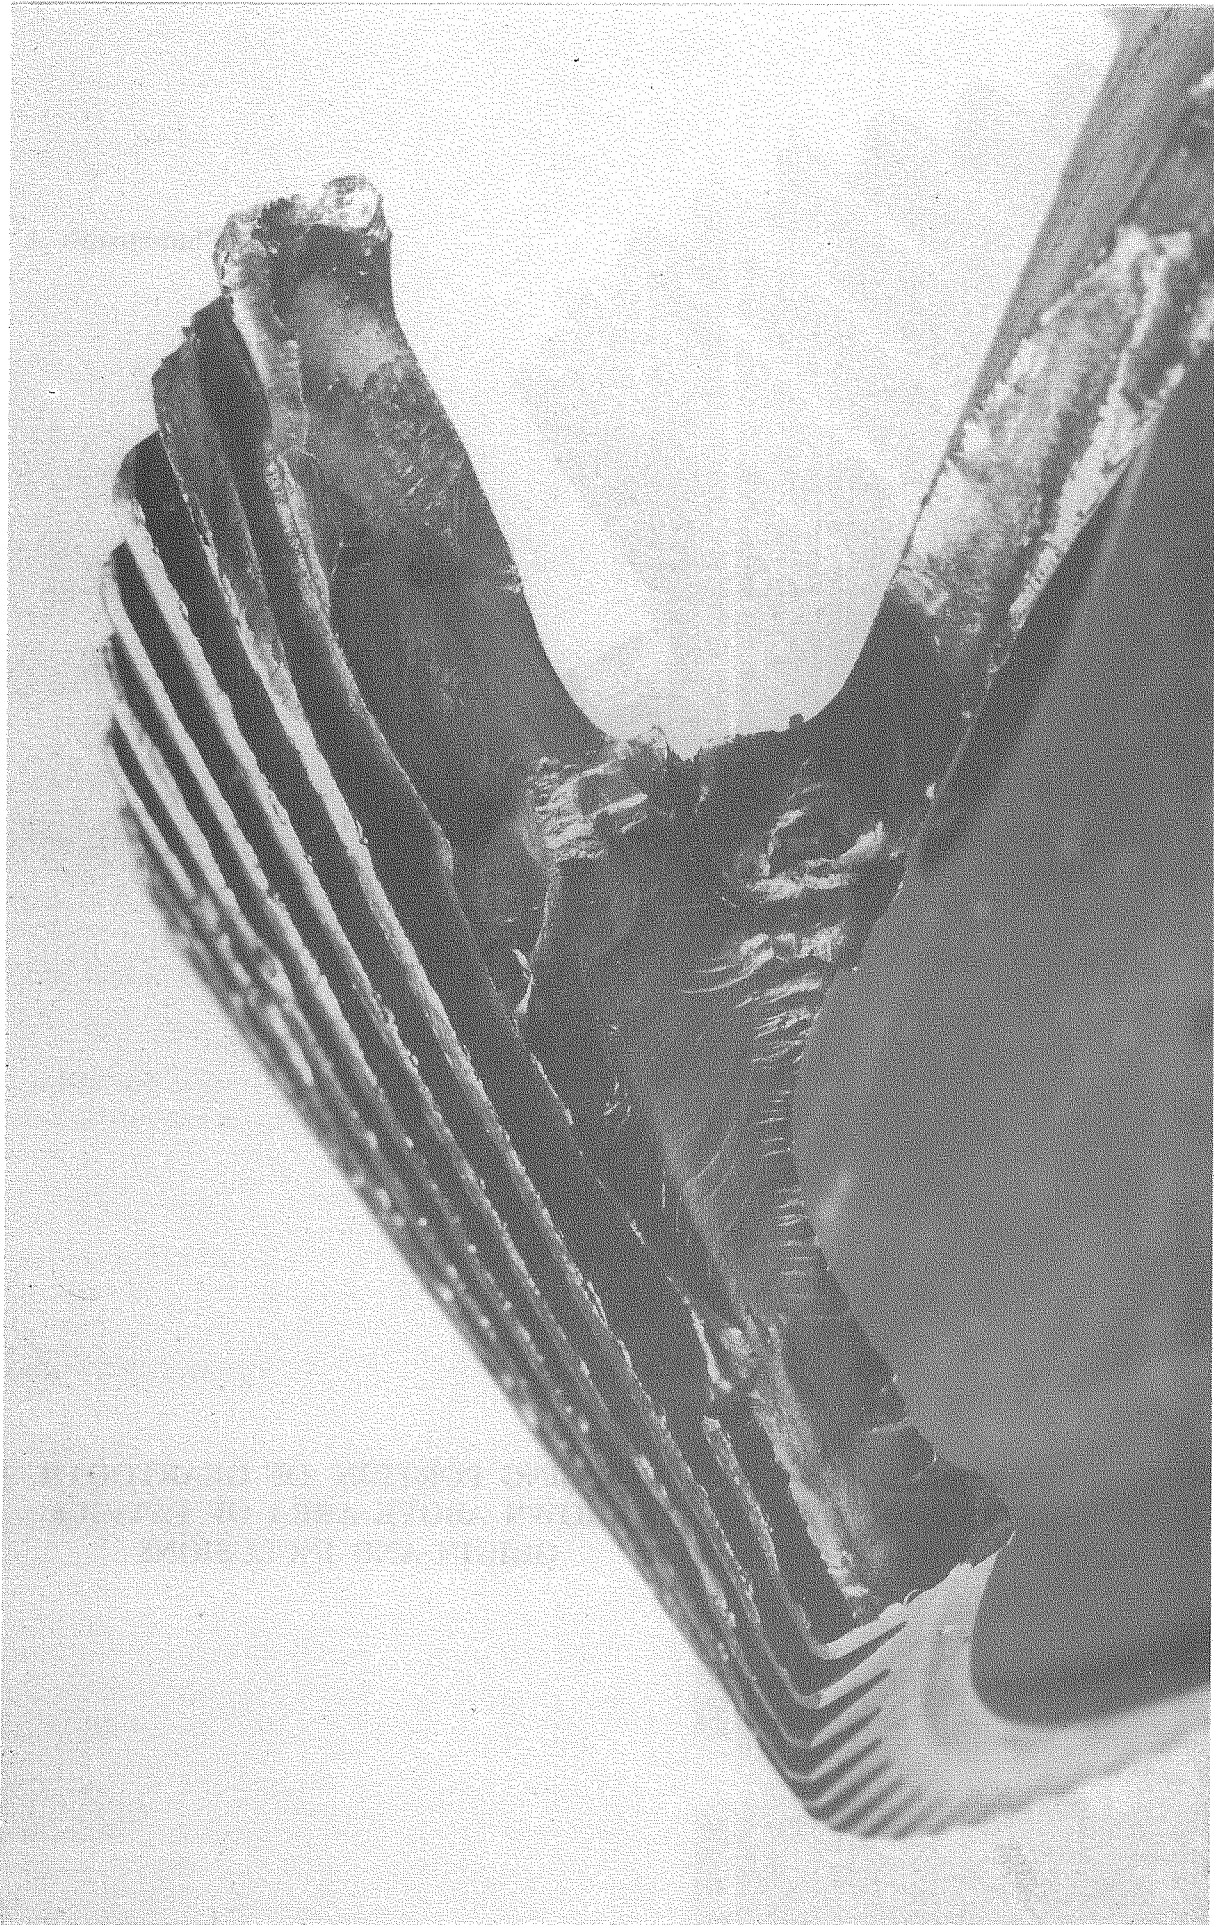
**FRACTURE FACE SHOWING FATIGUE DEVELOPMENT
WITHIN GEARTOOTH AND RIM**

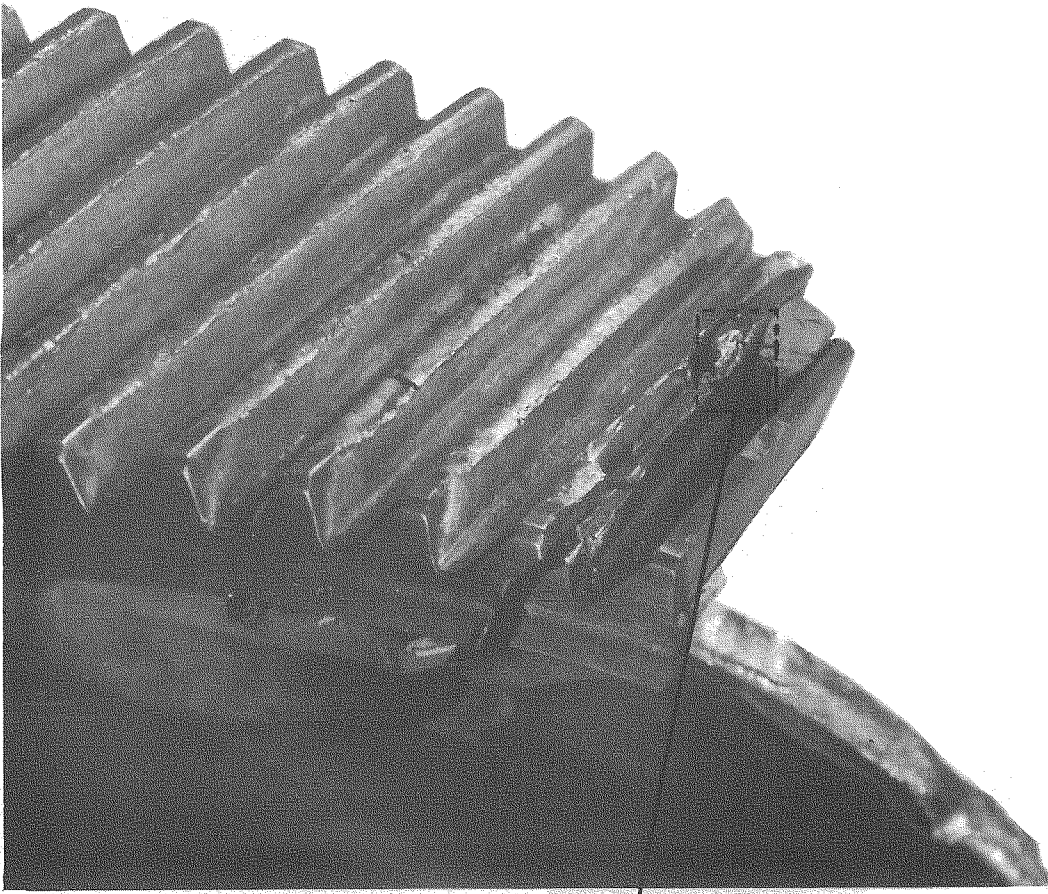
Photograph A

RECONSTRUCTION OF FRAGMENTED GEARTOOTH
AND SEPARATED GEARTOOTH

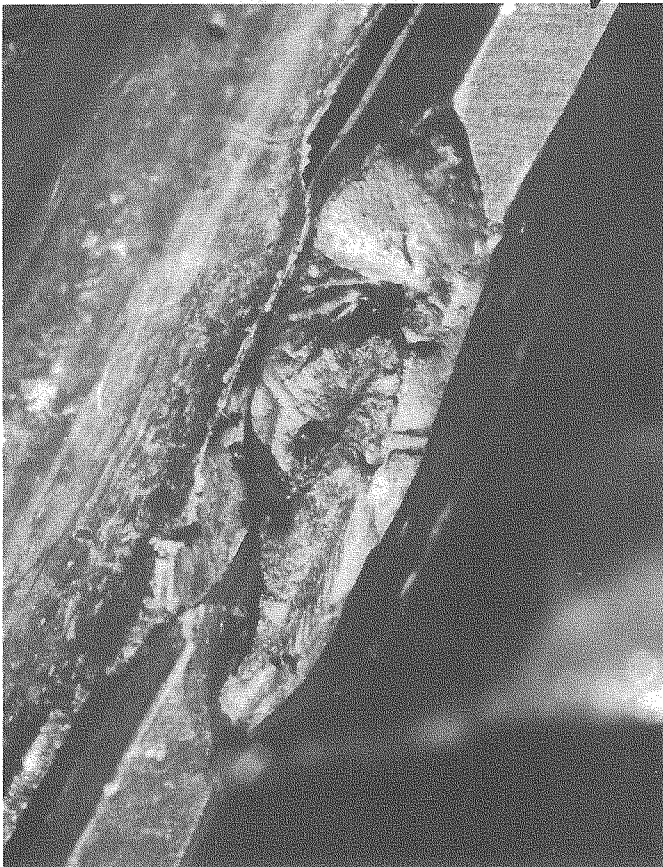
Photograph B

MISSING PORTION OF GEARTOOTH
CROWN ABOVE AREA OF FATIGUE
ORIGIN AND INCLUSIONS

OVAL FEATURE AS SEEN
ON RE-ASSEMBLED
TOOTH FRAGMENTS

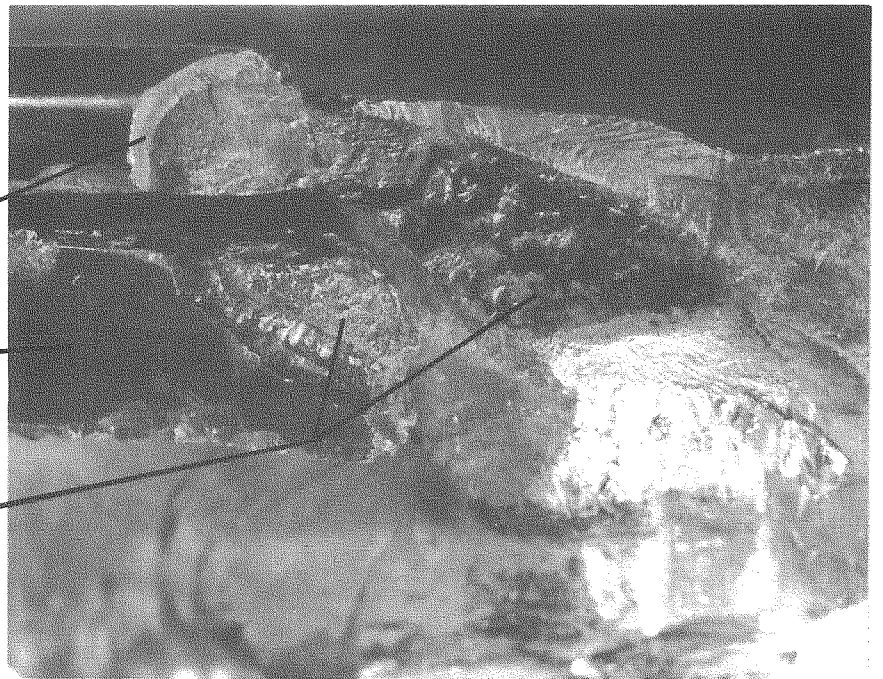
Photograph C

FRAGMENTED TOOTH
FROM ABOVE SHOWING
ANGLE OF OVAL FEATURE

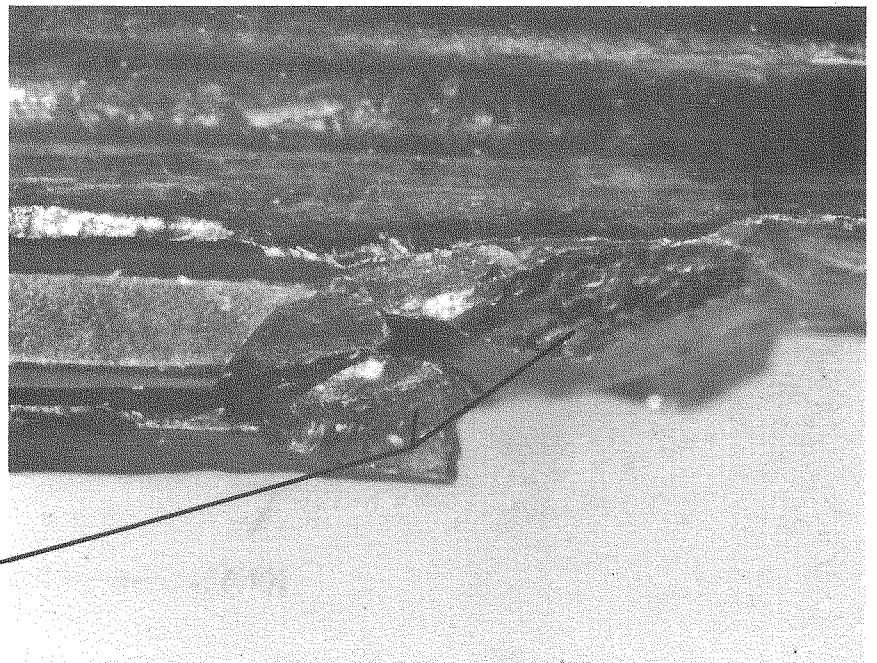
Photograph D

POSITION OF MISSING MATERIAL
FROM TOOTH CREST

CRACK DEVELOPMENT FROM OVAL FEATURE

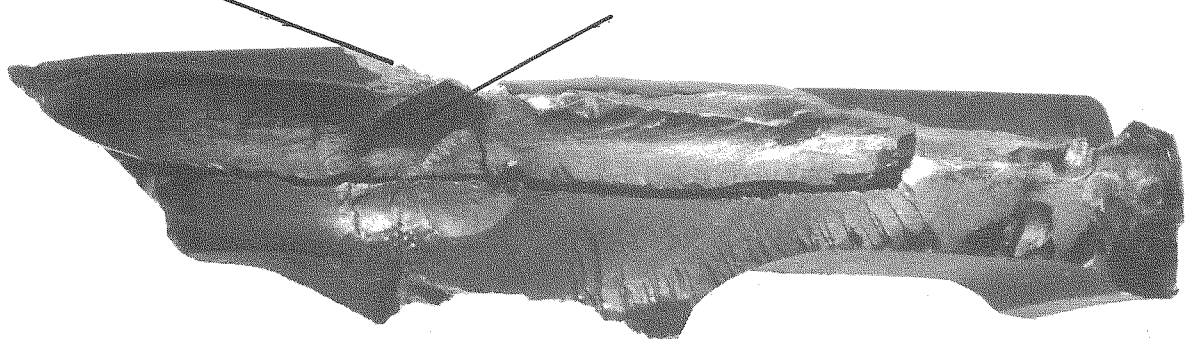
Photograph E

PARTIAL RECONSTRUCTION OF FRAGMENTED TOOTH
SHOWING FATIGUE DEVELOPMENT FROM
OVAL FEATURE INTO TOOTH

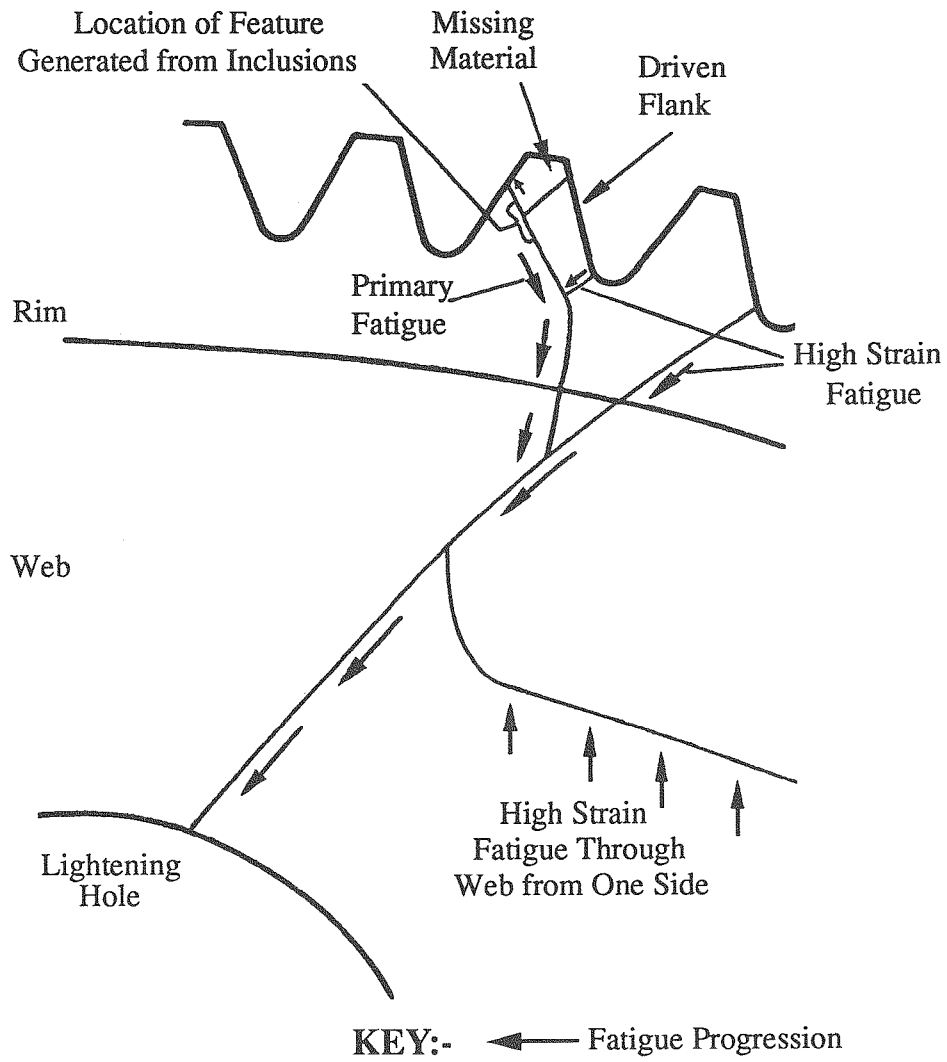
**CRACK DEVELOPMENT IN HELICAL
GEARWHEEL NO 1117**

LOCATION "A" OF METALLOGRAPHIC SECTION

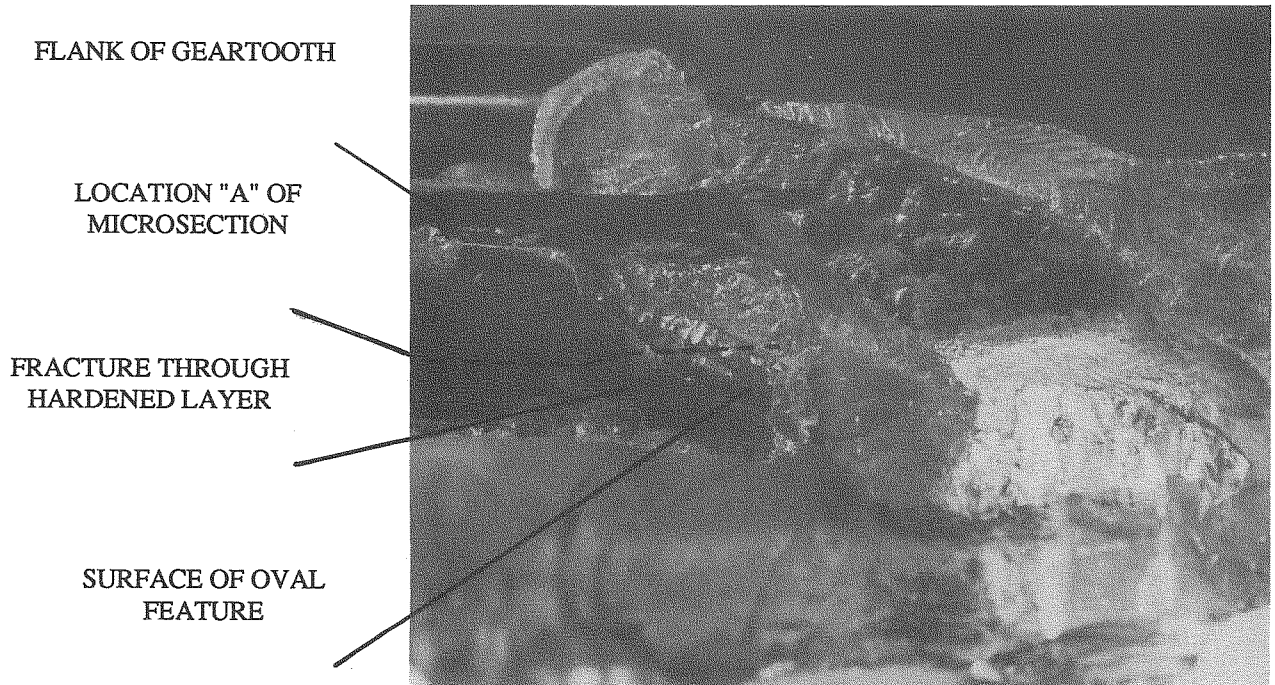
SECTION AT LOCATION "A"
(Before Etching)

FRACTURE THROUGH HARDENED SURFACE LAYER

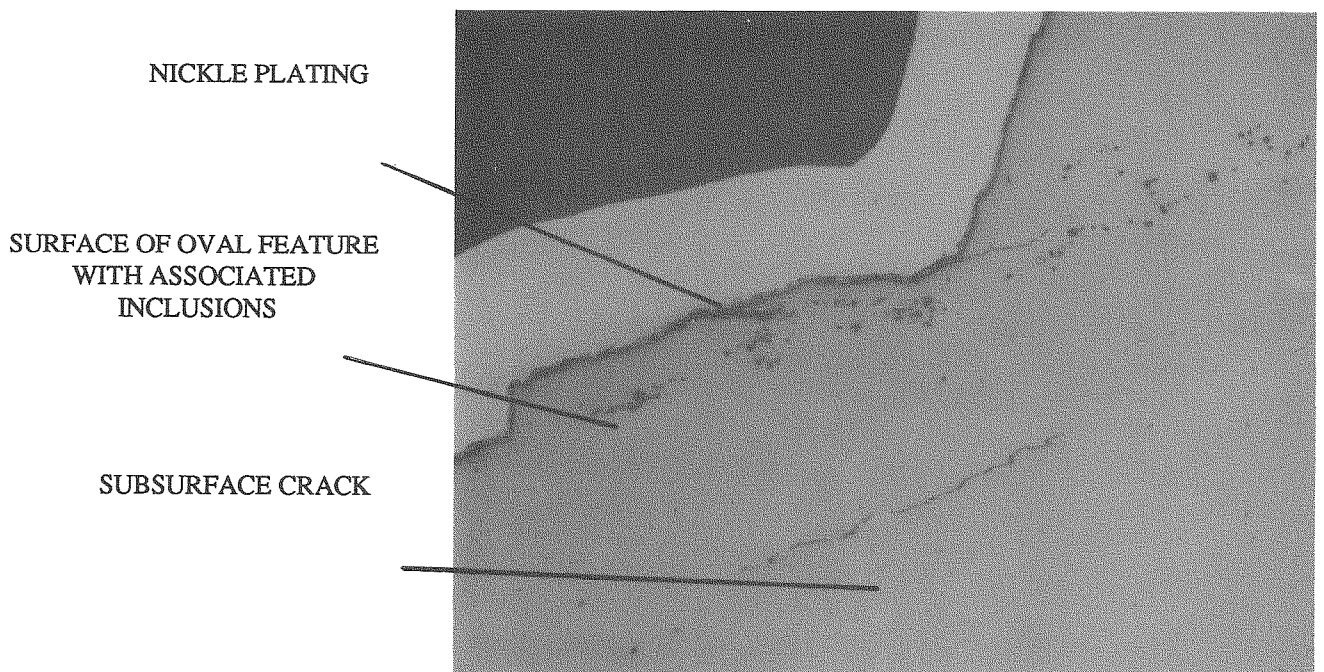
DETAIL OF SECTION AT "A" AFTER ETCHING
SHOWING SUB-SURFACE CRACKS, INCLUSIONS AND WHITE
ETCHED AREAS

FRACTURE THROUGH
HARDENED LAYER

SURFACE OF
OVAL FEATURE

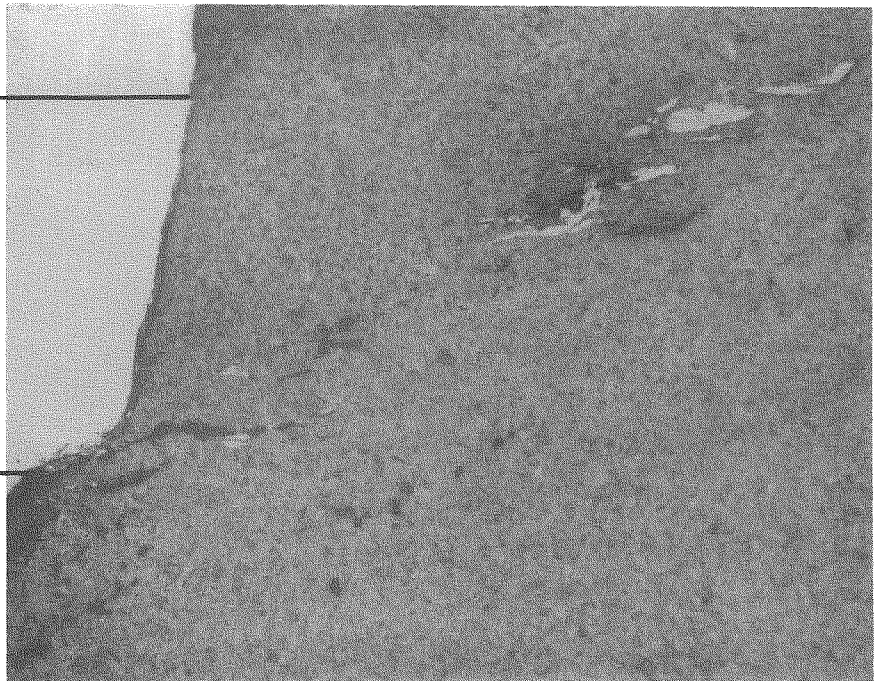
Photograph C
(x 200 approx)

DETAIL OF SECTION AT "A" AFTER ETCHING SHOWING
INCLUSIONS AND WHITE ETCHED AREAS

MICROHARDNESS IMPRESSIONS
IN WHITE ETCHED AREAS

MICROHARDNESS IMPRESSIONS
IN NORMAL TEMPERED
MARTENSITIC AREA

NON-METALLIC
INCLUSIONS

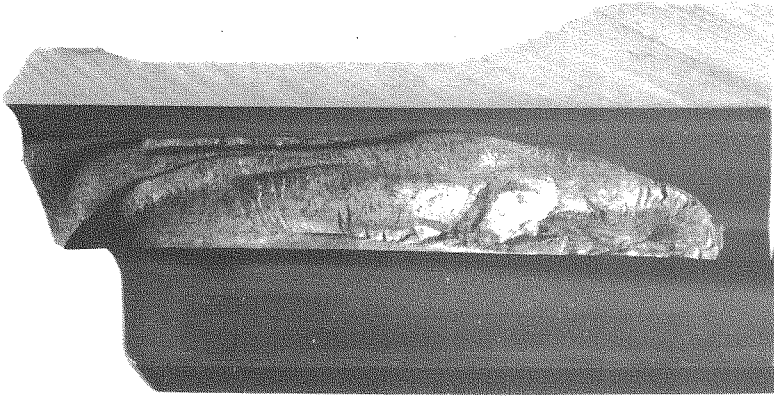
Photograph A

**EXAMPLE OF GEARTOOTH WITH
CAPPING FAILURE (GEARWHEEL SERIAL No. 1094)**

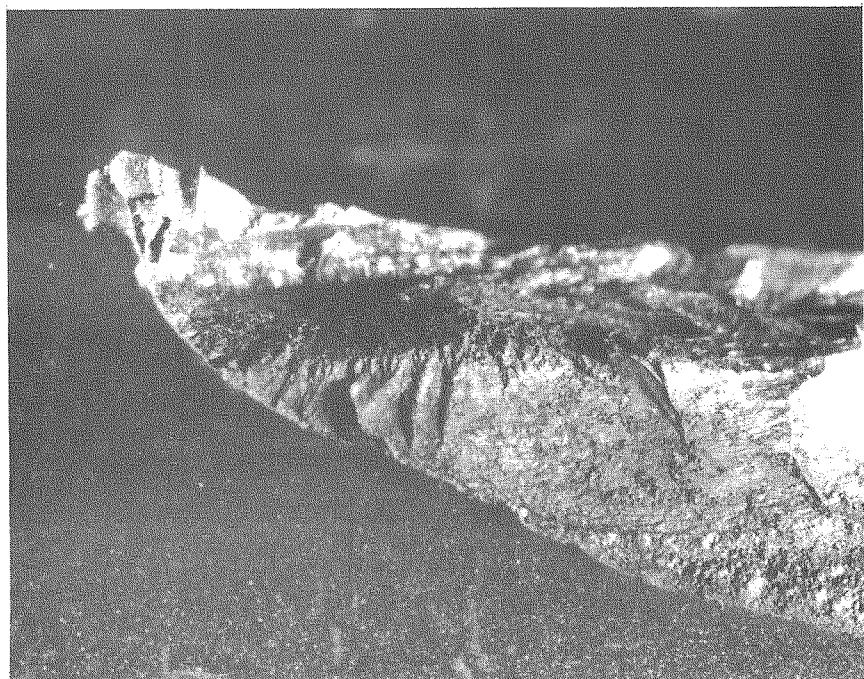
Photograph B

**PLANAR FEATURE CONTAINING
INCLUSIONS AT ORIGIN OF CAPPING FRACTURE**
