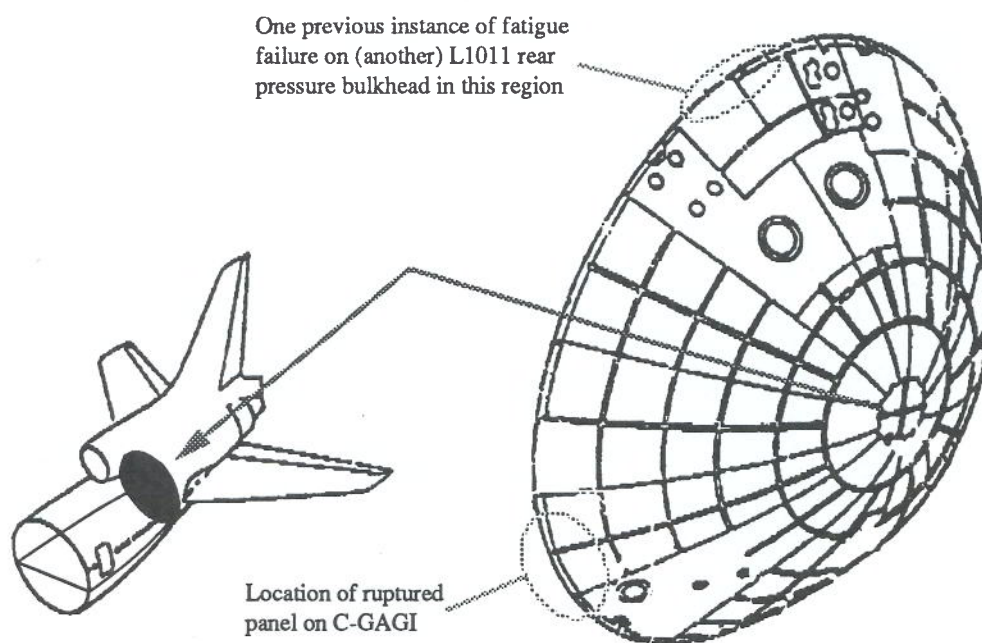
Figure 1
Rear pressure bulkhead
Location of failure on C-GAGI, and prior instance of failure on
another L1011 aircraft

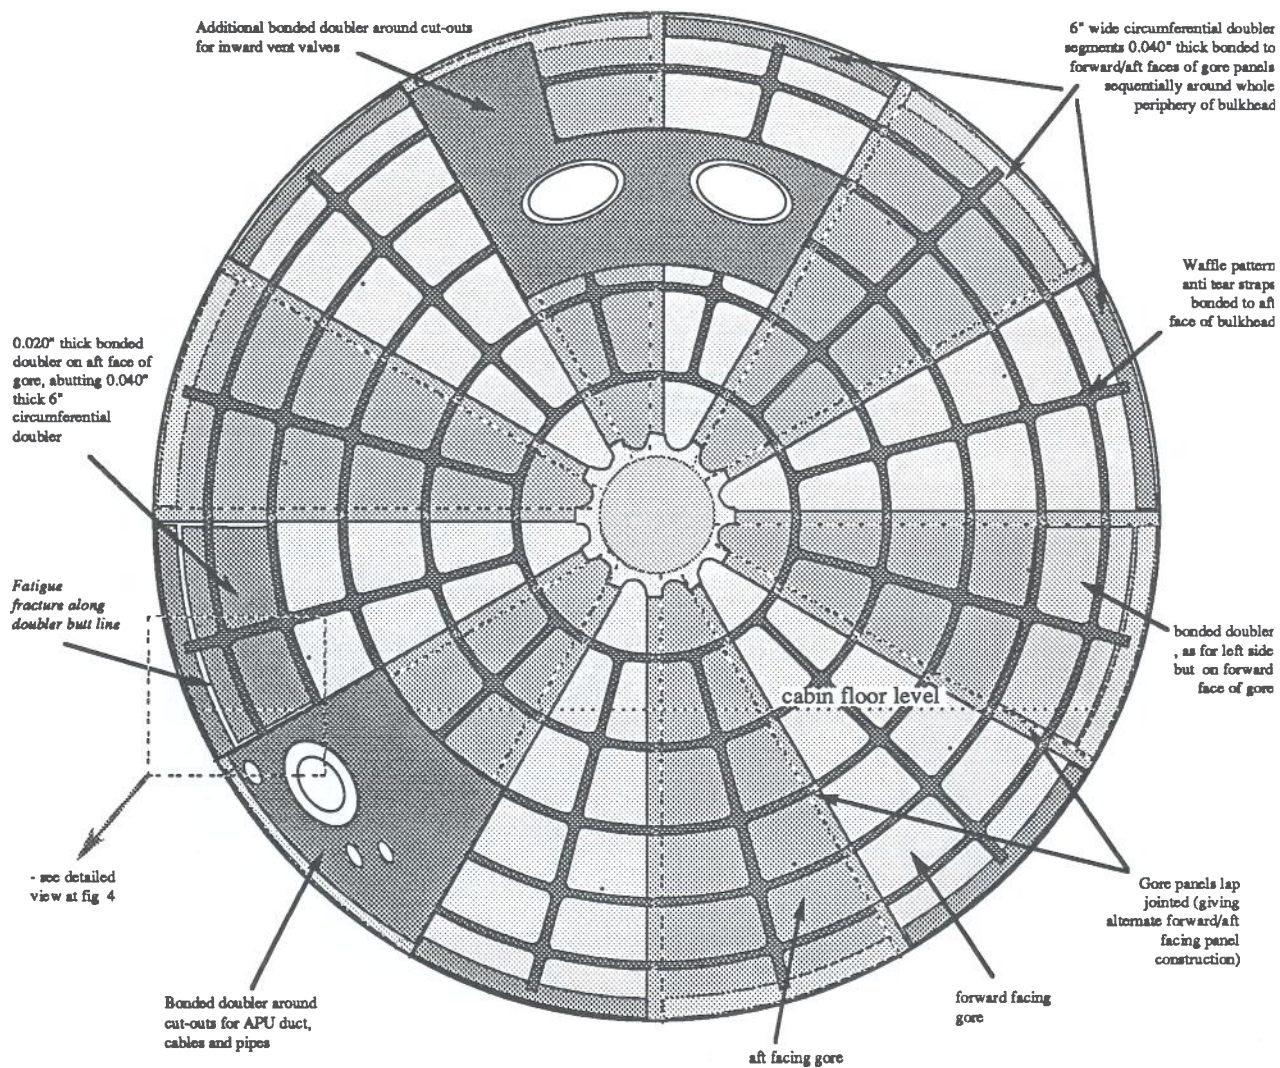
Figure 2
Rear pressure bulkhead constructional details
 Viewed from rear

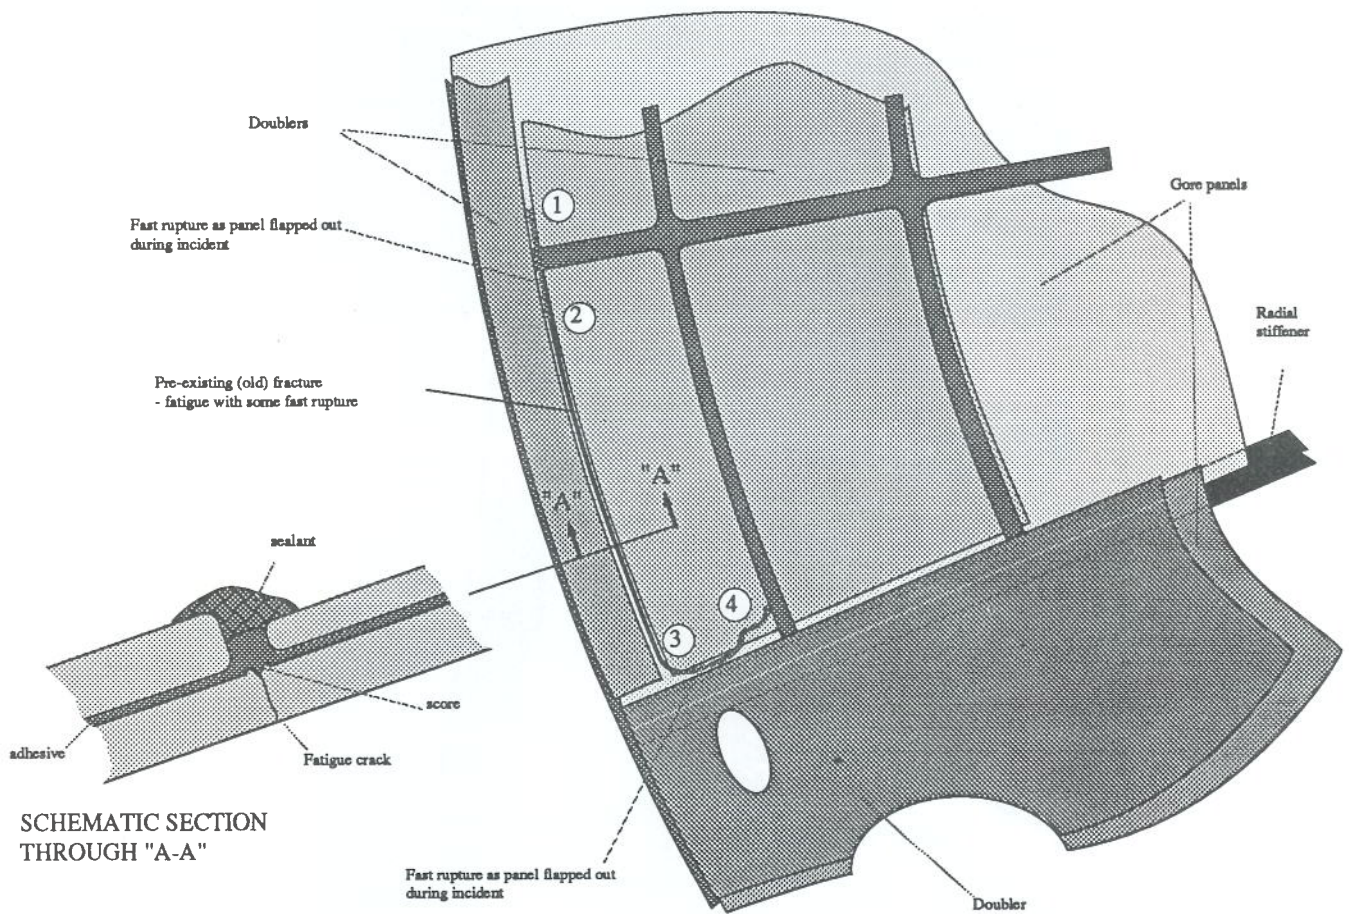
Figure 4
Rear pressure bulkhead fracture details
 View looking on aft side of bulkhead (region identified in figure 3)
