Robinson R22 Beta, G-CHYL

AAIB Bulletin No: 3/2004	Ref: EW/G2003/08/43	Category: 2.3
Aircraft Type and Registration:	Robinson R22 Beta, G-CHYL	
No & Type of Engines:	1 Lycoming O-320-B2C piston engine	
Year of Manufacture:	1989	
Date & Time (UTC):	11 August 2003 at 1500 hrs	
Location:	Bournemouth Airport, Dorset	
Type of Flight:	Training	
Persons on Board:	Crew - 1	Passengers - 1
Injuries:	Crew - None	Passengers - None
Nature of Damage:	Severe distortion of landing gear tubes and minor distortion of cabin structure	
Commander's Licence:	Commercial Pilot's Licence with Instructor rating	
Commander's Age:	45 years	
Commander's Flying Experience:	758 hours (of which 467 were on type)	
	Last 90 days - 73 hours	
	Last 28 days - 40 hours	
Information Source:	Aircraft Accident Report Form submitted by the commander plus additional enquiries

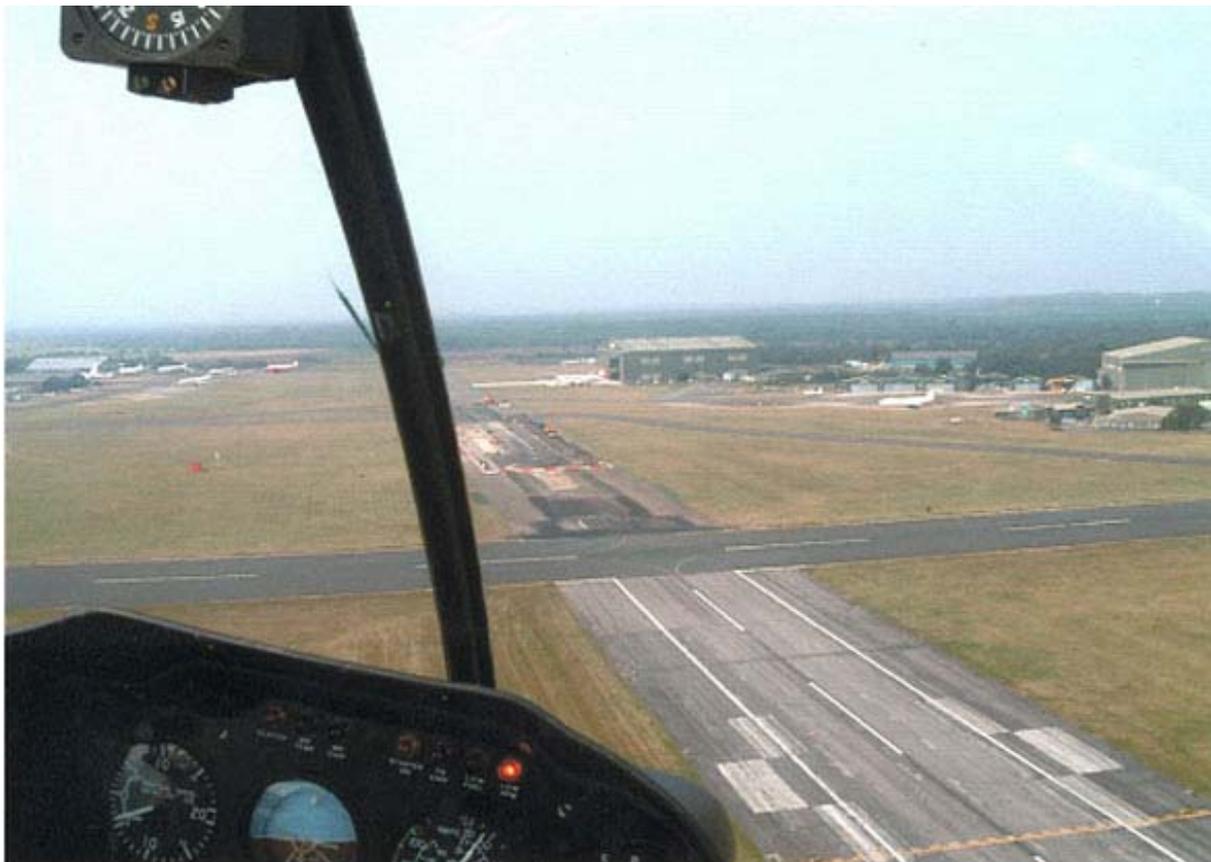
Figure 1

Passenger photograph taken from G-CHYL in descent

This image showed a portion of the instrument panel in the view looking forward onto the airfield. The LOW RPM rotor speed warning light is clearly illuminated, the VSI shows a rate of descent of 400 ft/min and the indicated airspeed is 27 kt. Neither the altimeter nor the dual (rotor and engine)

tachometer needles are visible in the picture. From the aspect of the buildings, the photograph appears to have been taken at a height of 150 to 200 feet. Other photographs showed that the surface wind was southerly at about 10 kt which equated to a 10 kt tailwind component during the 'forced' landing beside Runway 35.

From the evidence in the photograph (low rotor RPM, modest rate of descent and low forward speed) it is unlikely that a simple loss of power was the cause of the accident and the commander was convinced that he had applied carburettor heat properly before the descent.

A representative from the aircraft manufacturer commented that the conditions shown in the photograph made vortex ring state (or 'settling with power') unlikely as an alternative explanation for the accident. He also noted that the yaw string indicated a relative airflow from the right during the descent and that this would have further added to the power requirement of the helicopter in the descent and thus, potentially, to the rate of that descent.

The most likely explanation for this accident was the low energy state of the helicopter on final approach as shown in Figure 1. Precisely how and why this situation arose could not be determined from the evidence available to the AAIB.
