No: 6/91 Ref: EW/C91/3/2 Category: 1c

**Aircraft Type and Registration:** Cessna 175C, G-ARWM  
**No & Type of Engines:** 1 Continental GO-300-E piston engine  
**Year of Manufacture:** 1962  
**Date & Time (UTC):** 10 March 1991 at 1025 hrs  
**Location:** Near Chilgrove, West Sussex  
**Type of Flight:** Private  
**Persons on Board:** Crew - 1 Passengers - None  
**Injuries:** Crew - Fatal Passengers - N/A  
**Nature of Damage:** Aircraft destroyed  
**Commander's Licence:** Private Pilot's Licence with IMC rating and a USA Commercial Pilot's Licence with Instrument rating  
**Commander's Age:** 39 years  
**Commander's Flying Experience:** 794 hours (of which 278 were on micro-light aircraft and 76 hours on single engine Cessna aircraft. 6 hours were on type)  
**Information Source:** AAIB Field Investigation

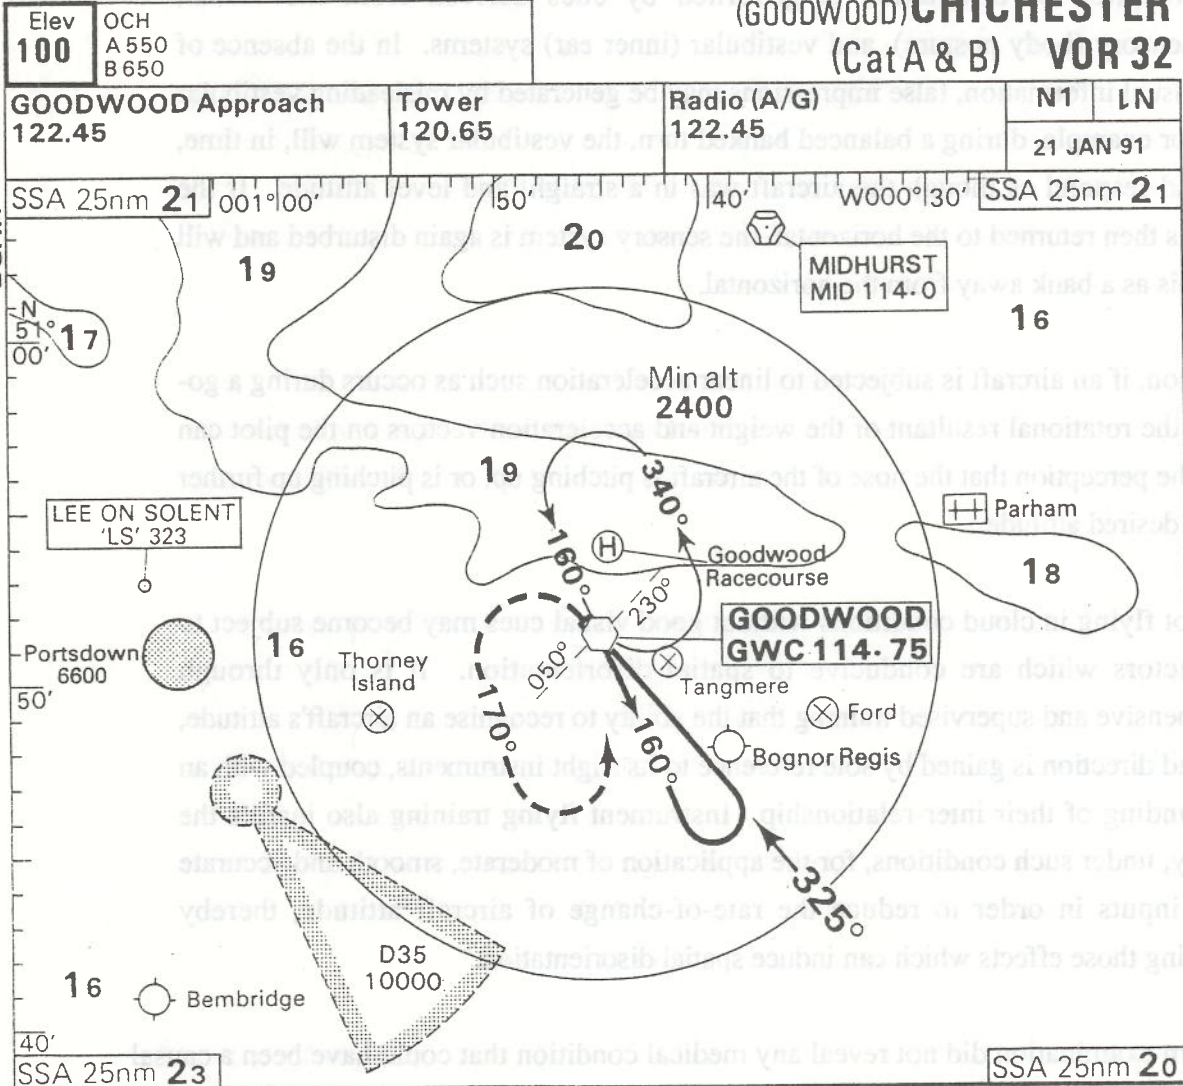
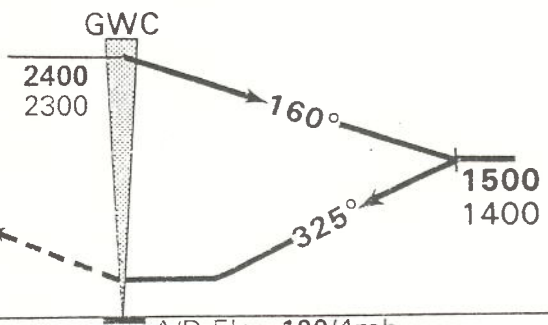
Figure 1

The VOR 32 procedure for Goodwood aerodrome is reproduced at Figure 1. The procedure requires a pilot to position his aircraft overhead the beacon at a minimum altitude of 2300 feet above aerodrome datum, and thereafter to descend, on the 160° radial, for 2 minutes and 30 seconds (still air conditions) to 1400 feet. At that point a left turn should be completed to establish inbound on the 145° radial when the aircraft may be descended to the appropriate speed related Minimum Descent Height (MDH). In this case the MDH was 550 feet above aerodrome datum or 650 feet amsl.

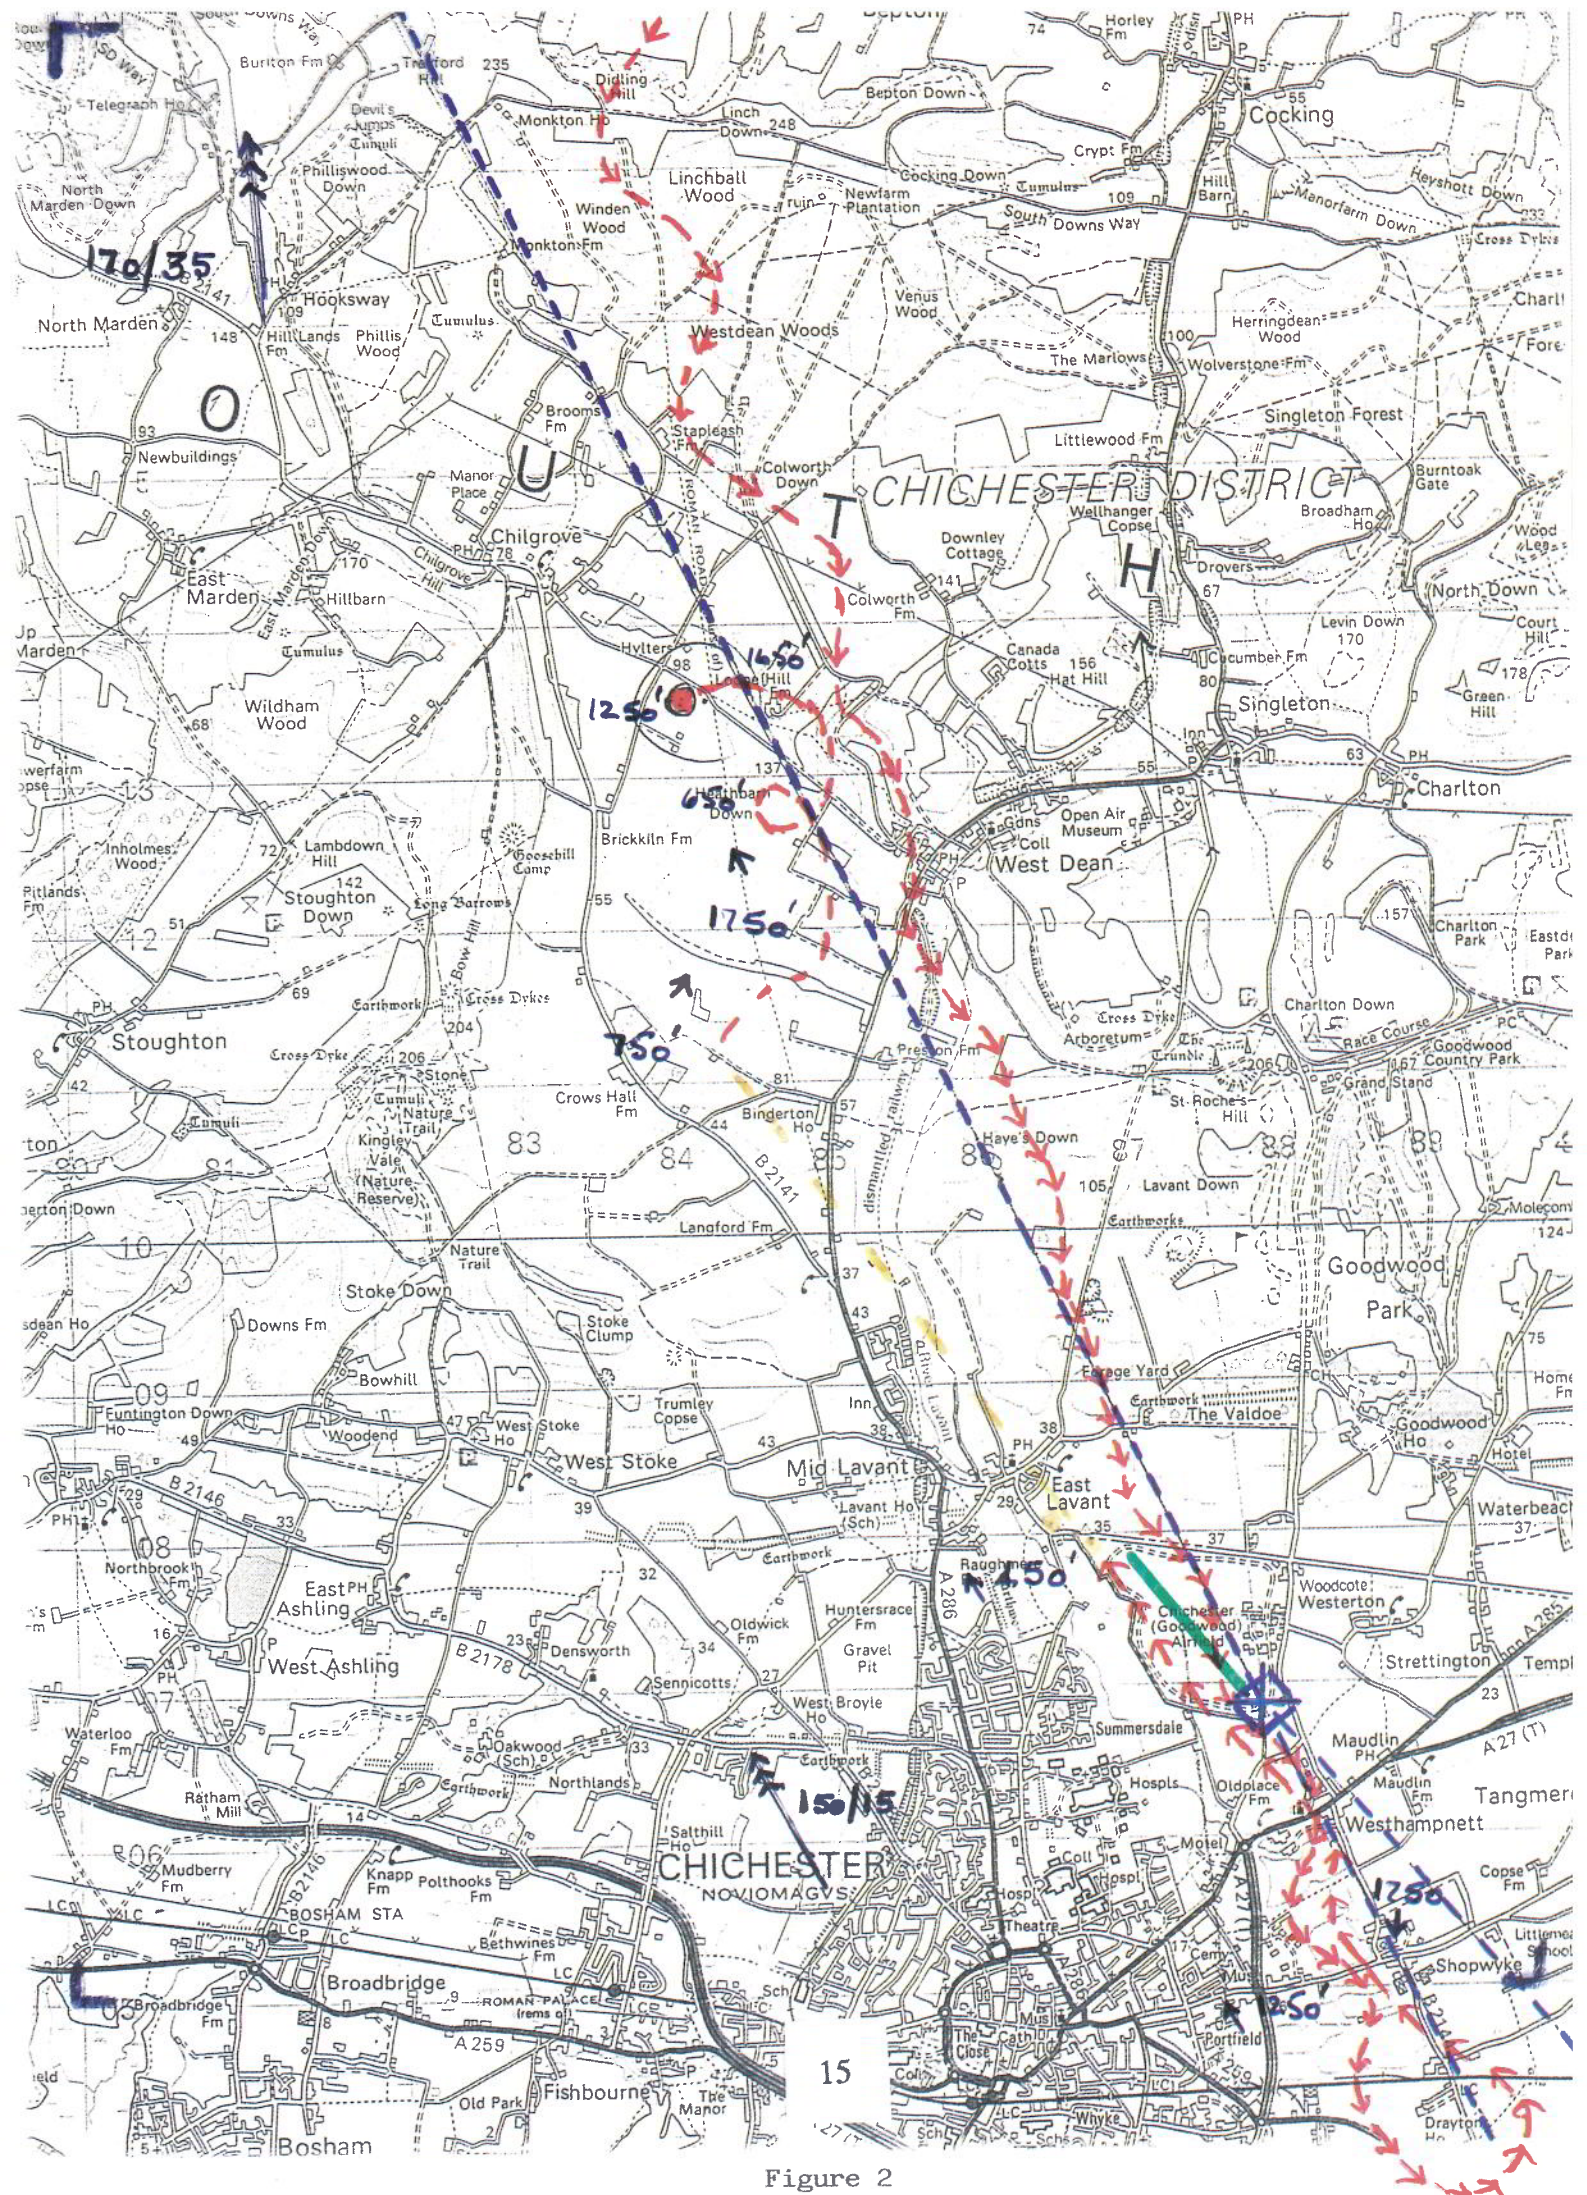
Figure 2

A radar recording of the aircraft's progress during the latter stages of the flight was available for examination and is included at Figure 2. Recorded altitudes are included and these have been converted to heights amsl. The recording shows that although the aircraft was flown to overhead the Goodwood VOR, the laid down procedure was not carried out accurately either in azimuth or altitude. The aircraft disappeared from radar coverage at 450 feet at a position slightly to the northwest of the aerodrome, and reappeared at 750 feet a further two nautical miles northwest. Thereafter it followed an erratic flight path with rapid changes in altitude that are consistent with the pilot's final R/T message that he was suffering spatial disorientation and believed that the aircraft was in a loop.
