ACCIDENT

Wing:	Paramania Revolution 23	
Paramotor unit:	Modified H & E Paramotores R120 series	
Year of Manufacture:	2005	
Date & Time (UTC):	8 July 2007 at 1950 hrs	
Location:	Middle Barn Farm, Bexhill, East Sussex	
Type of Flight:	Private	
Persons on Board:	Crew - 1	Passengers - None
Injuries:	Crew - 1 (Fatal)	Passengers - N/A
Nature of Damage:	Substantial	
Commander's Licence:	None required	
Commander's Age:	42 years	
Commander's Flying Experience:	5 years (paramotors)	
Information Source:	AAIB Field Investigation

Synopsis

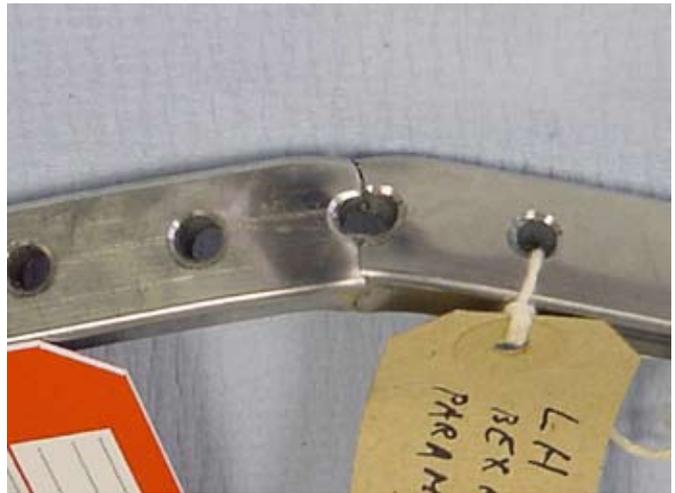
Figure 2
Left lift arm, from above

Figure 3
Left lift arm, outboard surface

The left arm had suffered a complex failure where the shackle-pin passed through the hole in the arm

(Figures 2 and 3). This appeared to be a bending failure in two axes allowing the clevis pin to break out of the hole but, after the failure, some remaining material in the box section surrounding the hole had allowed the forward end of the failed arm to remain united with the hinged end of the arm.

could have precipitated the failure of the left lift arm, at the hole in that arm supporting the clevis pin carrying the flight loads.

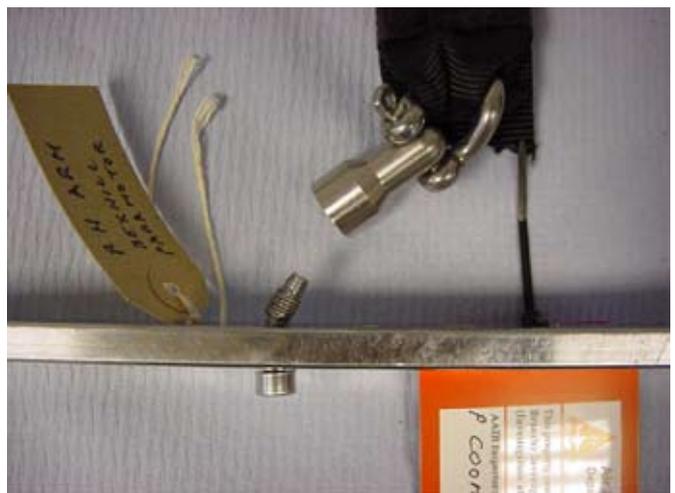
The additional fitting on the right side consisted of an internally-threaded cylindrical component, tapering to a reduced diameter cylindrical end section (Figure 4). This incorporated an eye-end through which passed a clevis pin, supporting a shackle to which the right-hand webbing was attached. The shackle was of the ‘right-angle’ type, with the portion to which the webbing was attached orientated at 90° to the shackle-pin axis. Although the shackle initially appeared to have been deformed to this condition by loading, shackles with this geometry are available from, for instance, suppliers of yacht equipment.

The fitting had been secured to the arm by means of a bolt passing through a hole in the arm and into the internally threaded section of the body of the fitting. It was attached to the body via a helical thread insert.

The right arm was not significantly damaged but the additional fitting, described above, had ‘pulled out’

Figure 4
Right lift arm, threaded connection

(Figure 4) as a result of the threaded insert failing to retain the bolt within the body of that fitting, under the influence of an axial load component. This bolt was also found to be severely bent.

Examination and sectioning of the right-hand load attachment fitting revealed that only two threads were fully engaged and a further four were only partly engaged. This would significantly reduce the failure load. In addition, a series of other variable factors would influence the strength of the attachments:

The bending of the bolt during the failure of the fitting on the right arm indicated a substantial load component at right angles to the bolt axis. This suggested a failure load range falling only slightly above the lowest range of the figures predicted for a direct lateral bolt load. Circular regions of compressive distortion of the material of the right arm surrounding the shackle holes were evident. These indicated that the bolt had been torque-tightened into the fitting on a number of occasions, whilst mounted in a number of different holes. The hole occupied by the bolt on the occasion of the failure was amongst those with significant compressive distortion. Calculations showed that a reduction of load-carrying capacity would have

In summary, the conclusion from the calculation of the failure loads was that it was probable that the failure of the bolted attachment (the right side of the paramotor unit) occurred first and load transfer to the shackle/pin attachment (the left side) followed. This sequence was further indicated by the bending directions of the failed left-hand arm, suggesting its failure load occurred after the seat and occupant had rotated about a longitudinal axis following failure of the right-hand attachment.
