No: 8/90

Ref: EW/C1160

Aircraft Type and Registration: Boeing 747-243B, G-VGIN

Location: Narita Airport, Tokyo, Japan

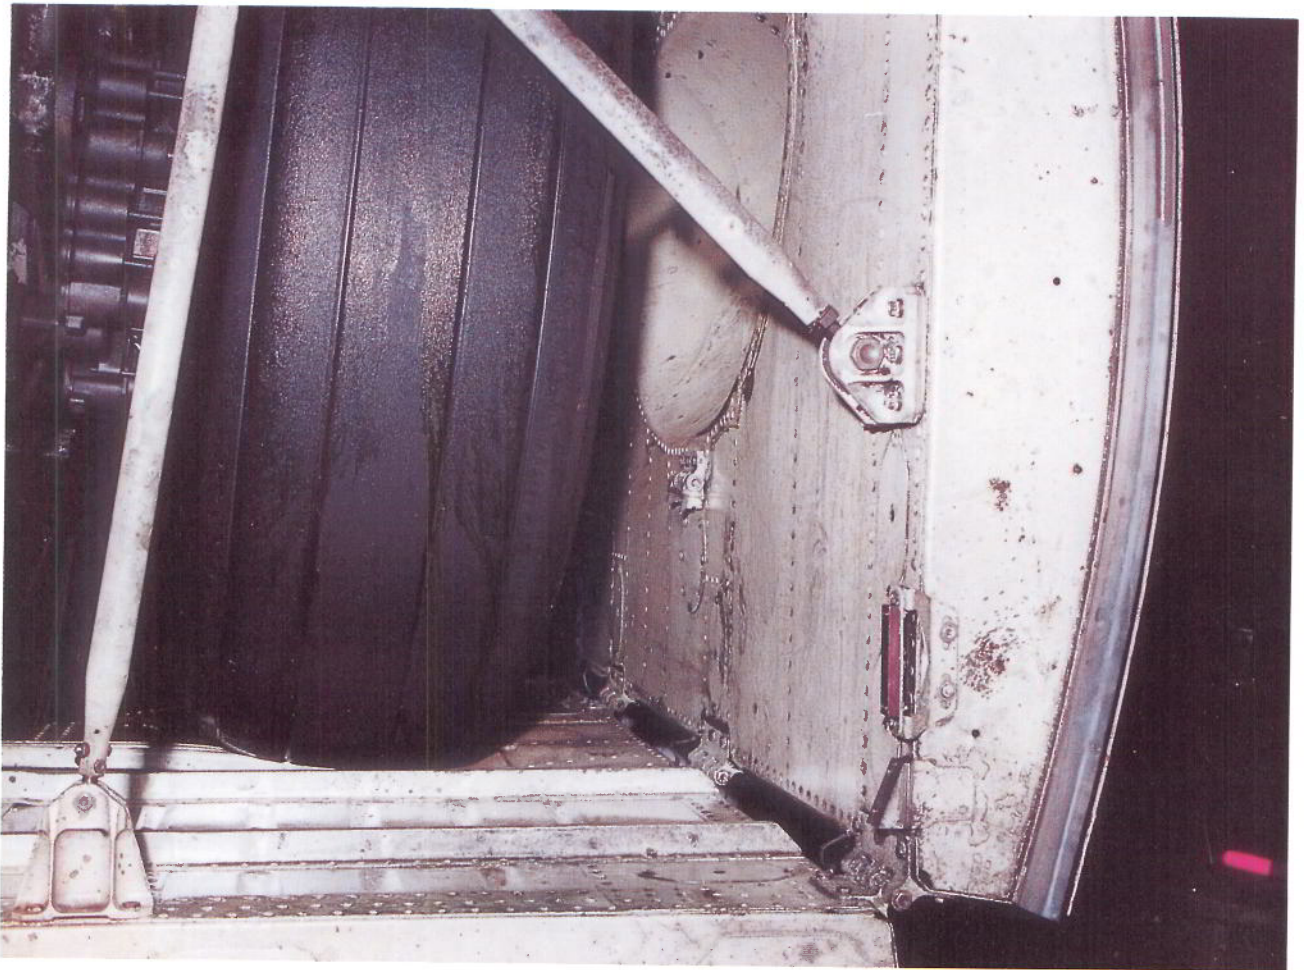
The left body landing gear bay was heavily contaminated with Skydrol hydraulic fluid and the No 7 wheel was resting on the bay door. See photo 1. The tread had detached from the No 6 tyre and two small pieces were found in the landing gear bay at Gatwick, the majority of the tread was recovered from near the point of rotation on the runway at Narita.

Damage to the aircraft within the left hand body landing gear bay included:

- Rupture of the hydraulic pipe from No 1 training edge flap
- Inboard trailing edge flap motor electrical loom and conduit
- Left hand body gear door slide ramp missing

During a normal extension of the body gear the bay doors are held out of the path of the wheels by hydraulic pressure. With the loss of the No 1 hydraulic system the gear is lowered under gravity and the wheels are designed to contact the door ramp, photo 2, and move the doors aside; in this case the door ramp was missing and the doors had arrested the fall of the gear.

PHOTO 1 NO 7 WHEEL RESTING IN LEFT BODY GEAR DOORS - (Viewed facing rearwards)

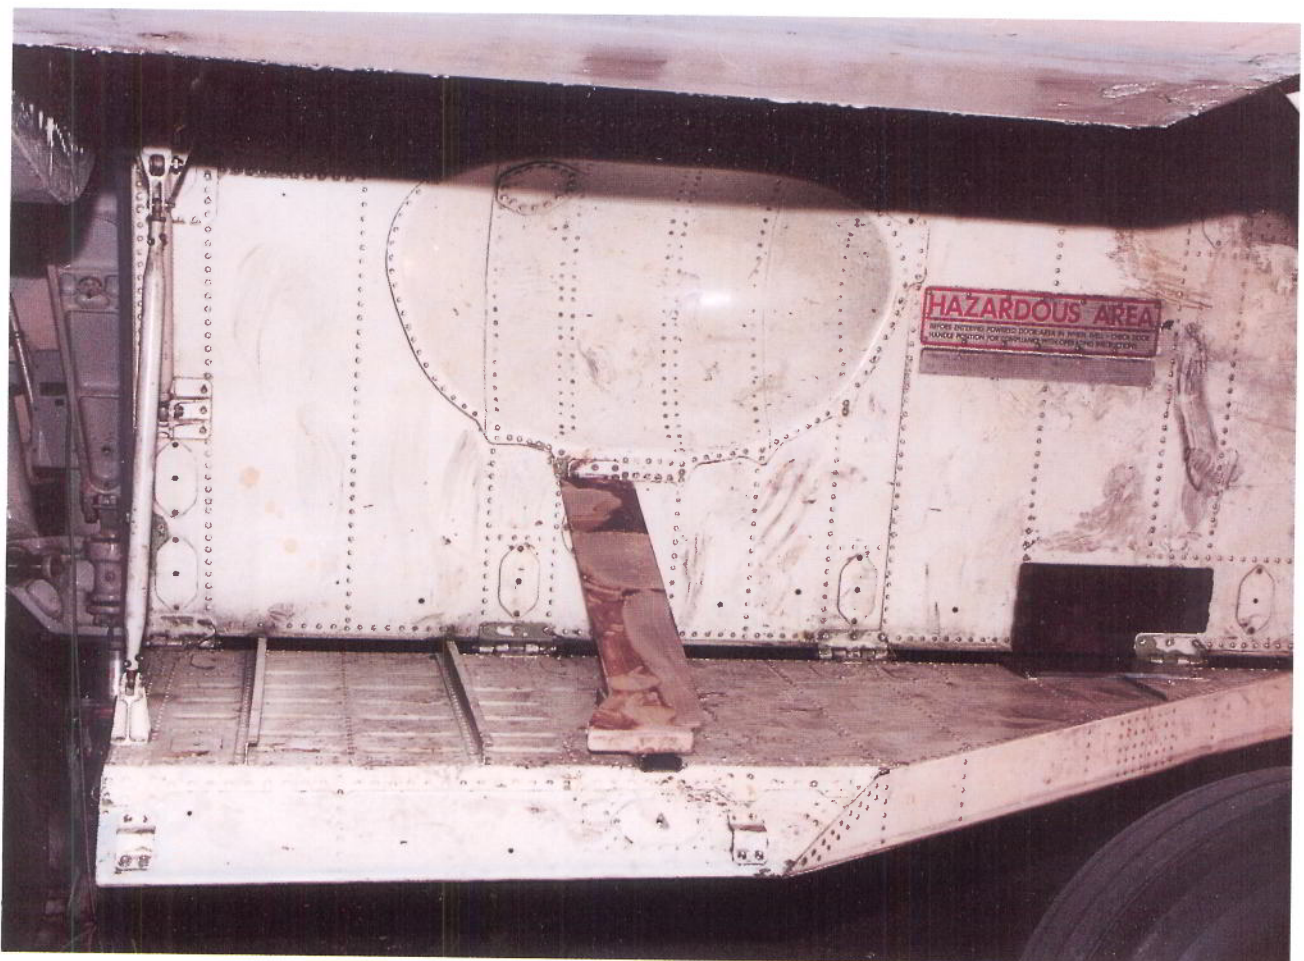
PHOTO 2 DOOR SLIDE RAMP FITTED TO RIGHT HAND BODY GEAR DOOR
