ACCIDENT

Aircraft Type and Registration:	Boeing 747-41R, G-VROC	
No & Type of Engines:	4 General Electric CF6-80C2B1F turbofan engines	
Year of Manufacture:	2003	
Date & Time (UTC):	28 October 2009 at 1956 hrs	
Location:	Johannesburg International Airport, South Africa	
Type of Flight:	Commercial Air Transport (Passenger)	
Persons on Board:	Crew - 18	Passengers - 228
Injuries:	Crew - None	Passengers - None
Nature of Damage:	No 14 tyre burst, part of a landing gear door detached, impact damage to flap and flap fairing	
Commander's Licence:	Airline Transport Pilot's Licence	
Commander's Age:	53 years	
Commander's Flying Experience:	16,073 hours (of which 8,630 were on type) Last 90 days - 182 hours Last 28 days - 53 hours	
Information Source:	AAIB Field Investigation

Synopsis

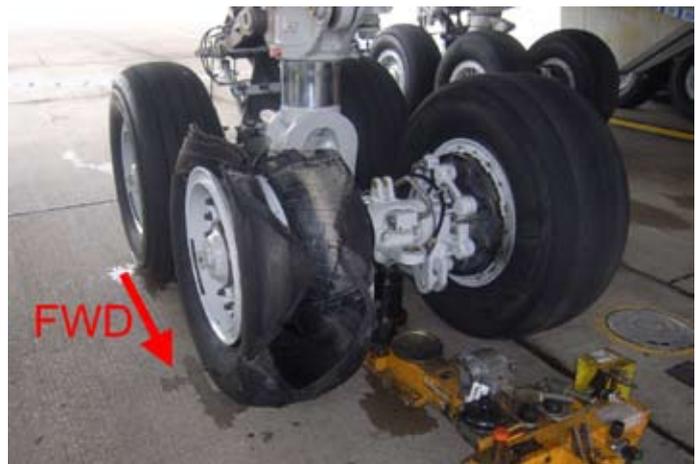
Figure 1

Examination of the aircraft revealed that the tyre on the No 14 wheel had burst. The Boeing 747 main landing gear consists of four four-wheeled main landing gear legs, and the No 14 wheel is the outboard front wheel on the right WLG. A large chunk of tyre carcass of almost half the tyre's circumference was missing (Figure 1). Part of the right WLG shock strut inboard door had separated and was found near taxiway A9 adjacent to Heathrow's Runway 27R. This door sits directly above the No 14 wheel and there were black tyre marks on its underside (Figure 2). The aircraft had also suffered impact damage to its right wing inboard flap fairing and to the leading edge and underside of the right inboard aft flap. A wishbone-shaped support bracket (p/n 65B13644-6) which forms part of the connection between the right WLG shock strut and the right WLG outboard door had failed at its lower forward lug. A rod (p/n 65B12747-1) connected to the forward hinge of the right WLG door had also failed. There was also some damage to clamps on the shock strut and drag strut of the right WLG.

Damaged No 14 tyre on G-VROC after landing at Heathrow

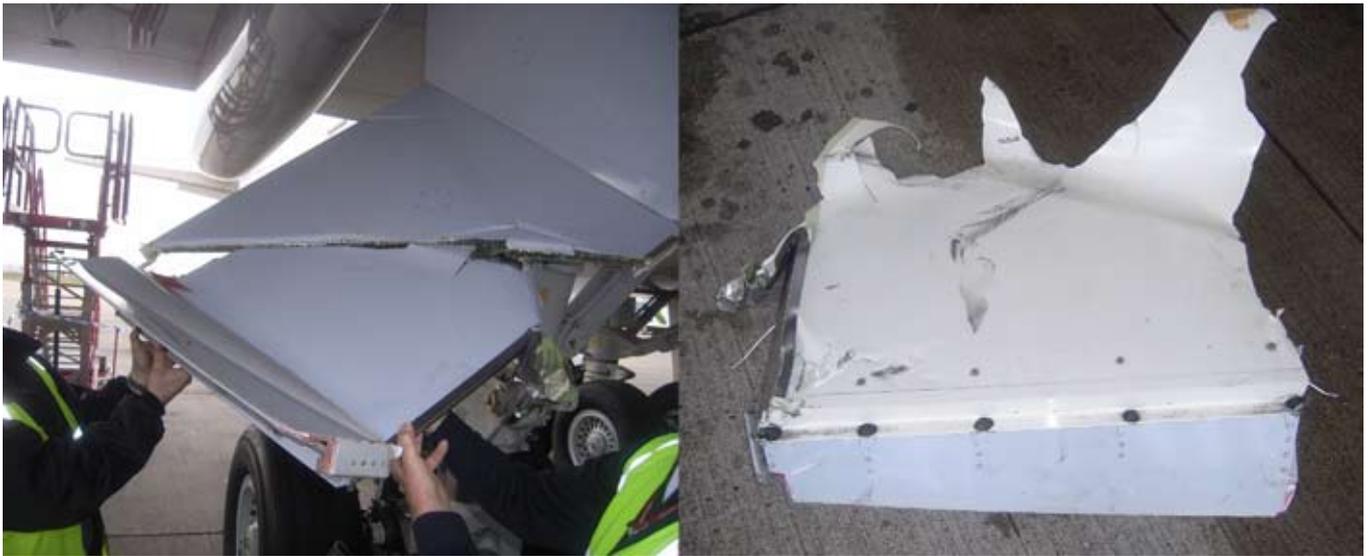
Figure 2

Separated section of the right WLG shock strut inboard door
(left: held in position against the rest of the door; right: black tyre marks visible on its underside)

The possibility that the small piece of failed lug caused the tyre to burst was considered, but this lug had failed in overload with no evidence of progressive cracking; it was therefore more likely that the lug had failed when ruptured sections of tyre carcass struck the WLG outboard door.

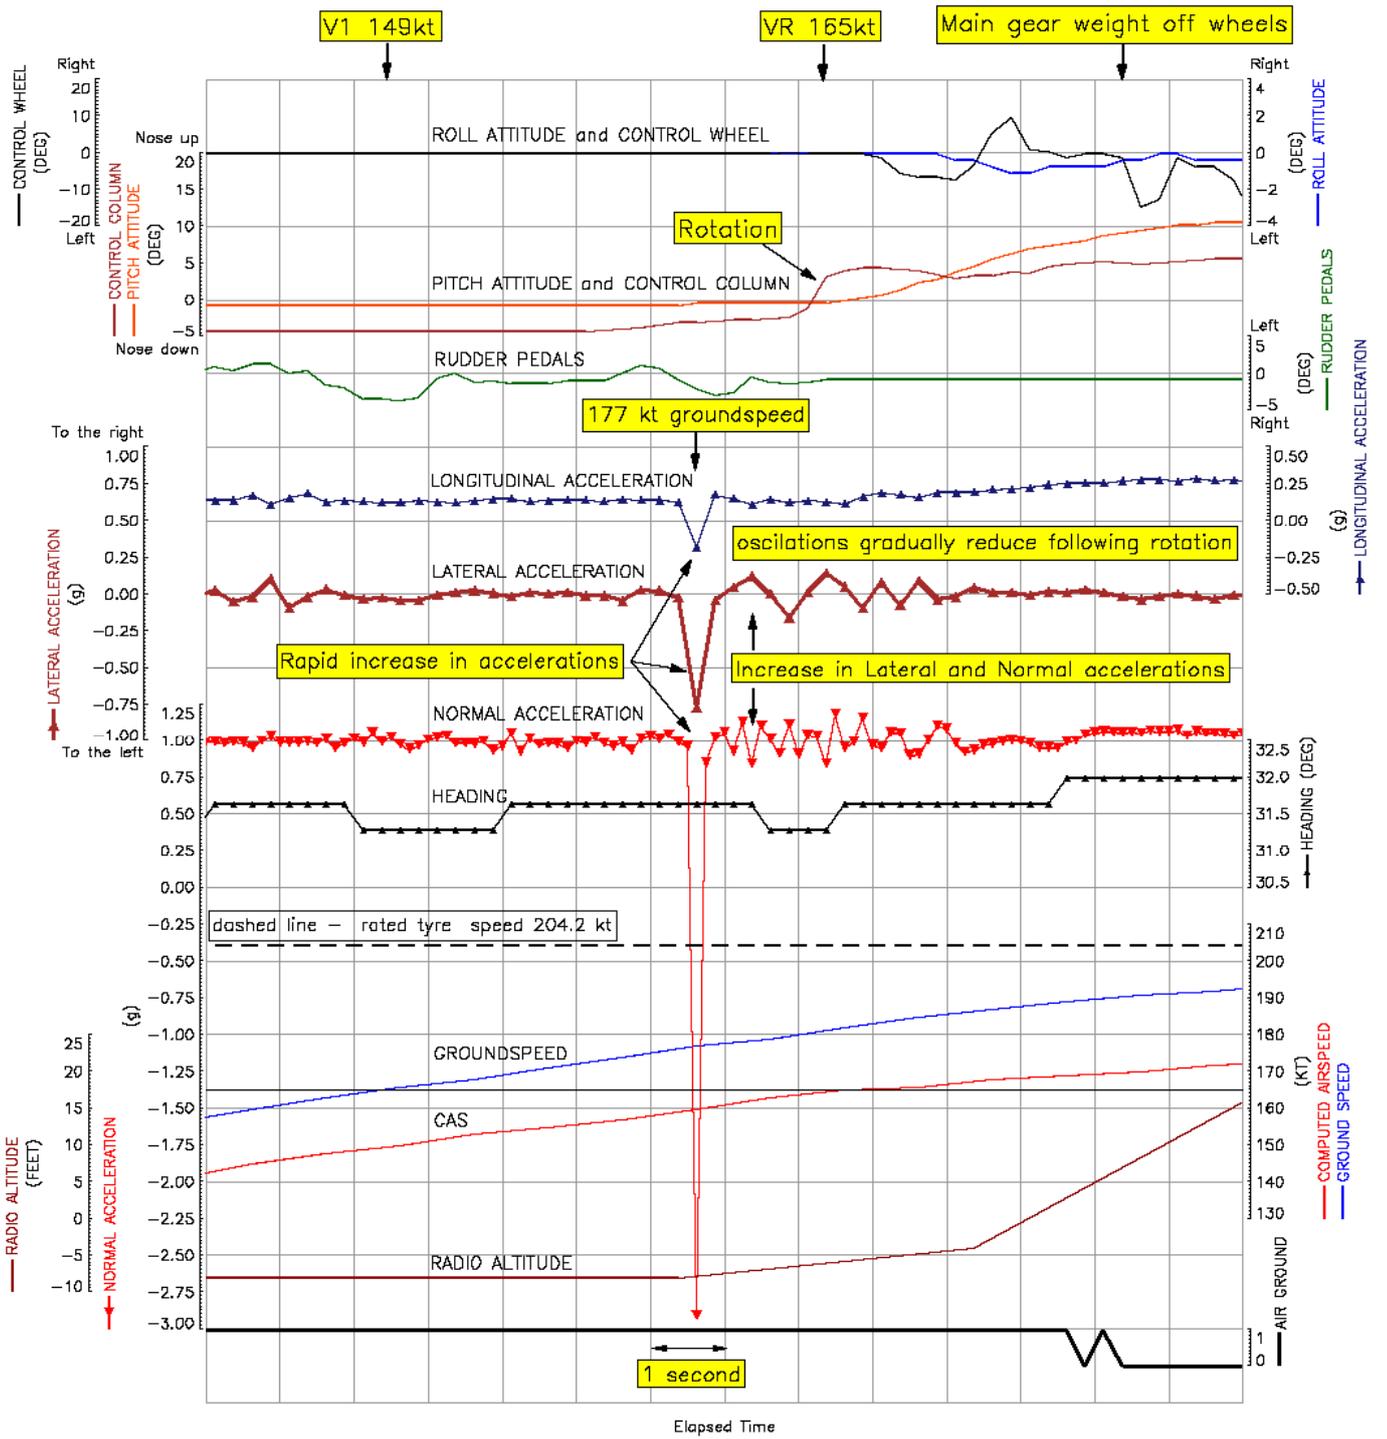
Figure 3

The takeoff appeared normal until shortly after passing V_1 , which was 149 kt (Figure 3). As the aircraft accelerated through 160 kt (177 kt groundspeed), there was a series of rapid fluctuations in lateral, longitudinal

and normal acceleration. For a period of one eighth of a second, a normal acceleration change from 1 g to -2.9 g occurred, coincident with a deceleration of 0.3 g and a lateral acceleration of 0.75 g. This rapid excitation of the accelerometer is believed to have been the result of either tyre debris or a shockwave striking the accelerometer as the tyre failed. The longitudinal acceleration returned to its previously normal indication, but the aircraft then commenced a series of four cyclic lateral oscillations, which was accompanied by an increase in normal axis vibration. Rotation occurred approximately two seconds later, at 165 kt. As the aircraft took off, the lateral oscillations and normal axis vibration stopped. The maximum recorded groundspeed with the main gear in contact with the runway surface was 189 kt. The aircraft climbed without further incident.

G-VROC – Recorded data for takeoff from Johannesburg Airport

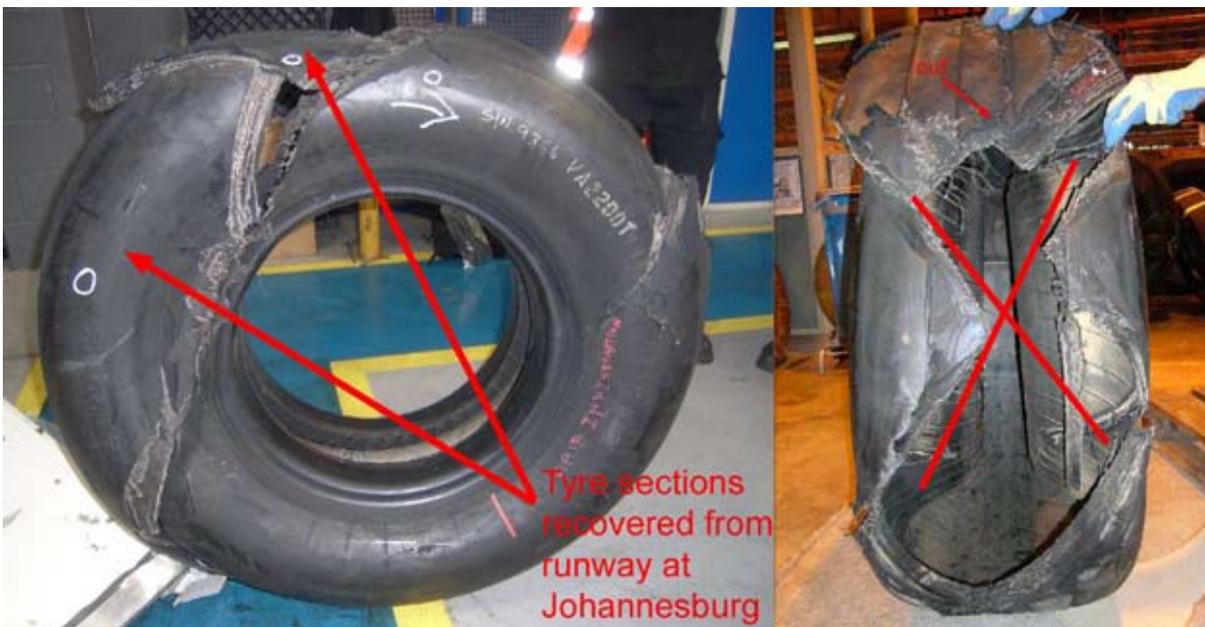
Figure 4

pattern was revealed (Figure 4). An X-type rupture indicates a high pressure blowout, and therefore the tyre had not burst in a low pressure ‘run-flat’ condition. On one of the separated sections there was an area in the centre of the crown where there was a straight break between almost all the casing plies (Figure 5), as if they had been cut. The area surrounding this straight ‘cut’ exhibited plies that had the appearance of having failed in tensile overload.

No 14 tyre reconstructed with the two large sections found on runway at Johannesburg. Right: classic X-type burst pattern and ‘cut’ in upper section

The No 14 tyre burst during the takeoff ground roll at approximately 160 kt, which was well below the 204 kt rated tyre speed. The X-type burst pattern of the tyre indicated that it had ruptured at high pressure. Such ruptures can occur during a heavy landing, but this event occurred during the takeoff roll and the FDM data revealed no exceedences during the previous 57 landings. The adjacent tyre to the No 14 tyre was in satisfactory condition and its pressure was within limits, which meant that the No 14 tyre would not have been carrying excessive load. There was no evidence of a manufacturing defect in the tyre or overheat within the liner, and therefore the most probable cause of the tyre burst was penetration by a foreign object. The missing tyre material in the vicinity of the X made it impossible to determine what type or shape of object caused the

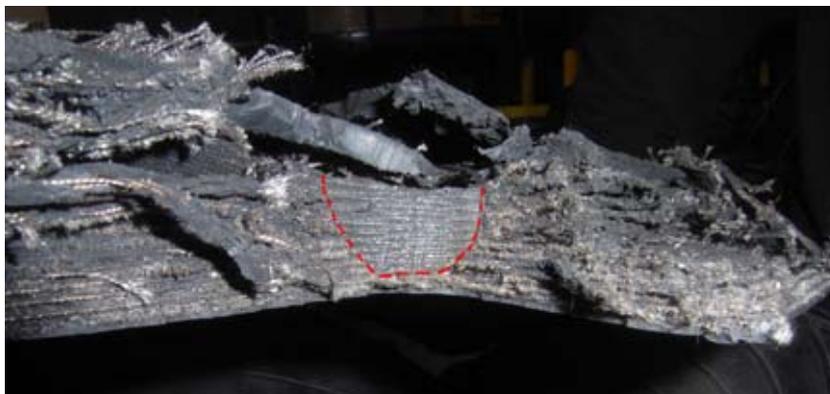
Figure 5

Close-up of ‘cut’ area highlighted in top right section of Figure 4

The manufacturer determined that there were no defects in the construction of the tyre and there was no evidence of internal heat or inner liner wrinkling. Because there were missing pieces in the area of the X-type rupture, the manufacturer could not determine a definitive cause, but they considered that impact from a foreign object was the most probable cause of the tyre burst. They considered that the section of tyre with the straight 'cut' was probably caused by a sharp object, but because the 'cut' was not located near the centre of the X, it is probable that this cut occurred after the initial tyre burst.

rupture. The cut in one of the separated tyre sections was probably caused after rupture, as it was not located in the centre of the X. Despite a repeat inspection of the runway area environment by the airport authority, no foreign objects or the missing tyre sections were found.
