No: 3/91

Ref: EW/G91/01/01

| <b>Aircraft Type and Registration:</b> | Piper PA-38-112, G-BMVL |
| <b>Nature of Damage:</b> | Nose landing gear strut failed, propeller and underside of engine cowling damaged and engine shock-loaded |

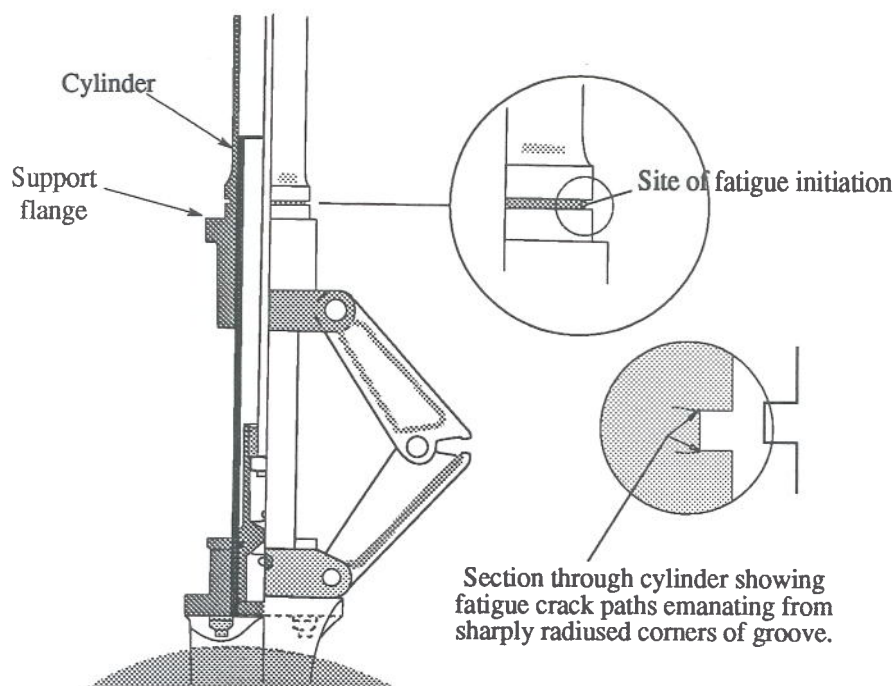
**Half Section of PA38  
(Tomahawk) Nose Leg**

Engineering examination showed that the nose landing gear strut cylinder had failed at a groove just above the lower support flange. Metallurgical examination showed that this failure stemmed from multiple origin fatigue cracking which had initiated in the sharp radiused corners of the groove. The failure is shown in the accompanying drawing and photographs.

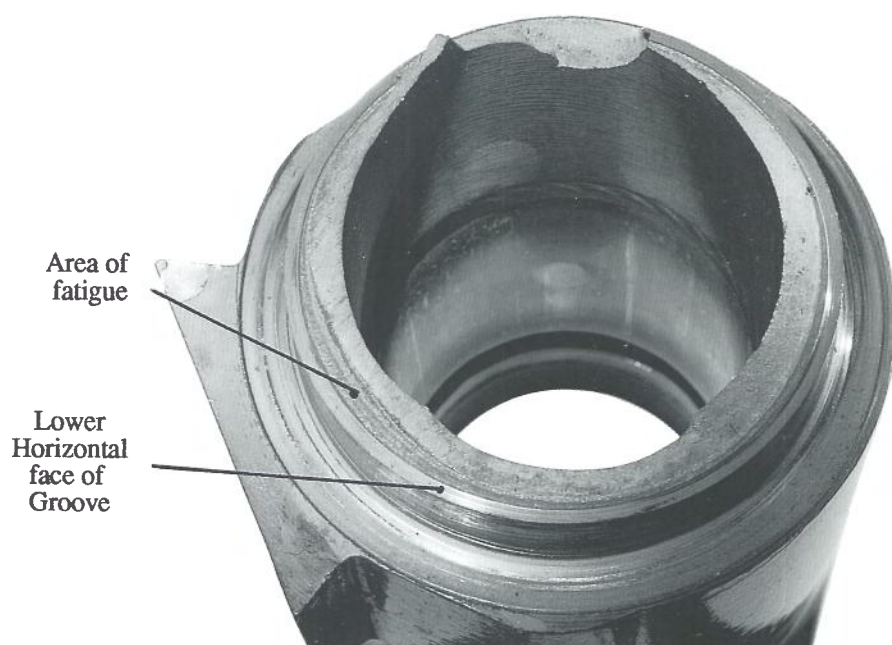
**Fracture - on lower piece of cylinder**
