INCIDENT

| Aircraft Type and Registration: | Boeing 747-436, G-BNLA | |
| Nature of Damage: | Fire damage in cabin, plus damage to electrical looms | |

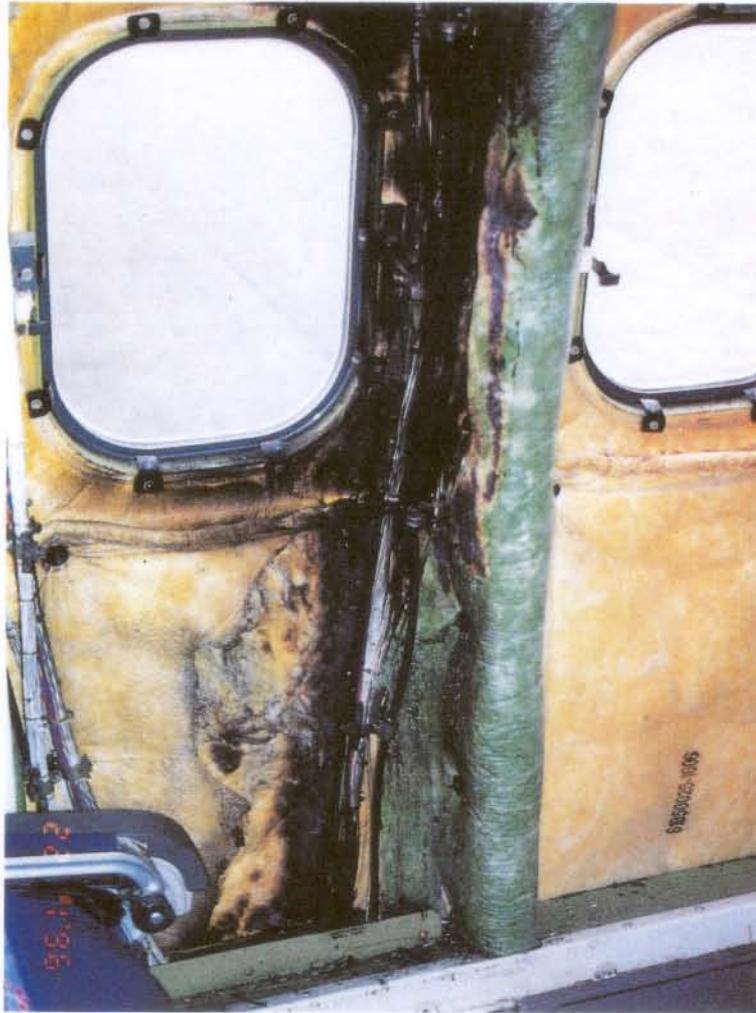
The fire had occurred in a bundle of electrical cables behind a trim panel at fuselage frame no. 1600. The cables were part of a loom, the bulk of which originated from power distribution panels P180 and P415 in the main electronic centre in the forward fuselage. The loom was routed aft, below the cabin

The fire had been locally very intense, with some of the conductors having melted through, causing globules of copper to drop down towards the vent at the base of the trim panel. The loom in the cabin sidewall ran between two insulation blankets, one attached to the fuselage skin, and the other to the cabin trim panel. Both blankets were scorched and blackened. Away from the fire damaged area, it was apparent that other areas of the loom had been subjected to heat, with localised discoloration and even charring of cable insulation, and deformed and embrittled nylon cable-wraps. A photograph of the fire affected area is shown at Figure 1, with Figure 2 showing wiring loom damage remote from the fire.

FIGURE 1. View of fire damaged area (trim panel removed)

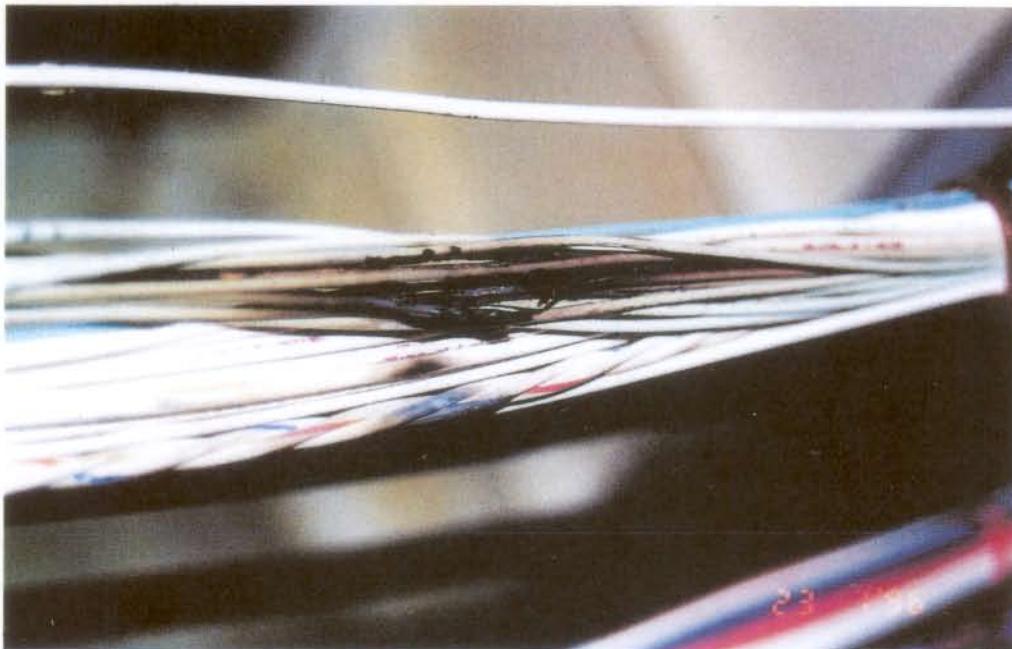
The resistance of 22 gauge cable was found to be approximately 0.15 ohms per metre. With an estimated 50 metres of cable between the circuit breaker panel and the humidifier, and adding the residual resistance of the stator coils, the total resistance per phase lead was probably around 8 ohms; this would have resulted in a current of approximately 14.5 amps. Assuming a direct short occurred in the area of the fire, the minimum resistance in the (reduced) cable run was unlikely to have been below 5 ohms, giving a current of around 23 amps. It is therefore not surprising that the 25 amp circuit breaker failed to trip. Depending on the exact value of resistance, the power consumption would have been in the region of 1.7 to 2.6 kW per phase. The heat generated as a result would not readily have dissipated in that portion of the loom behind the cabin trim panel, where it was sandwiched between layers of insulation material. This is the most probable reason for the fire breaking out in that location. Retained heat, in addition to the possibility of the humidifier supply cables shorting out on adjacent cables, were most likely responsible for the re-ignition which occurred after the aircraft landed. Elsewhere in the loom, a degree of ventilation probably prevented combustion of the cable insulation .

FIGURE 2. Typical damage to loom away from fire
