**ACCIDENT**

<b>Aircraft Type and Registration:</b>	Cessna FR172E, G-OMAC
<b>No &amp; Type of Engines:</b>	1 Continental Motors IO-360-D piston engine
<b>Year of Manufacture:</b>	1969
<b>Date &amp; Time (UTC):</b>	7 August 2005 at 1717 hrs
<b>Location:</b>	Bracklesham Bay, West Sussex
<b>Type of Flight:</b>	Private
<b>Persons on Board:</b>	Crew - 1                      Passengers - None
<b>Injuries:</b>	Crew - 1 (Fatal)              Passengers - N/A
<b>Nature of Damage:</b>	Aircraft destroyed
<b>Commander's Licence:</b>	Commercial Pilot's Licence with Instrument Rating
<b>Commander's Age:</b>	25 years
<b>Commander's Flying Experience:</b>	373 hours (of which 170 were on type) Last 90 days - 127 hours Last 28 days - 69 hours
<b>Information Source:</b>	AAIB Field Investigation

**Synopsis**

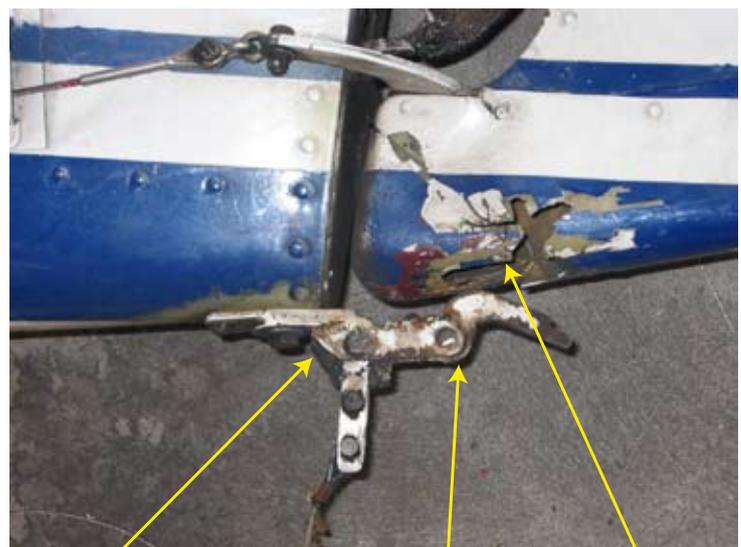
**Figure 1**

Evidence of repeated operation was apparent on G-OMAC by long term damage to the base of the rudder (see Figure 1). There was a possibility that the hook could become lodged within the rudder. However, given the lightweight fibreglass structure it is likely that rudder pedal pressure would liberate the hook and allow the rudder to move freely again.

Main hook attachment

Main hook

Damage to base of rudder

Cessna stated they have not had any experience of these types of tow hooks interfering or jamming the flight controls, although damage such as found on G-OMAC is not uncommon.

Secondly, damage had occurred to the rudder surface over time as a result of the banner towing hook springing back as the banner was released. It was considered possible that this could result in a restriction to the normal operation of the rudder system. However, the material in the contact area was frangible and it was considered unlikely that the hook would have remained in a jammed position. Any such restriction would normally only occur after banner release and the accident occurred on takeoff when the hook would have been in the 'normal' vertical position against the latch. In that position, it was considered unlikely that the hook would then make contact with the rudder. There was a slight possibility that, during takeoff on a grass surface, the hook could bounce around its 'normal' position and contact the bottom of the rudder. However, it was considered highly unlikely that this would have resulted in a permanent jam to the rudder system.

The tow hook was supplied by the manufacturer and is fitted to a large number of aircraft. Although there have been no reported instances of flying control restrictions caused by a tow hook, and it is considered unlikely that the banner-towing hook had any bearing on the accident to G-OMAC, any possibility of the hook impinging on a primary flight control is undesirable. The following recommendation is therefore made.

#### **Safety Recommendation 2006-42**

It is recommended that the European Aviation Safety Agency review the design of tow hooks fitted to banner-towing aircraft with particular regard to eliminating any possibility of the hook interfering with the aircraft's primary flying control surfaces.

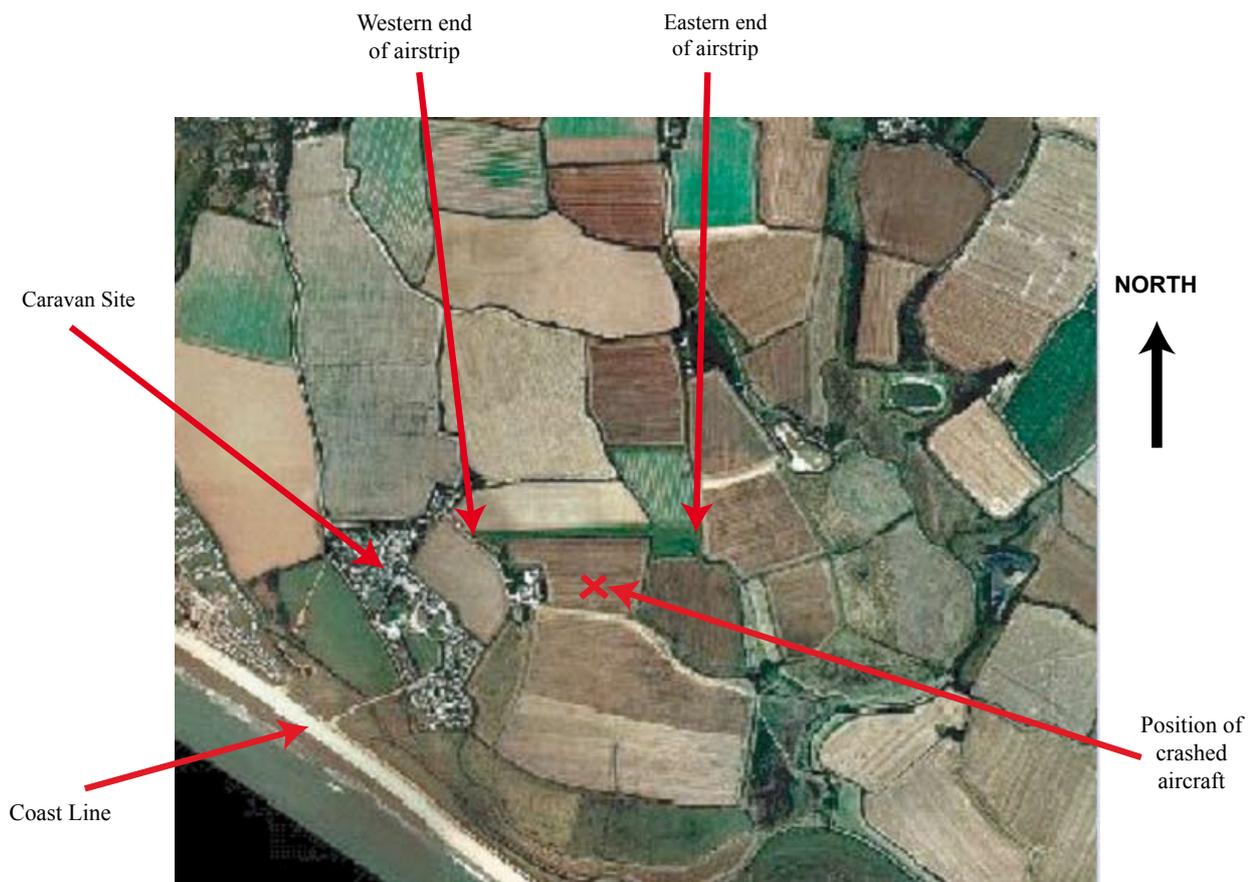
**Figure 2**

Bracklesham Bay Airstrip has a grass surface and a length of some 550 m; at the time of the accident, the grass was dry and short and the surface of the airstrip was firm. The airstrip is orientated east/west and has a grass parking area at the eastern end where there is a small hangar and a caravan. To the west of the airstrip is a caravan site and pilots operating from the airstrip are asked to avoid this site whenever possible. The prevailing wind is generally south-west and the normal procedure used by pilots after takeoff on the westerly runway was to turn left towards the coast.
