INCIDENT

Aircraft Type and Registration:	Boeing 747-443, G-VLIP	
No & type of Engines:	4	CF6-80C2B1F turbofan engines
Year of Manufacture:	2001	
Date & Time (UTC):	5 July 2006 at 0905 hrs	
Location:	Taxiway Lima, London (Gatwick) Airport	
Type of Flight:	Public Transport (Passenger)	
Persons on Board:	Crew - 18	Passengers - 289
Injuries:	Crew - None	Passengers - None
Nature of Damage:	Trailing edge skin of right winglet damaged	
Commander's Licence:	Airline Transport Pilot's Licence	
Commander's Age:	34 years	
Commander's Flying Experience:	8,000 hours (of which 6,500 were on type) Last 90 days - 209 hours Last 28 days - 75 hours	
Information Source:	Aircraft Accident Report Form submitted by the operator

Synopsis

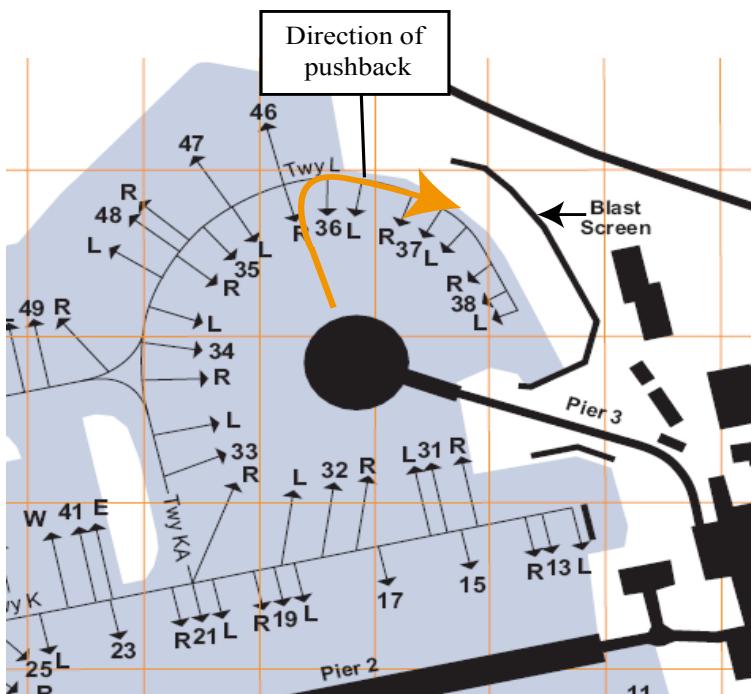
**Figure 1**

Stands 31 to 38 are arranged around the circular head of Pier 3, which is located at the north-west end of a spur attached to the South Terminal at Gatwick Airport (see Figure 1). To increase parking flexibility, each stand has Left (L) and Right (R) parking positions, which can be occupied simultaneously by narrow-body aircraft, and a Middle parking lane which is used by single wide-body aircraft. Aircraft manoeuvre to and from the stands via Taxiway Lima, which runs circumferentially around the Pier 3 apron area. The north-east segment of this taxiway is bounded by a blast fence which protects adjacent roadways and buildings.

Pier 3, Stands 31-38 and blast fence

The collision occurred when the aircraft was pushed back into an area of Taxiway Lima where insufficient clearance existed between the blast fence and the taxiway centreline to accommodate its wingspan. The pushback was conducted in accordance with standard procedures and the request to conduct a long push onto the taxiway area adjacent to Stands 37 and 38 was not specifically prohibited by existing local instructions. The tug driver had no means of determining when the extremities of a particular aircraft type had entered this area.

- a. Ground staff involved in pushback operations may enter the manoeuvring area adjacent to stands to the extent necessary to provide position guidance.
- b. During pushback operations the nosewheel of any wide-bodied aircraft should not be pushed rearwards beyond the Stand 36L lead in arrow.
