## ACCIDENT

<b>Aircraft Type and Registration:</b>	Rockwell Commander 114 Commander, G-BDYD	
<b>No &amp; Type of Engines:</b>	1 Lycoming IO-540-T4A5D piston engine	
<b>Year of Manufacture:</b>	1976	
<b>Date &amp; Time (UTC):</b>	31 May 2009 at 1218 hrs	
<b>Location:</b>	Ballynakilly Road, Cookstown, Northern Ireland	
<b>Type of Flight:</b>	Private	
<b>Persons on Board:</b>	Crew - 1	Passengers - 1
<b>Injuries:</b>	Crew - 1 (Serious)	Passengers - 1 (Serious)
<b>Nature of Damage:</b>	Aircraft destroyed	
<b>Commander's Licence:</b>	Private Pilot's Licence	
<b>Commander's Age:</b>	51 years	
<b>Commander's Flying Experience:</b>	526 hours (of which 145 were on type) Last 90 days - 6 hours Last 28 days - 4 hours	
<b>Information Source:</b>	Aircraft Accident Report Form submitted by the pilot and subsequent AAIB examination of the aircraft

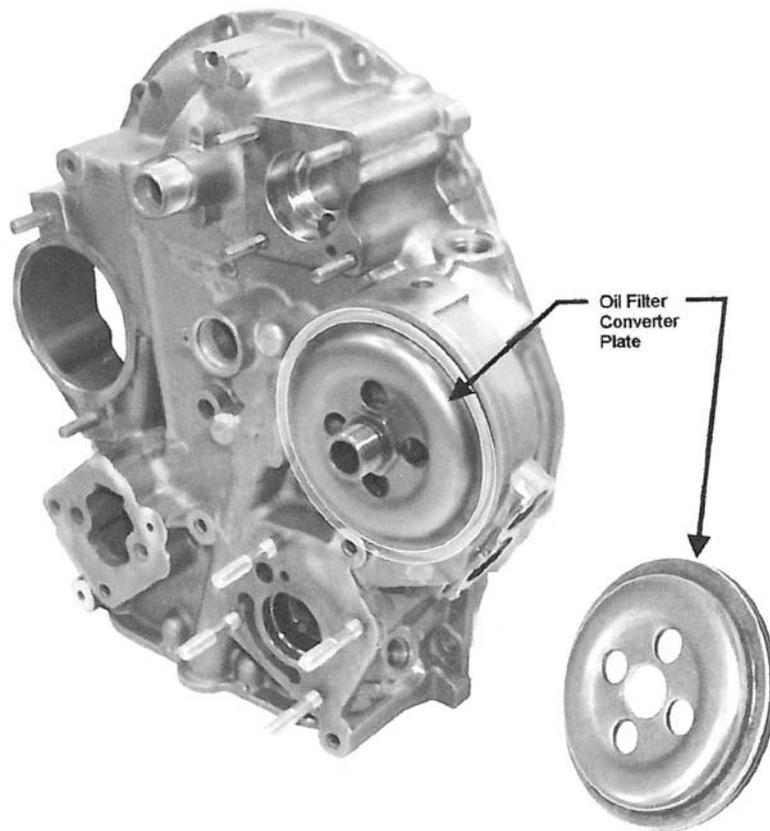
**Figure 1**

the oil filter from its threaded boss, it was apparent that a seal on the converter plate within the filter mount, Figure 1, was in a deteriorated condition. The converter plate was removed from the mount after unscrewing the boss, which is shown at Figure 2. It can be seen that there is a breach in the circumference of the seal, which has also been 'extruded' between the converter plate and the accessory housing. It was established that the filter was the correct type for use with this particular engine.

Oil filter converter plate location on the accessory drive housing

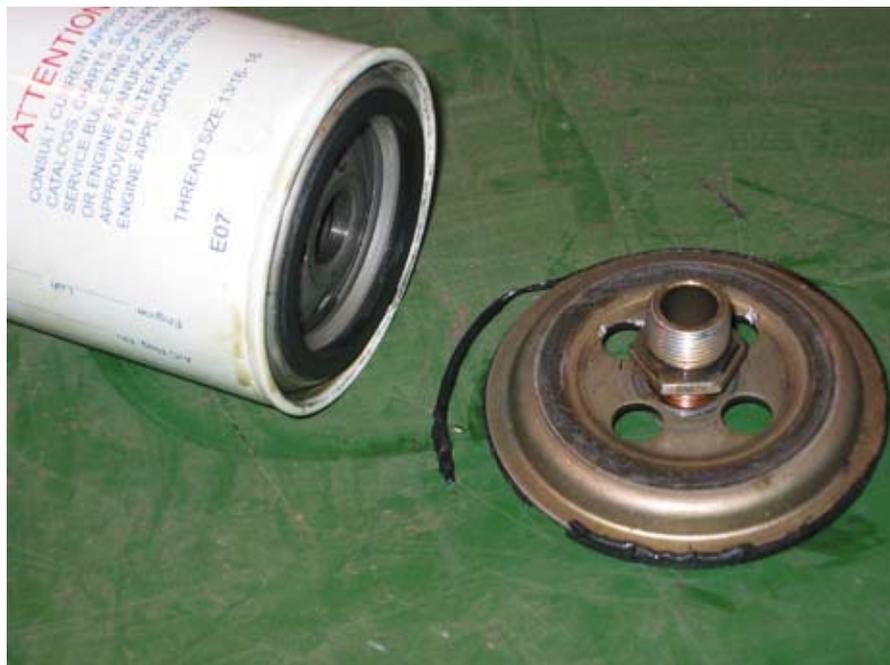
**Figure 2**

View of filter and converter plate, showing damaged gasket

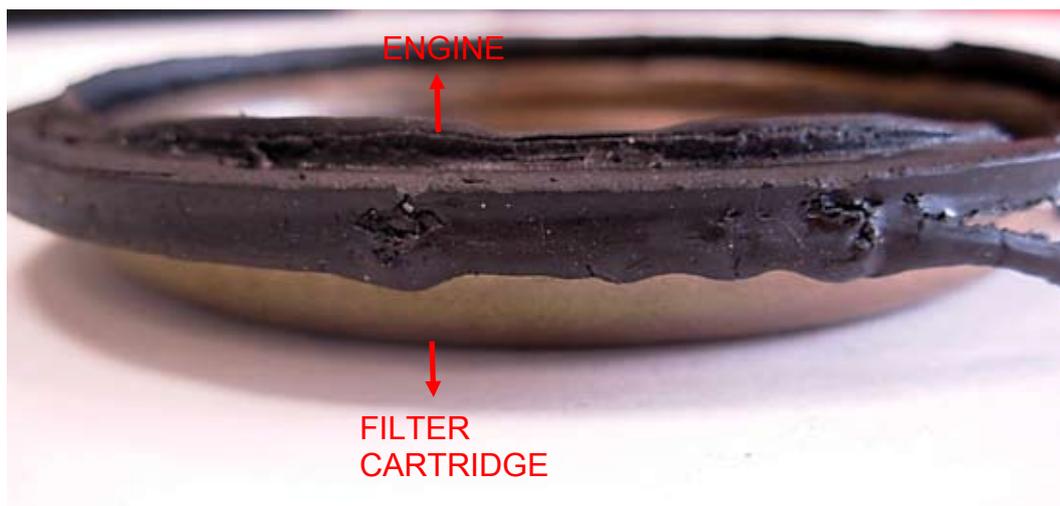
Fig 3a

The failed gasket had sustained considerable damage, as shown in the photographs at Figure 3a and 3b. It was concluded that this was partly the result of high temperatures generated within the engine following the loss of lubrication.

Views of damaged gasket
