## ACCIDENT

<b>Aircraft Type and Registration:</b>	Cessna 182S Skylane, G-BXZM	
<b>No &amp; Type of Engines:</b>	1 Lycoming IO-540-AB1A5 piston engine	
<b>Year of Manufacture:</b>	1998	
<b>Date &amp; Time (UTC):</b>	24 February 2011 at 1256 hrs	
<b>Location:</b>	White Waltham Airfield, Berkshire	
<b>Type of Flight:</b>	Private	
<b>Persons on Board:</b>	Crew - 1	Passengers - 3
<b>Injuries:</b>	Crew - 1 (Minor)	Passengers - 3 (Minor)
<b>Nature of Damage:</b>	Nosewheel, propeller, left wing spar, right wingtip, tail and fuselage	
<b>Commander's Licence:</b>	Private Pilot's Licence	
<b>Commander's Age:</b>	44 years	
<b>Commander's Flying Experience:</b>	84 hours (of which 4 were on type) Last 90 days - 8 hours Last 28 days - 6 hours	
<b>Information Source:</b>	Aircraft Accident Report Form submitted by the pilot and subsequent AAIB enquiries

## Synopsis

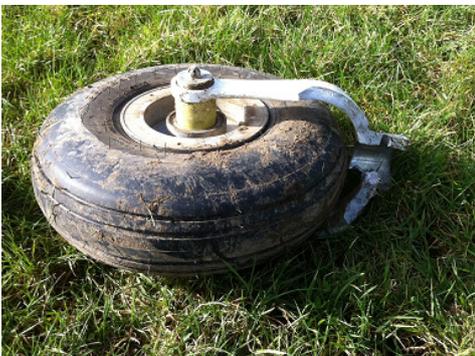
Photographs of the accident site provided to the AAIB show ground markings consistent with a heavy nosewheel touchdown (Figure 1). The nosewheel (Figure 2) was found approximately 10 m to the right of the runway centreline. Subsequent propeller strikes and a furrow caused by the nose landing gear leg contacting the ground are also evident (Figure 3).

**Figure 2**  
Nosewheel

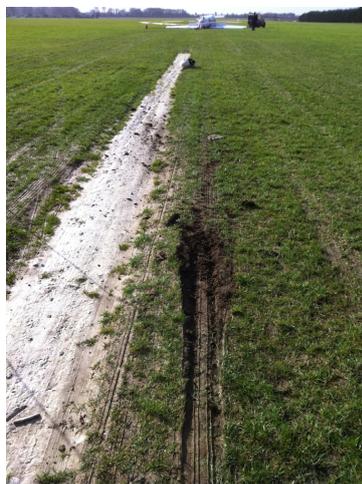
**Figure 1**  
Nosewheel impact mark

The nosewheel yoke had fractured causing the nosewheel to separate from the landing gear. The fracture surfaces of the yoke were examined using a binocular microscope and a scanning electron microscope to determine the failure mechanism. Two distinct regions of fracture were evident indicating a two-stage failure process, resulting from overload of the component. It was concluded that a crack had initially propagated upwards from the base of the yoke due to tensile overload caused by excessive drag loading on the nosewheel. There was also evidence of compressive loading consistent with a hard landing. It is likely that the nosewheel buckled under the compressive loading after one of the bounces, causing compressive failure on one side of the yoke. Drag loading is likely to have arisen from the nosewheel impact shown in Figure 1; the depth of this mark also indicates the presence of significant compressive loading.

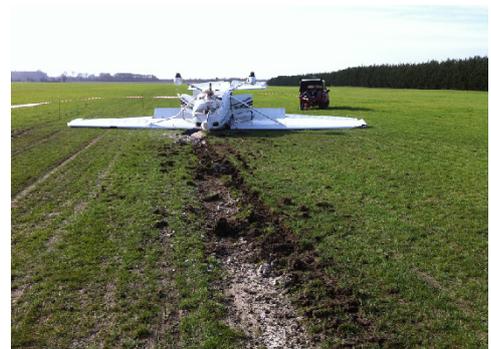
**Figure 3**  
Propeller strike and  
ground marks
