Part C

Review of the Report on the accident to Piper PA E 23 (Aztec) Series 250 G-AYSF at Moffat, Drumfriesshire, Scotland on 27 July 1976

I have the honour to submit my Report upon the Review of the aircraft accident report on the accident to Piper PA E 23 (Aztec) Series 250 G—AYSF on 27 July 1976.

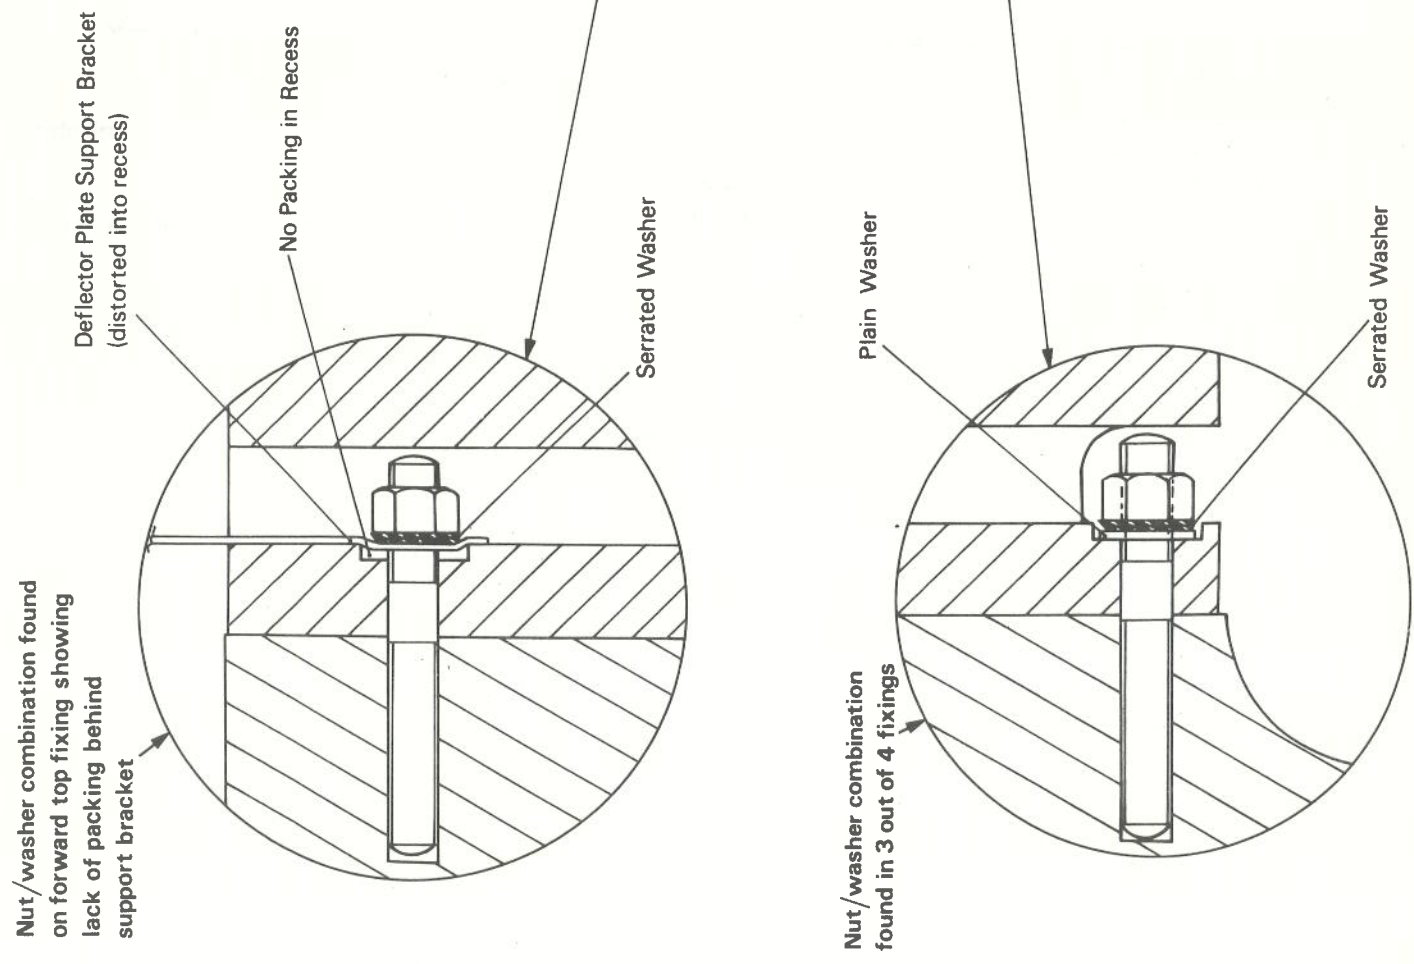
Sketch indicating the method of attachment
of the Propeller Governors used on G - AYSF

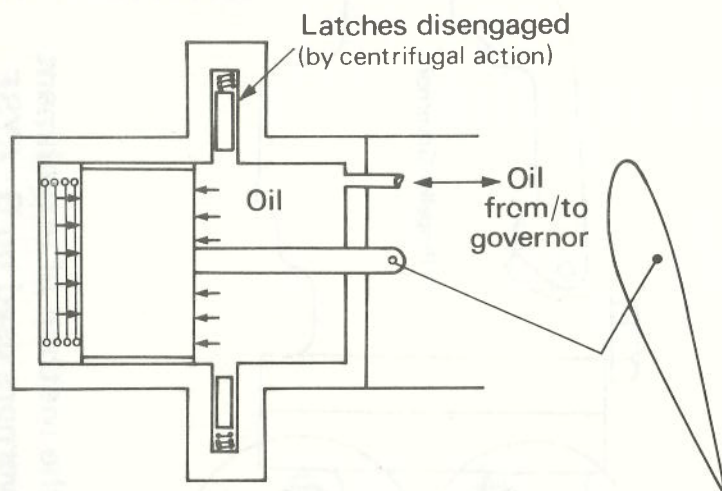
Fig2 FEATHERED AND
STOPPED

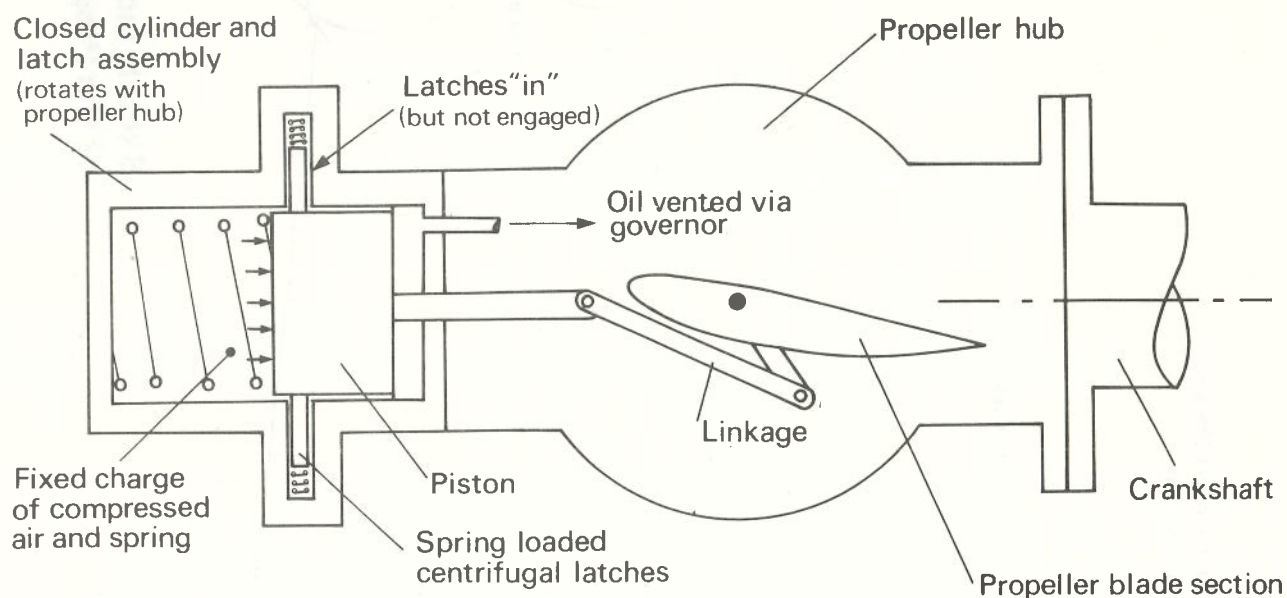
Fig 3 LATCHED CONDITION
(condition of left propeller
at impact)

- 20 I do not consider that the marks on the pre-load Plates upon which Mr Harlament relied, when these marks are compared with other pre-load Plates which were produced, support his conclusion as to the precise angle of pitch of the propeller when it hit the ground. I was however impressed by his evidence as to the likely effect of the impact on the blade and his reasons for concluding that the latches were not engaged at the time of impact. I therefore consider that it is more likely that the latches were not engaged when the propeller struck the ground.

("The examination of the pitch change mechanism and the damage thereto indicated that at the time of impact the latches were probably not engaged. The point of latch engagement for this type of propeller varies between individual propellers, but should lie in the range 19 to 22°. The fine pitch stop is normally set to approximately 14½° and the feather position is normally between 79 and 81°.")

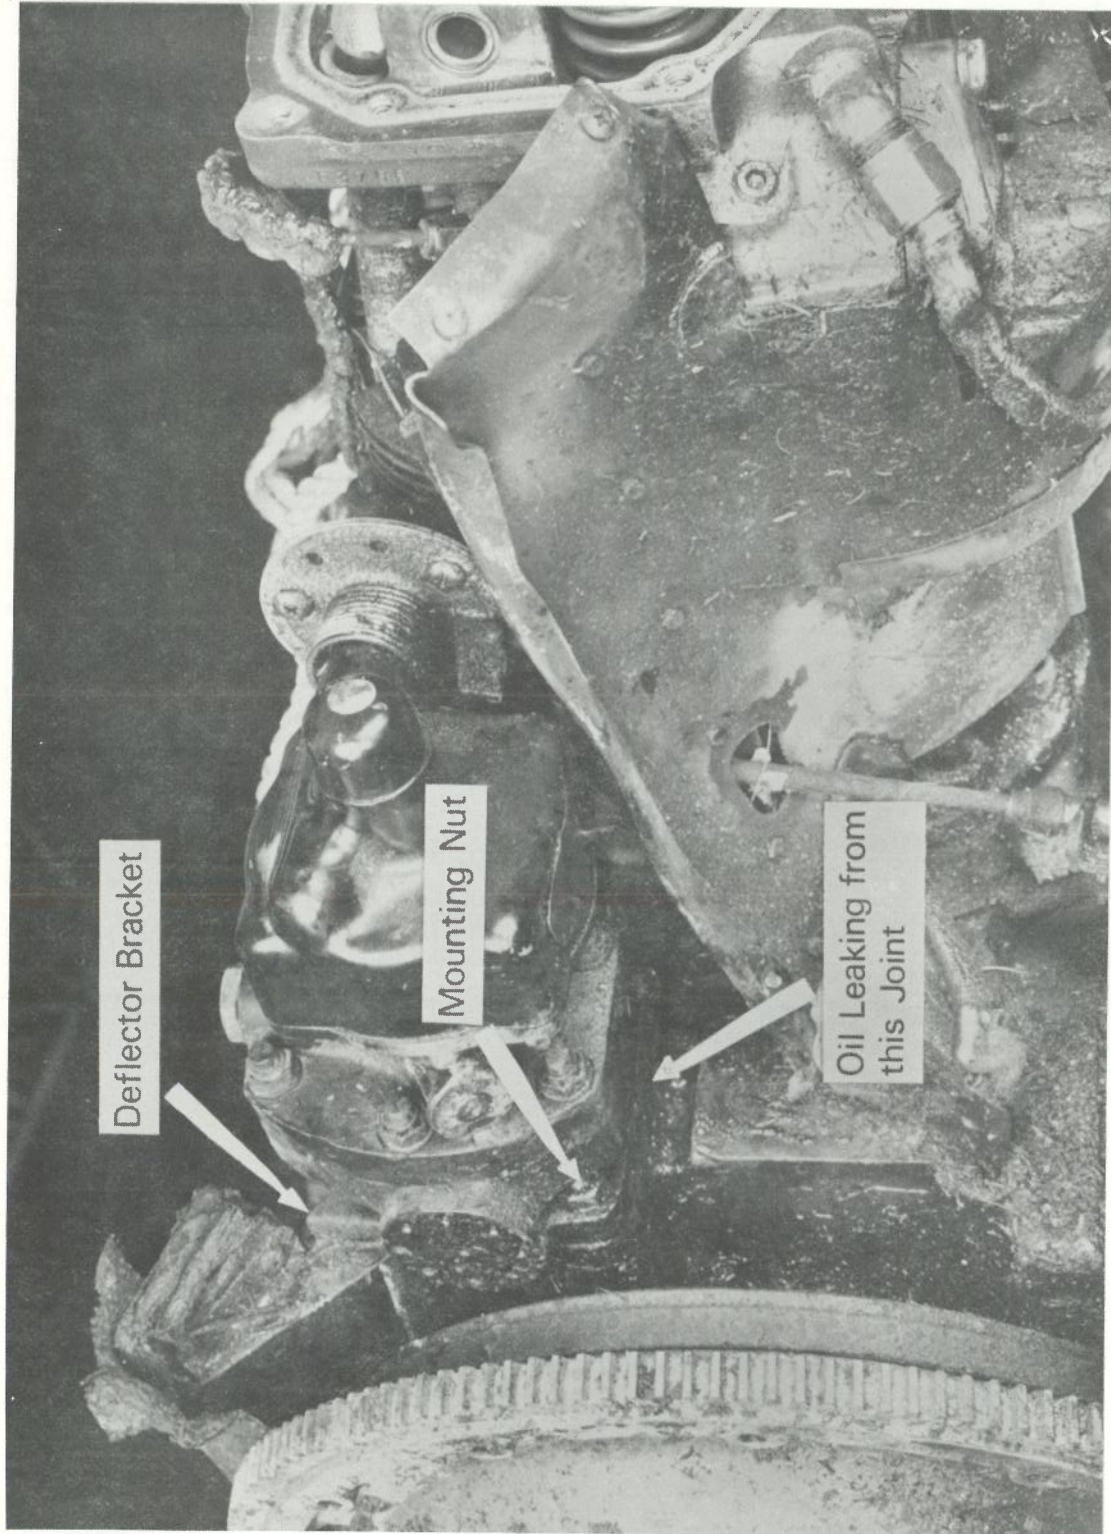
G - AYSF: Port Propeller Governor Installation
- showing oil seepage from
attachment joint

12 If the Governor Unit was loose before impact there can be no doubt that it could only have been as loose as it was found to be by Mr Protheroe for a very short time. The rate of oil loss through the gap at a pressure of 300 p.s.i. was calculated to be 2.7 imp. pints per minute which would have emptied the sump in a few minutes and this had not occurred. In reaching the conclusion that the Governor Unit had become loose before impact Mr Protheroe relied on the examination of the studs which secured it to the crankcase, which examination had been carried out by AQD Laboratories and on the amount of oil found on the inside of the cowling. There was, however, some doubt as to the extent of that examination. Mr Protheroe thought that the threads in the light alloy casting of the crankcase which received three of the four steel studs had been examined and found to be intact whereas Mr Cripps who carried out the tests considered that no such examination had been made since no mention thereof appeared in the Test Report. He further considered that distortion would be more likely to have occurred in the light alloy casting than in the steel studs and agreed that in the absence of information as to whether there was distortion in the casting the investigation could not be assumed to be complete. Mr Light with whose evidence as a whole I was much impressed also thought that failure or deformation of threads would first be found in the casting as happened in the case of the vacuum pump mounting studs and that in any event an examination after the studs had been withdrawn could destroy evidence of distortion because of the interference fit of the studs.

13 So far as the oil on the inside of the cowling is concerned there is no doubt that it could have come from a loose Governor Unit but it could also have come from other sources in the engine and the presence of oil in such a position and in such quantity is I am informed by my Assessors by no means unusual. It is reasonable to assume that the

14 In the foregoing circumstances I consider that it would be unsafe to assume that the Governor Unit had become loose prior to the impact. However even if it had I am satisfied that no criticism can be levelled at the method of securing the nuts. Mr Protheroe agreed that the possibility of properly torque-tightened nuts coming loose was remote and Mr Light, in his very considerable experience, had never heard of one properly torque-tightened Governor Unit nut slacking off after a substantial period of trouble-free operation let alone four such nuts at the same time. Mr Light further considered that the system of nut and washers used to secure the Governor Unit was entirely satisfactory. In the absence of any suggestion that properly torque-tightened nuts on a similar Governor Unit had ever come loose before I consider that Recommendation 4.2 is neither justified nor necessary.
