AIB Bulletin

No: 7/85

Ref: EW/G84/10/06

Morane — Saulnier MS 894A, G-AXOH (Light single-engined fixed wing

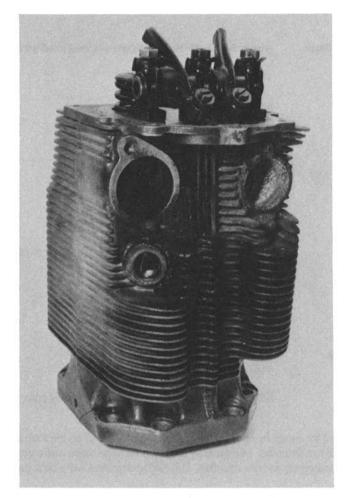
Fig 1

Subsequent AIB inspection of the engine, a Franklin 6A350C1, showed the No 5 (front/left) cylinder barrel to have

partially separated from the crankcase due to fatigue fractures around its mounting flange on its forward side and through the crankcase around the aft/upper retaining stud. In addition the smaller diameter retaining stud adjacent to the latter had also failed due to fatigue. The barrel had in effect only been retained by two of its eight studs — ie, the aft/lower pair of studs, and showed evidence of repeated contact with the No 3 cylinder. Torque-checks carried out on the retaining nuts of the other cylinder barrels showed them to be within the specifications of 300—330 inch pounds. The cylinder head valvegear and piston were visually satisfactory.

A further crack was discovered on the No 6 (front/right) cylinder barrel, within the aft/lower area of the mounting flange. Figs 1 and 2.

Metallurgical examination of the fractures on the No 5 cylinder at the Royal Aircraft Establishment, Farnborough, indicated that the fatigue had originated from some marked porosity present in the cylinder casting, between the two upper/forward retaining stud holes in the mounting flange. Fracture-separation of this area of the flange had then led to the other secondary fatigue failures on this cylinder. The crack present on the opposing No 6 cylinder mounting flange was also found to be due to fatigue.
