AAIB Bulletin No: 2/96

Ref: EW/G95/08/18

Aircraft Type and Registration:	Piper PA-34-200T Seneca II, G-BOUL	
No & Type of Engines:	2 Continental TSIO-360-E piston engines	
Year of Manufacture:	1976	
Date & Time (UTC):	17 August 1995 at 1142 hrs	
Location:	Oxford Airport, Kidlington	
Type of Flight:	Private (Training)	
Persons on Board:	Crew - 2	Passengers - None
Injuries:	Crew - None	Passengers - N/A
Nature of Damage:	Left landing gear unit and doors, false spar, flap, propeller and dynamic source mast; puncture to wing underside	
Commander's Licence:	Airline Transport Pilot's Licence with Instructor Rating	
Commander's Age:	57 years	
Commander's Flying Experience:	7,500 hours (of which 1,525 were on type) Last 90 days - 22 hours Last 28 days - 12 hours	
Information Source:	Aircraft Accident Report Form submitted by the pilot; examination of damaged aircraft, during repair, by AAIB Engineering Inspector; laboratory examination of failed components

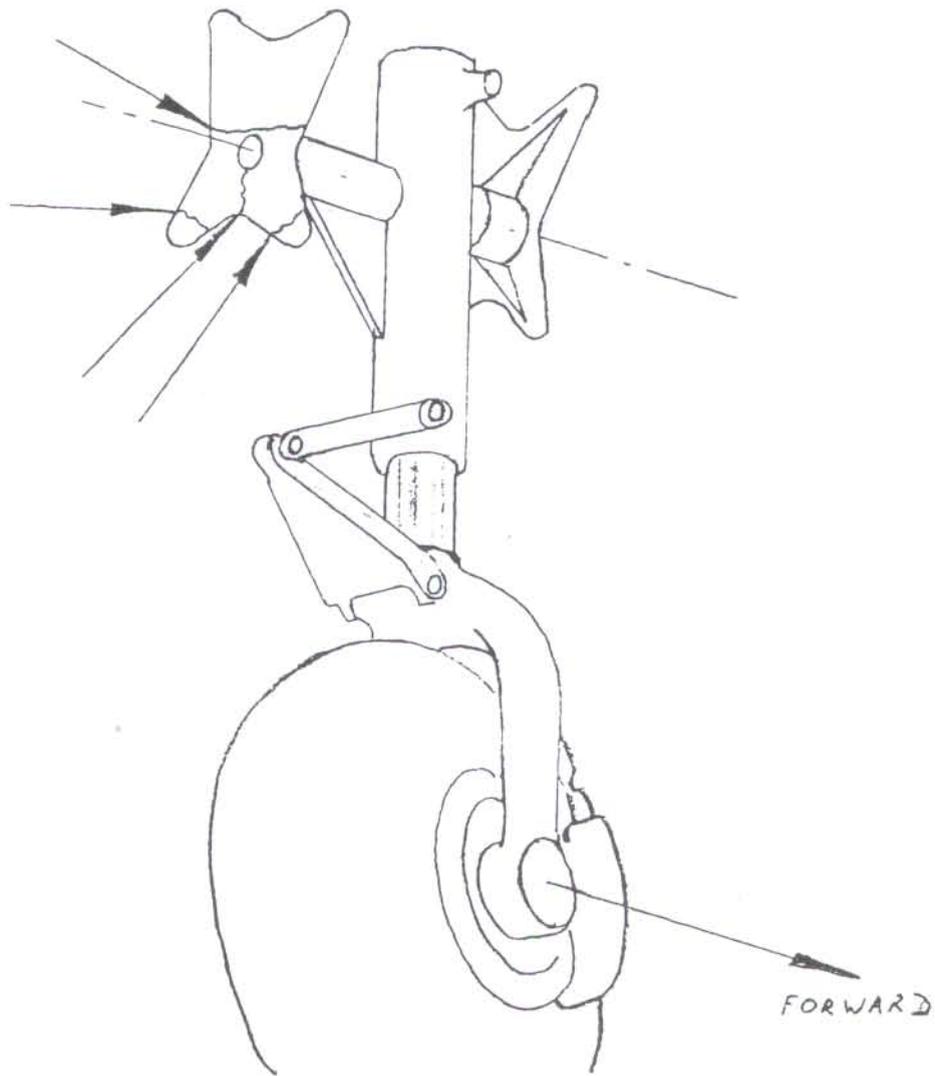
Figure 1

Examination of the aircraft indicated that the rear trunnion support fitting had failed on the left landing gear unit. This fitting is an aluminium alloy casting housing the rear of the two trunnion bearings in which the landing gear leg pivots during retraction and extension. The failure took the form of a number of fractures, positioned such that the lower portion of the fitting, surrounding the trunnion bearing, broke away (Figure 1). This allowed the aft pivot pin to displace downwards and the leg to adopt a forward inclination before distortion of, and disengagement from, the forward trunnion support fitting allowed complete collapse to take place.

Examination of the fractures revealed no evidence of a failure mechanism other than overload. It was noted during macroscopic examination, however, that the core of the rear fitting was very porous, resulting from extensive interdendritic shrinkage. It was considered that the degree of shrinkage found would have reduced the load carrying capacity of the fitting, although it could not be established whether the strength would have reduced to a point below the design figure. Some evidence of interdendritic shrinkage was also noted on the exposed fracture faces of the forward attachment bracket.

**LANDING GEAR UNIT
SHOWING POSITION OF FRACTURES IN AFT SUPPORT FITTING (ARROWED)**

95-44: The FAA should require an assessment of the adequacy of the strength of the main landing gear support fittings, together with that of the structure to which they are attached. This assessment should bear in mind the effect, if any, of the latest, stiffer, design of trunnion units on landing loads applied to the fittings and the fact that this failure has finally taken place during deflection of the landing gear in a forward direction. This assessment should also take into account the likely variation of the strength of the cast attachment fittings, evident from the porous states of both the failed component in G-BOUL and of the fitting, from another aircraft, found cracked during the investigation. It should include consideration of the suitability of the material and casting process of the fitting in that application.

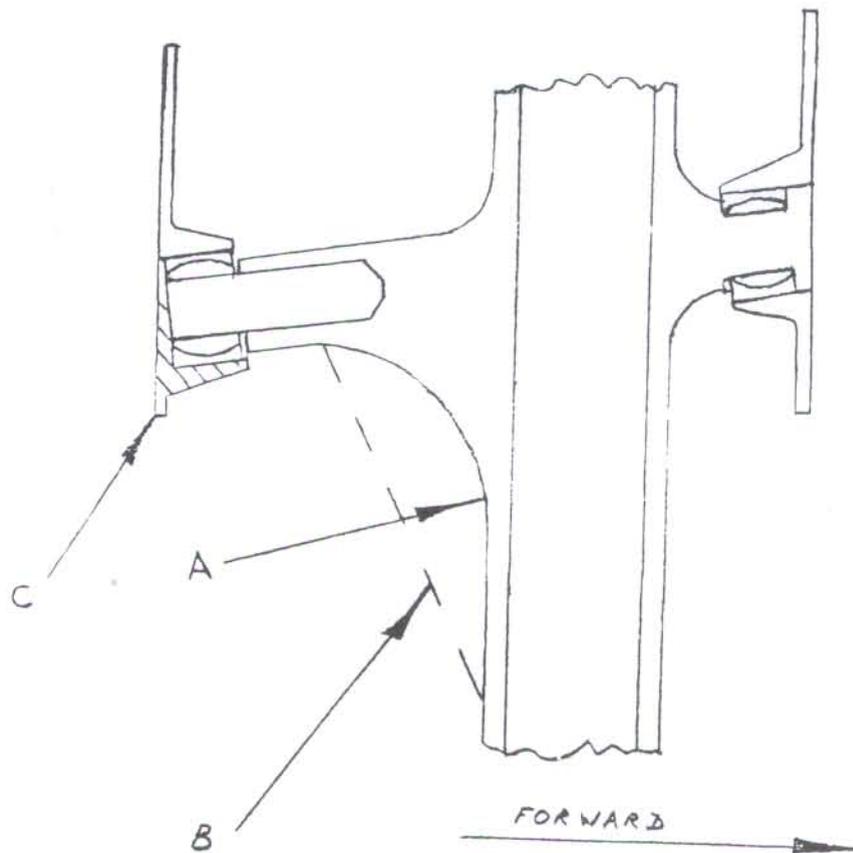
Figure 2

Over a lengthy period, a large number of failures have occurred to the landing gear trunnion units on PA-34 series aircraft involving cracking mechanisms occurring on the rear face of the leg at a point where the curved web joins the purely cylindrical section of the leg (Figure 2). This cracking has involved both fatigue and stress-corrosion mechanisms and, if not detected, results eventually in a forward bending failure of the leg immediately after a landing.

It was noted that the legs installed on G-BOUL and on the aircraft from which the cracked fitting was removed were of a different design to those involved in all the above mentioned failures. This new leg

design utilises a broad, straight edged reinforcing web on its rear face, in place of the two alternative designs of curved undercut web found on previously examined legs. The practical effect of this modification would be to stiffen the leg as well as to reduce the stress level at the point where previous failures have occurred. The increase in leg stiffness is presumed to increase the level of 'spring back' loading applied to the aft mounting brackets, following a firm landing, above the level of loading experienced at the same point on aircraft equipped with the earlier, more flexible designs of leg.

**SECTIONAL VIEW OF TRUNNION
SHOWING POSITION OF CRACKING AND FRACTURE FOUND
IN PREVIOUS FAILURES (A), PROFILE OF MODIFIED STANDARD WEB
AS FOUND ON G-BOUL (BROKEN LINE AT B) AND AREA OF FAILED
CASTING ON AFT SUPPORT FITTING OF G-BOUL (SHADED REGION AT C)**
