ACCIDENT

Aircraft Type and Registration:	Shadow Series CD, G-MYUS	
No & Type of Engines:	1 Rotax 503-2V piston engine	
Year of Manufacture:	1995 (Serial no: 257)	
Date & Time (UTC):	22 August 2012 at 1619 hrs	
Location:	Near Laverstock, Salisbury, Wiltshire	
Type of Flight:	Private	
Persons on Board:	Crew - 1	Passengers - None
Injuries:	Crew - 1 (Fatal)	Passengers - N/A
Nature of Damage:	Destroyed	
Commander's Licence:	National Private Pilot's Licence	
Commander's Age:	79	
Commander's Flying Experience:	164 hours (of which 164 were on type) Last 90 days - 2 hours Last 28 days - 1 hour	
Information Source:	AAIB Field Investigation

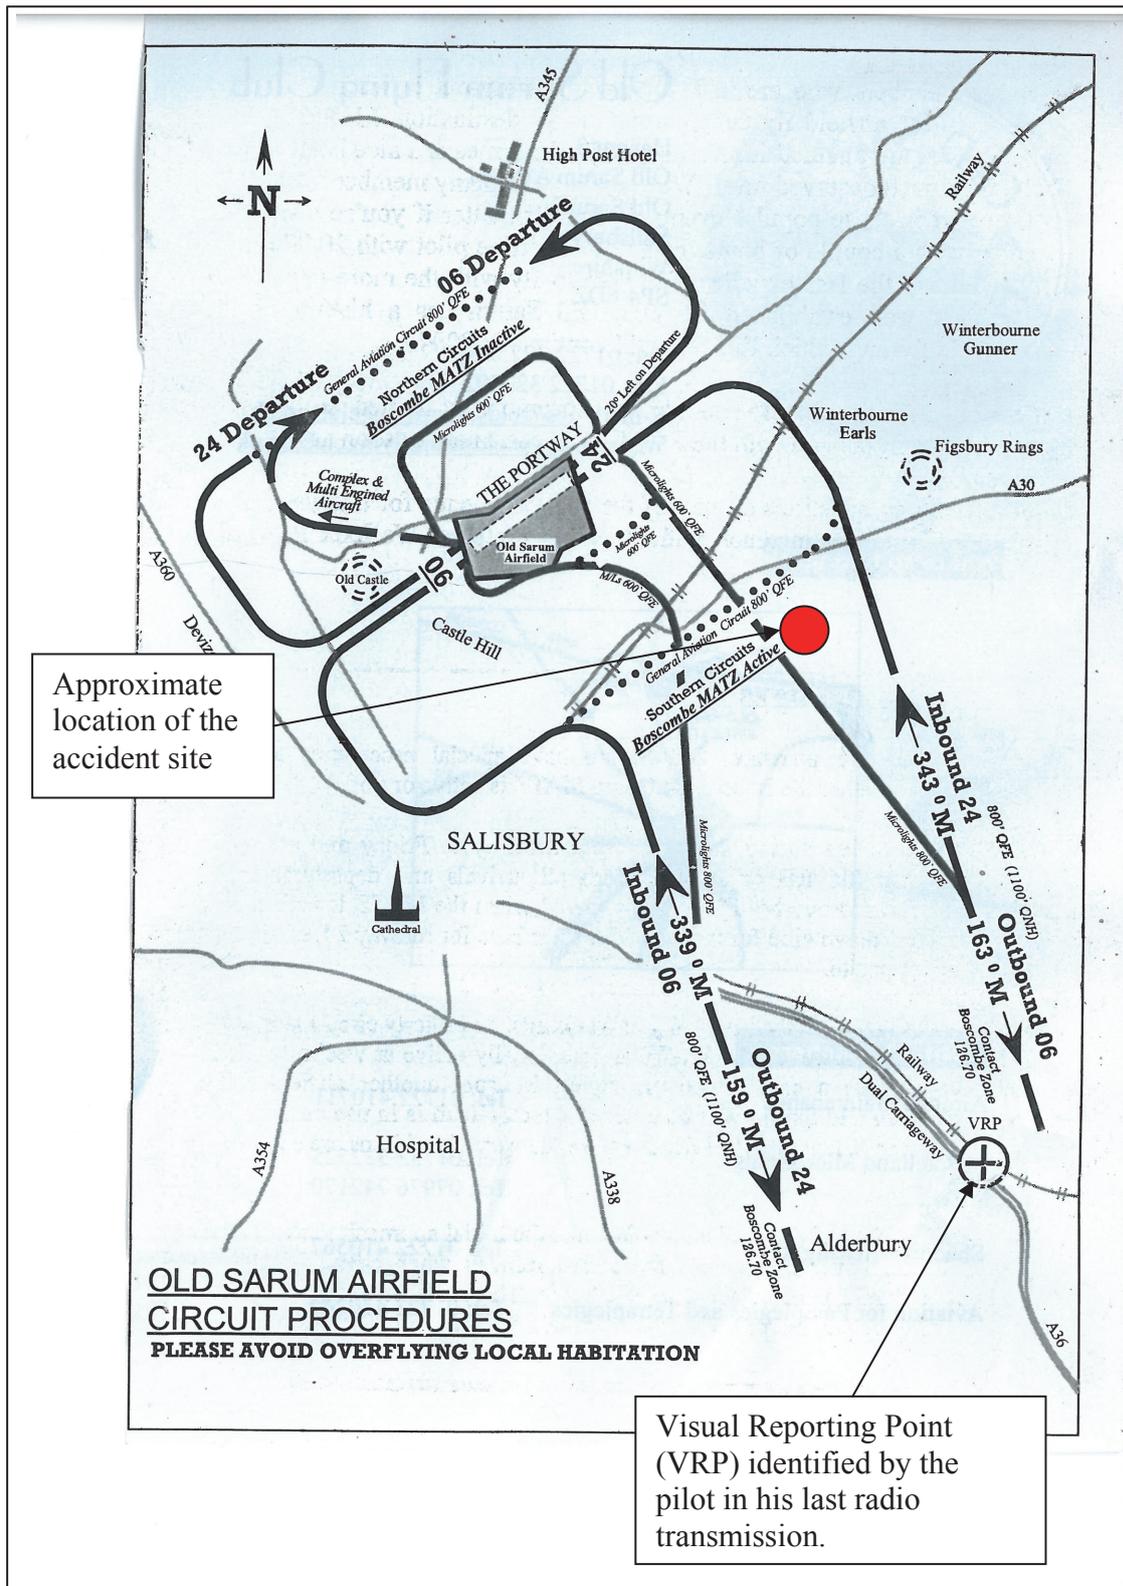
Figure 1

Having performed the pre-flight inspection, the pilot was lowered into the cockpit using a specially adapted winch. The instructor secured the pilot's harness and carried out a final inspection of the aircraft, before pushing it up to the parking area. After engine start, the pilot taxied to the holding point of Runway 24. He departed at 1347 hrs making a left turn climbing towards Alderbury. However, at 1357 hrs the air/ground operator stated that the pilot reported on the radio "Alderbury for re-join with 24, left hand, QFE 1008" (Figure 1).

Airfield circuit diagram recovered from the wreckage
