**AAIB Bulletin No:** 11/93      **Ref:** EW/G93/08/19      **Category:** 1.3

**Aircraft Type and Registration:** Cessna U206A Super Skywagon, G-ATLT

**Nature of Damage:** Nose leg collapsed, propeller damaged, engine shock loaded, nose underside structure damaged

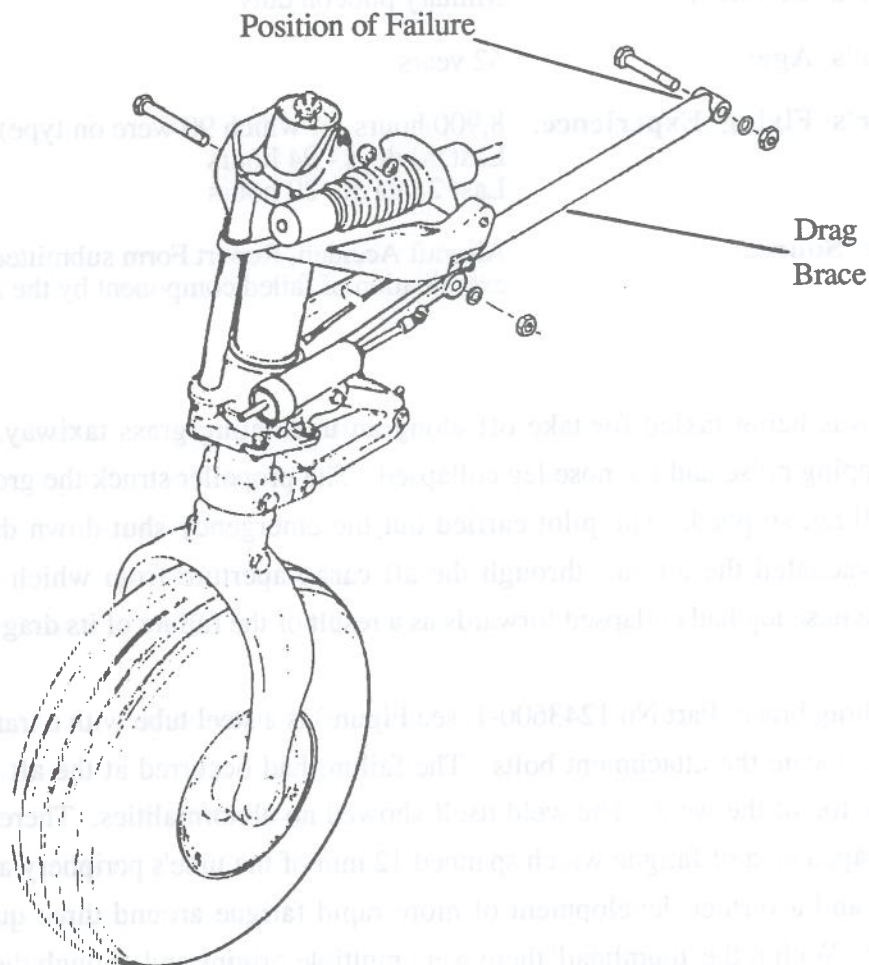
The nose leg brag brace (Part No 1243600-1, see Figure) is a steel tube with a transverse boss welded to each end to locate the attachment bolts. The failure had occurred at the aft end within the tube material at the toe of the weld. The weld itself showed no abnormalities. There was a well-defined 'thumbnail' shaped area of fatigue which spanned 12 mm of the tube's periphery and penetrated to the inner surface and a further development of more rapid fatigue around three quarters of the tube's circumference. Within the 'thumbnail' there were multiple origins and, though the paint protection of the outer surface of the tube was not intact and there was some corrosion, there did not appear to be any corrosion pitting associated with the initiation of the fatigue. As no local defect was found the

fatigue would appear to have been caused by high cyclic loads or high usage. The total airframe hours were recorded as 4950 and it is known that during the last 1836 hours the aircraft had been used in the parachute dropping role

Vertical loads on the nosewheel produce tensile loads on the drag brace because of the forward swept angle of the oleo but the fatigue initiation was centred on the right side of the tube and this suggested that bending in the transverse plane had also been a component of the fatigue loading. Each end face of the boss exhibited fretting damage over one half of its surface. These fretted areas were diametrically opposite one another and this implied that there had been some misalignment between the brace and the airframe attachment lugs. There were similar asymmetric fretting marks on the inside face of the lugs. However, the direction of the fretting loads could not be reconciled with the direction of the bending fatigue load and, as none of the nose leg or drag brace attachment bolts showed any unusual degree of play in their locations, the cause of a bending fatigue load in the brace, additional to the normal tensile loads, could not be identified.
