Cessna 152, G-MASS

AAIB Bulletin No: 3/2004	Ref: EW/C2002/09/04	Category: 1.3
INCIDENT		
Aircraft Type and Registration:	Cessna 152, G-MASS	
No & Type of Engines:	1 Lycoming O-235-L2C piston engine	
Year of Manufacture:	1979	
Date & Time (UTC):	28 September 2002 at 1340 hrs	
Location:	Chenies, Buckinghamshire	
Type of Flight:	Training	
Persons on Board:	Crew - 2	Passengers - None
Injuries:	Crew - None	Passengers - N/A
Nature of Damage:	Nil	
Commander's Licence:	Commercial Pilot's Licence	
Commander's Age:	41 years	
Commander's Flying Experience:	601 hours (of which 226 were on type)	
	Last 90 days - 43 hours	
	Last 28 days - 19 hours	
Information Source:	Aircraft Accident Report Form submitted by the pilot, Telephone discussions with aircraft maintenance company, aftercast and other information from the Met Office. Results of tests carried out on a similar aircraft

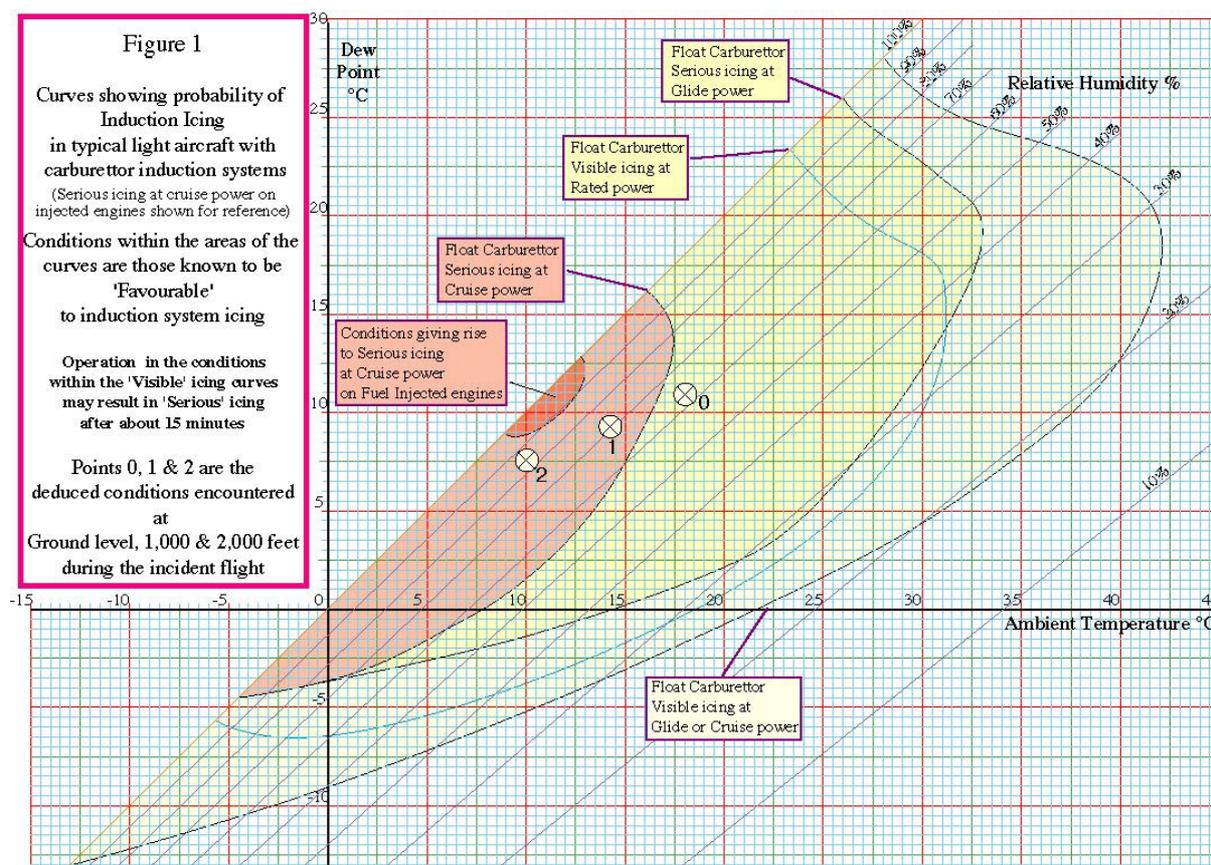
The cloud base, estimated from the aftercast, was 3,000 to 3,500 feet amsl and it would be reasonable to assume that the relative humidity reached 100% by 3,500 feet. This represents an average increase of approximately 10% in relative humidity for every 1,000 feet above sea level. Based on these premises, as the aircraft climbed to a height in the region of 1,900 feet, the relative humidity it experienced would have increased from 64% to 90%, approximately, whilst the ambient temperature dropped from +18°C to about +10°C.

On Figure 1, the deduced conditions at the surface, at 1,000 feet and at 2,000 feet in the locality where power loss occurred are plotted as points 0, 1 and 2 respectively on the generally accepted curves for the probability of induction icing related to air temperature and dewpoint or relative humidity.

From this it can be seen that the aircraft took off in conditions conducive to 'serious icing at glide power' or 'visible icing at rated power', and close to conditions of 'serious icing at cruise power'. As the flight progressed, the conditions encountered are estimated to have become steadily closer to the most critical combination for such icing, ie those which can cause severe icing even of injected engines at cruise power. (Injected units are less susceptible to induction ice build up than are carburettor equipped engines.) Thus any power reduction by the handling pilot of this aircraft, followed by prolonged operation at reduced power, once it had reached the higher levels of this flight, would have rendered it more than usually vulnerable to complete power loss from carburettor icing.
