INCIDENT

Aircraft Type and Registration:	Airbus A321-231, G-MEDJ
No & Type of Engines:	2 International Aero Engines V2533-A5 turbofan engines
Year of Manufacture & Serial No:	2004, MSN 2190
Date & Time (UTC):	24 August 2010 at 0225 hrs
Location:	At FL360 over northern Sudan
Type of Flight:	Commercial Air Transport (Passenger)
Persons on Board:	Crew - 7 Passengers - 42
Injuries:	Crew - None Passengers - None
Nature of Damage:	None
Commander's Licence:	Airline Transport Pilot's Licence
Commander's Age:	34 years
Commander's Flying Experience:	Approximately 7,500 hours (of which approximately 1,400 were on type) Last 90 days - 165 hours Last 28 days - 61 hours
Information Source:	AAIB Field Investigation

Synopsis

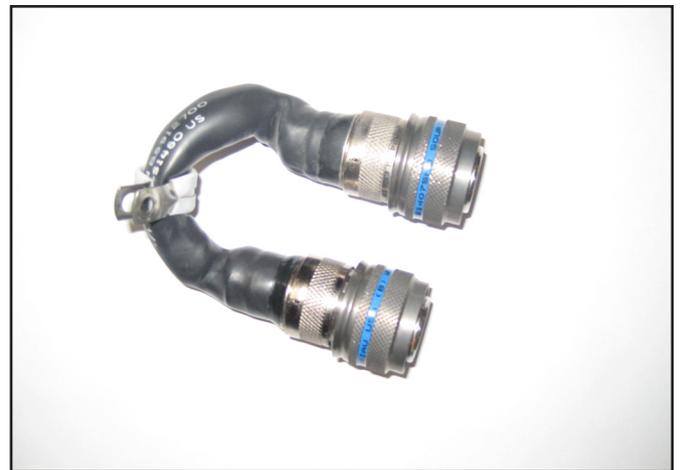
Figure 2

IDG1 and GCU1 were then taken to their manufacturer for further inspection. The IDG was subjected to a detailed strip examination under AAIB supervision with experienced overhaul and design specialists from the manufacturer present. The jumper lead appeared distorted (Figure 2) and when the outer cover was removed significant material damage to the wire braid was found at both ends, near the connectors (Figure 3).

Jumper lead as removed

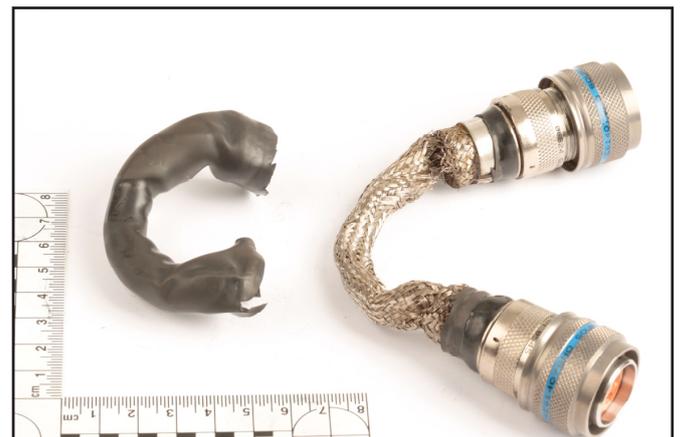
Figure 3

Jumper lead with outer cover removed

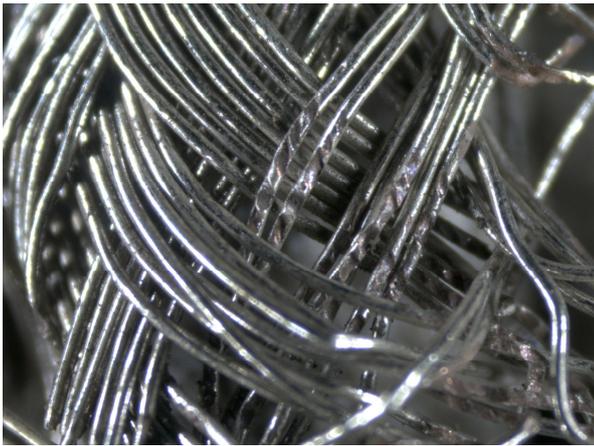
Figure 4

The jumper lead was taken to a forensic laboratory for examination. Evidence that the strands of wire braid had been chafing against each other was found (Figure 4). It was confirmed that wear marks made by the braid were present on the insulation of the seven wires inside

Close up of wire braid on jumper lead showing evidence of chafing

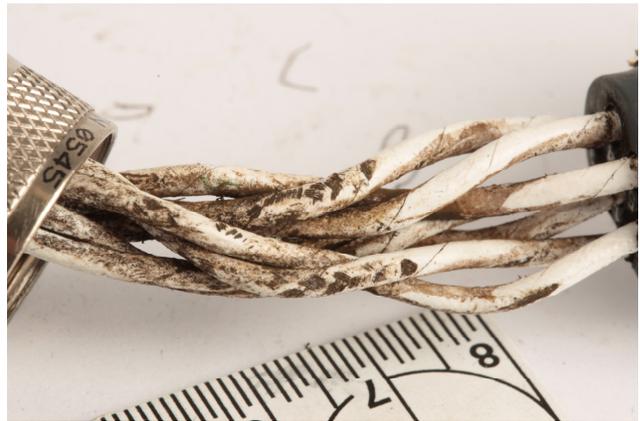
Figure 5

the braided outer sheath (Figure 5). The insulation was worn down on some of the cables, exposing the central conductor inside. Some cables exhibited holes in the insulation containing debris that was confirmed by an EDAX⁶ technique as being of the same composition as the wire braid. Using a Scanning Electron Microscope (SEM), evidence of arcing was found on wire No 5 (Figure 6). Despite extensive efforts, it was not possible to positively identify arcing or a short on any of the other wires. It was concluded that the failure mechanism of

Close up of wire in jumper lead showing wear marks

the jumper lead was the wire braid rubbing against the seven wires, with the vibration of the engine and the tight bend in the routing of the jumper lead providing the conditions conducive to wear. It was not clear if the ‘P’ clip, mid-way along the jumper lead, was a factor in the failure mechanism.

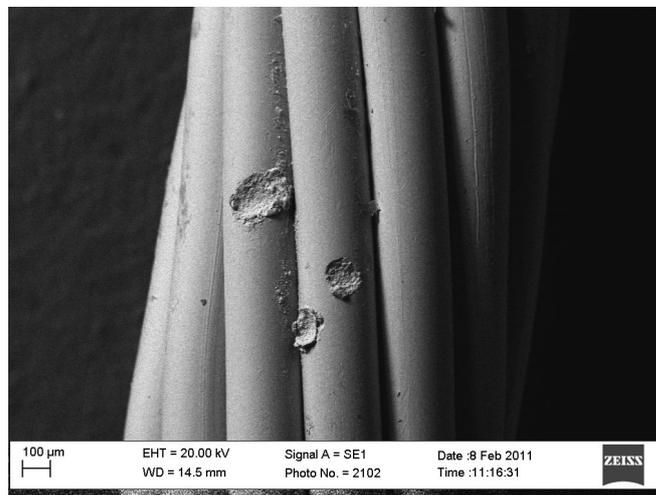
Figure 6

SEM image showing arcing damage on surface of strands in wire No 5
