AAIB Bulletin S9/2006

INCIDENT

Aircraft Type and Registration:	Airbus A319-111, G-EZAC	
No & type of Engines:	2 CFM56-5B5/P turbofan engines	
Year of Manufacture:	2006	
Date & Time (UTC):	15 September 2006 at 1052 hrs	
Location:	Near Nantes, France	
Type of Flight:	Commercial Air Transport (Passenger)	
Persons on Board:	Crew - 6	Passengers - 138
Injuries:	Crew - None	Passengers - None
Nature of Damage:	None	
Commander's Licence:	Airline Transport Pilot's Licence	
Commander's Age:	42 years	
Commander's Flying Experience:	8,782 hours (of which 394 were on type) Last 90 days - 211 hours Last 28 days - 77 hours	
Information Source:	AAIB Field Investigation

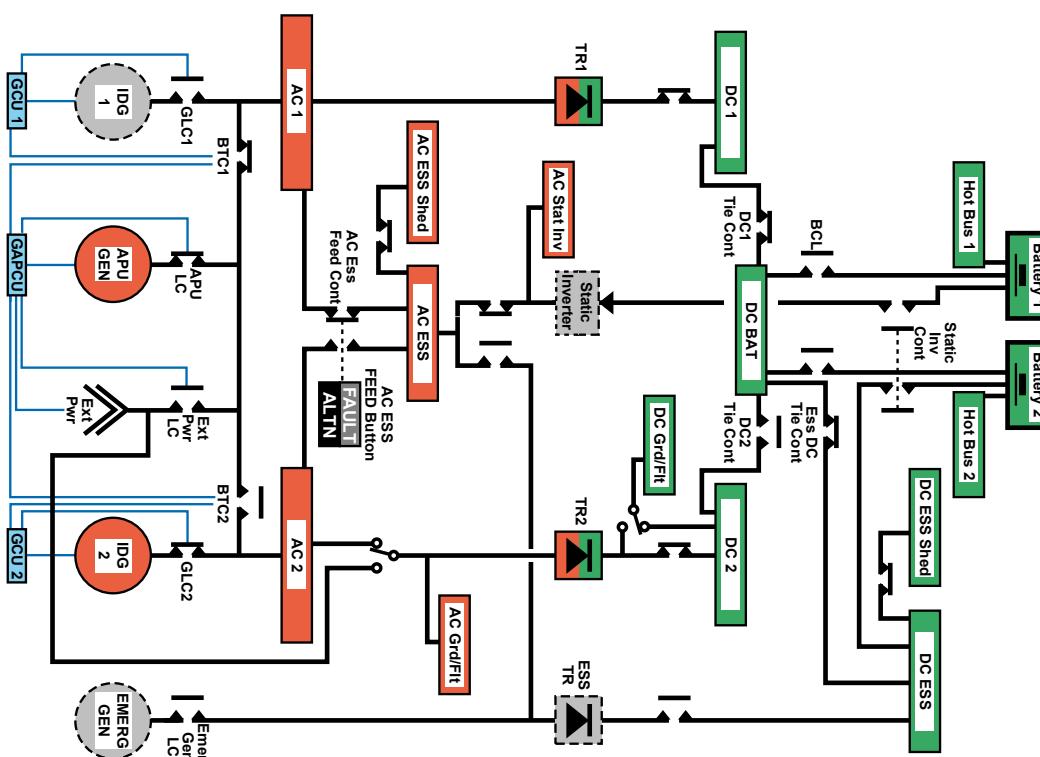
Figure 1.1 Configuration On Dispatch

Two engine-driven IDGs normally power the aircraft's electrical services (Figure 1.1). Each IDG provides 3-phase Alternating Current (AC) power to an AC main busbar (AC1 or AC2) via a Generator Line Contactor (GLC). The IDG outputs are isolated from each other by two Bus Transfer Contactors (BTC). A Generator Control Unit (GCU) monitors the IDG output and opens the GLC if it detects an out-of-limits condition. The BTCs then close, to supply both AC main busbars from one generator. Selecting an IDG off also opens the respective GLC. In the event of loss of output from an IDG, a generator driven by the APU can also supply either of the AC main busbars, via the respective BTC. Monitoring and control of the APU generator output is by a combined Ground Power/APU Generator Control Unit (GAPCU). An electrical system control panel is provided in the flight deck overhead panel and system status can be monitored on the lower ECAM display; system operation is normally automatic.

The aircraft manufacturer's Master MEL (MMEL) permits dispatch of the aircraft for non-Extended Twin Operations (ETOPS) with one IDG selected off, provided the APU generator is on line. In this configuration, a fault monitoring facility within the GCU for the inoperative

IDG checks for correct opening of the associated GLC by monitoring the generator current in each phase, as detected by Current Transformers (CT) fitted in the generator. If a fault current is detected, the GCU opens the associated BTC. As this function is intended to protect against failure of the GLC contacts to open, it remains in effect even when the associated IDG is selected off.

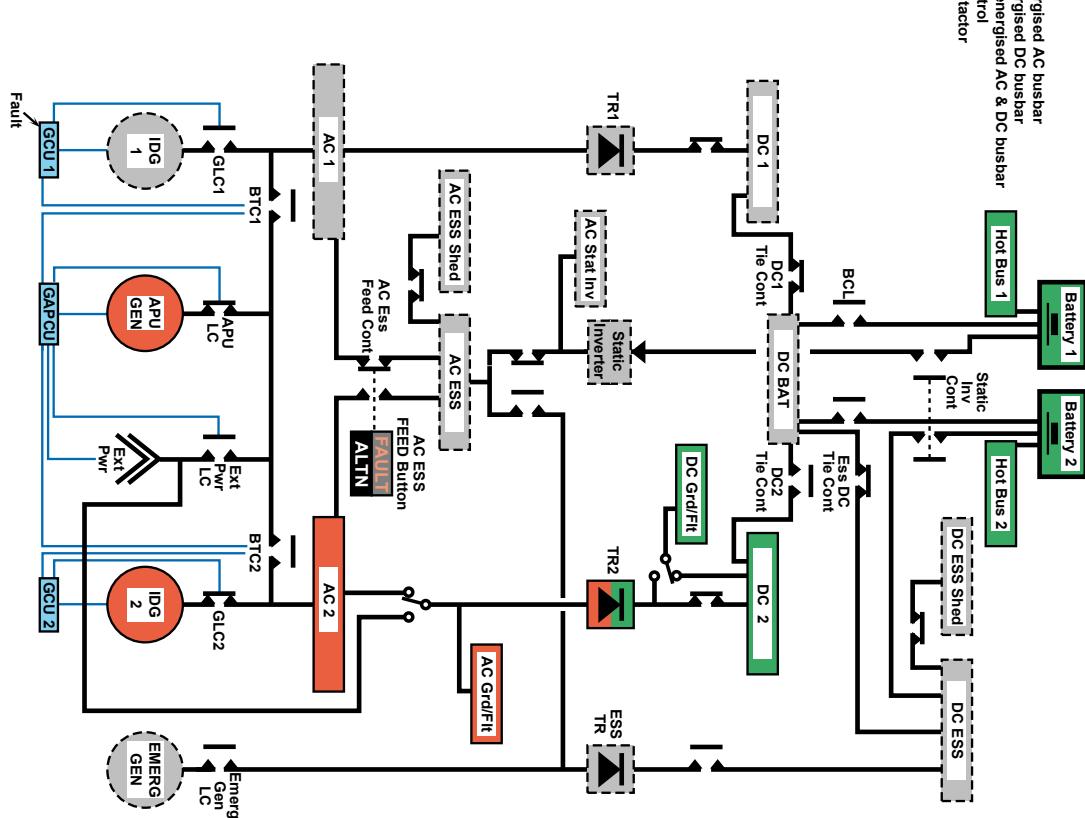
Figure 1.2 Configuration Immediately After Fault

The evidence indicated that a monitoring system had incorrectly interpreted a fault in GCU1 as a GLC1 fault and opened BTC1 as a result. This had disconnected the APU generator from the AC1 busbar, leading to the loss of AC1 and a number of other busbars, including the AC ESS and DC ESS busbars. It was undesirable that the incorrect interpretation of a single fault should cause the loss of a main busbar. At this time the inappropriate action by the GCU appears to have been due to inadequate logic in the monitoring system. Therefore:

The aircraft's electrical distribution system is automatic in both normal operation and in some failure situations. It was apparent that the AC1 busbar is a crucial part of the system and its de-energisation results in a major loss of aircraft services, possibly at a critical stage of flight. Because the transfer of the AC ESS busbar did not occur, this resulted in a continued loss of essential services for the remainder of the flight.

It is recommended that Airbus should introduce, for Airbus A320 series aircraft, a modification to automatically transfer the electrical feed to the AC Essential busbar in the event of the loss of the No 1 Main AC busbar.
