ACCIDENT

Aircraft Type and Registration:	Wittman W10 Tailwind, G-BJWT	
No & Type of Engines:	1 Lycoming O-290-G piston engine	
Year of Manufacture:	1984	
Date & Time (UTC):	1 December 2007 at 1340 hrs	
Location:	Hucknall Airfield, Nottinghamshire	
Type of Flight:	Private	
Persons on Board:	Crew - 1	Passengers - 1
Injuries:	Crew - None	Passengers - None
Nature of Damage:	Significant damage to undercarriage, engine mount and propeller	
Commander's Licence:	Private Pilot's Licence	
Commander's Age:	48 years	
Commander's Flying Experience:	254 hours (of which 80 were on type) Last 90 days - 1 hour Last 28 days - 0 hours	
Information Source:	Aircraft Accident Report Form submitted by the pilot and subsequent investigation by the AAIB

Synopsis

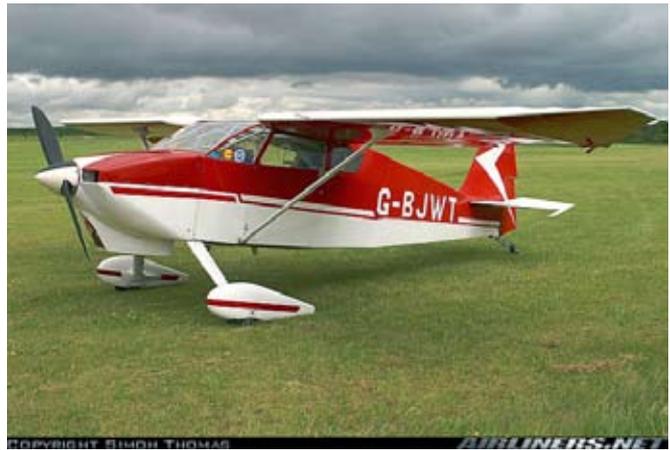
Figure 1

The Wittman Tailwind is homebuild aircraft that was designed in the 1950's and features a high wing and a

tail-wheeled undercarriage, see Figure 1. The main gear legs are undamped steel struts and are attached to the tubular steel engine mount. These gear legs are 44 inches long with a bend immediately inboard of the axle. They are made of a heat-treatable alloy steel (6150) for which the Wittman drawings specifies:

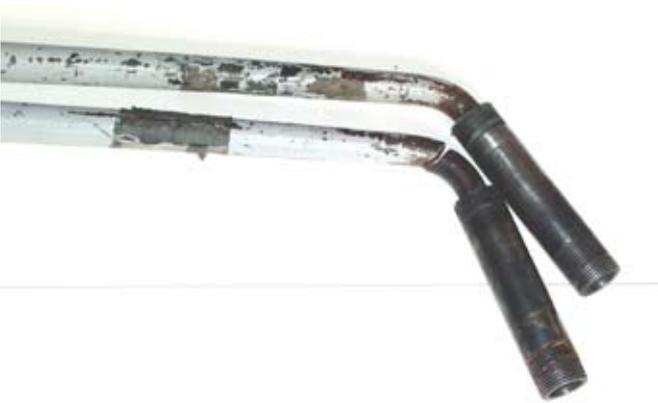
Figure 2

The right and left main gear legs, see Figure 2, were recovered to the AAIB and then sent to a metallurgist for examination. The metallurgist determined that the

The hardness was measured at several locations in the vicinity of the failure and the material was found to be very soft in the centre (circa 200 HV) and very hard on the surface (greater than 600 HV). It was concluded that the fracture had resulted directly from the use of incorrect heat treatment methods after the strut was fabricated.

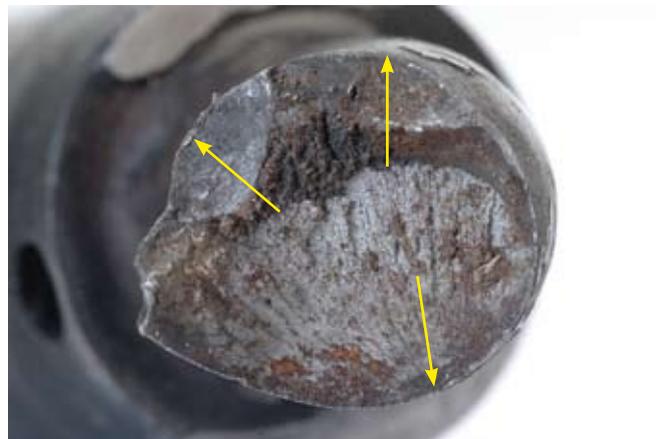
Figure 3

failure had resulted from a low-cycle, high-peak cyclic stress, fatigue mechanism that had initiated in three positions, see Figure 3, although the conditions could not be explained by the normal service loading in a gear leg with uniform properties throughout its volume.

The LAA have been informed and will publish an article in their newsletter to highlight the importance of correct heat treatment for critical components. In view of this action, no safety recommendations are made.
