## ACCIDENT

<b>Aircraft Type and Registration:</b>	Aeromot AMT-200S Super Ximango, G-CECJ	
<b>No &amp; Type of Engines:</b>	1 Rotax 912-S2 piston engine	
<b>Year of Manufacture:</b>	2006	
<b>Date &amp; Time (UTC):</b>	17 August 2007 at 1520 hrs	
<b>Location:</b>	Lasham Airfield, Hampshire	
<b>Type of Flight:</b>	Private	
<b>Persons on Board:</b>	Crew - 1	Passengers - None
<b>Injuries:</b>	Crew - 1 (Minor)	Passengers - None
<b>Nature of Damage:</b>	Substantial damage to landing gear, wings, propeller, cowlings and engine bearer	
<b>Commander's Licence:</b>	Private Pilot's Licence	
<b>Commander's Age:</b>	68 years	
<b>Commander's Flying Experience:</b>	505 hours (of which 12 were on type) Last 90 days - 10 hours Last 28 days - 5 hours	
<b>Information Source:</b>	Aircraft Accident Report Form submitted by the pilot

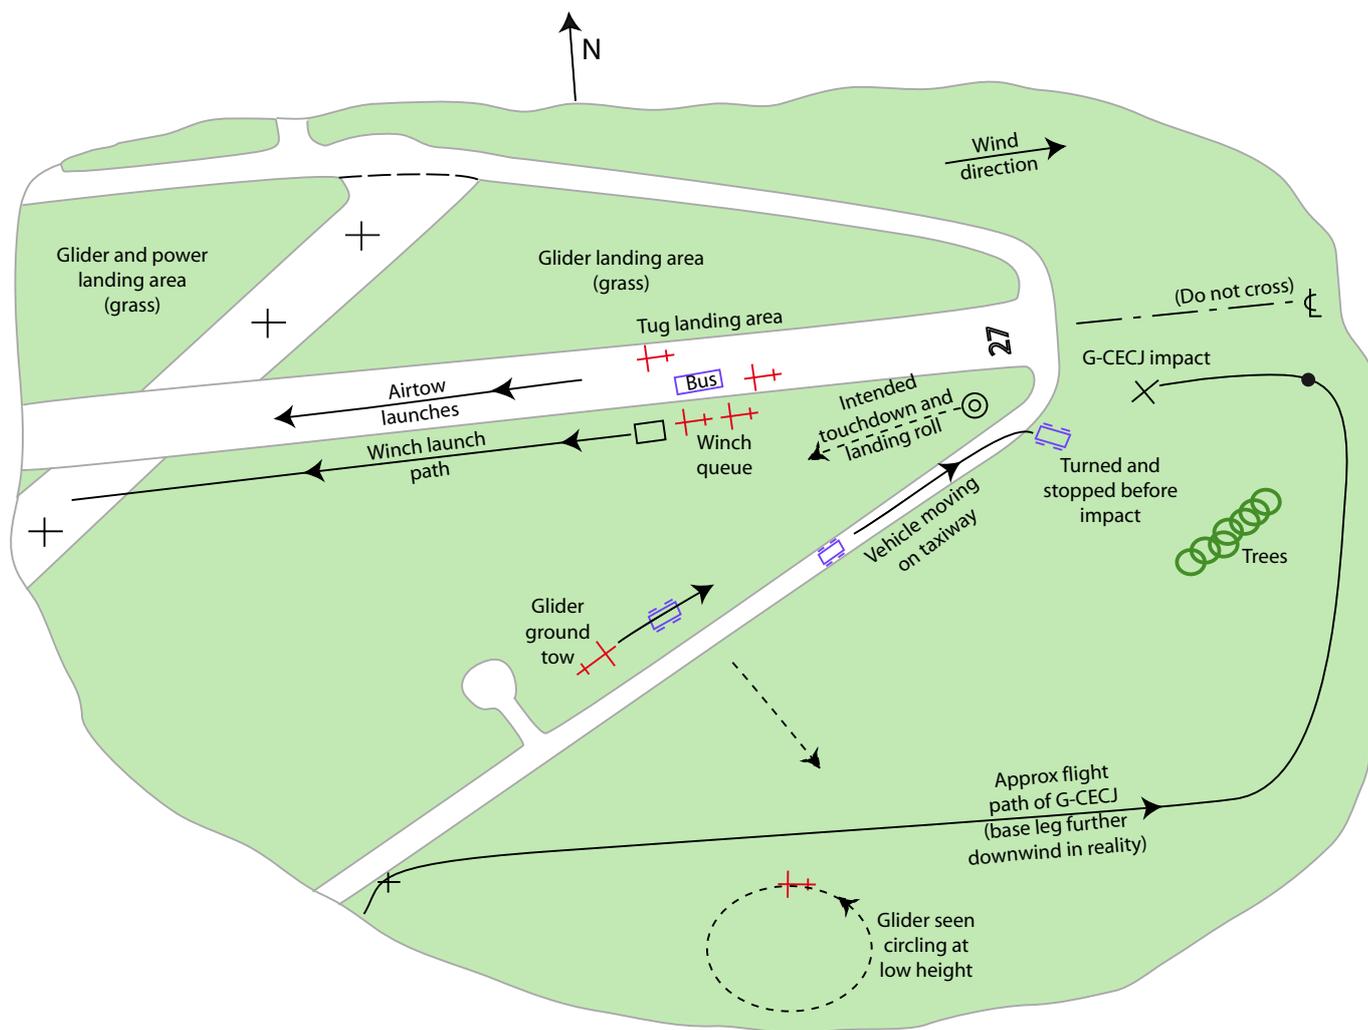
**Figure 1**

In addition to a verbal account, the pilot provided a sketch (Figure 1) describing the activity on the airfield and the presence of an airborne glider to the south of the field, which he thought might be in contention for the landing area. He decided that he would land on the grass just to the south of the paved Runway 27, in order to avoid a glider which was being towed just inside the southern perimeter track. Mindful of the proximity of the

Reproduction of pilot's sketch
