AAIB Buletin No: 8/93

Ref: EW/C93/4/1

**Aircraft Type and Registration:** Cessna 172 N Skyhawk, G-GRAY

**Nature of Damage:** Severe damage to engine and lower cowl, salt water damage to remainder of aircraft

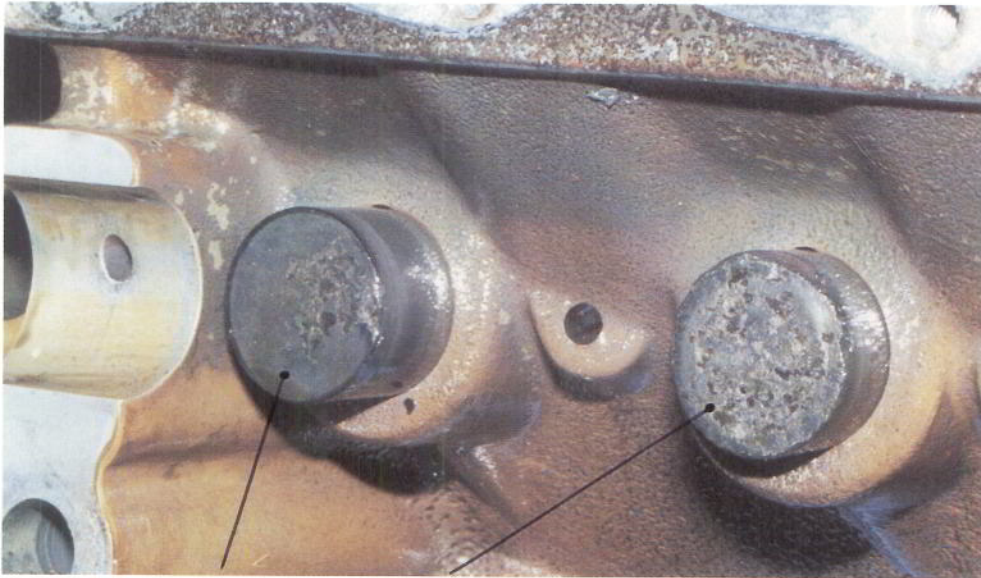
Of significance was a region of heavy wear and damage on the camshaft lobe and cam follower associated with the inlet valve for no 1 cylinder, as also shown at Figure 1. Metallurgical examination of these components indicated that 1) the quality and thickness of the surface hardening, on both the cam and follower, had been satisfactory as manufactured and, 2) that the degree and nature of the wear present on these components were such as to suggest that their degeneration had occurred over a significantly longer period than the duration of this flight. Additionally, extreme pitting and damage was present on the other cam follower faces for cylinders nos 1 and 2, with a lesser amount of wear present on the cam lobes for these same cylinders. Those associated with cylinders 3 and 4 showed little signs of abnormal wear.

Spalled exhaust and inlet valve cam followers for No 1 cylinder

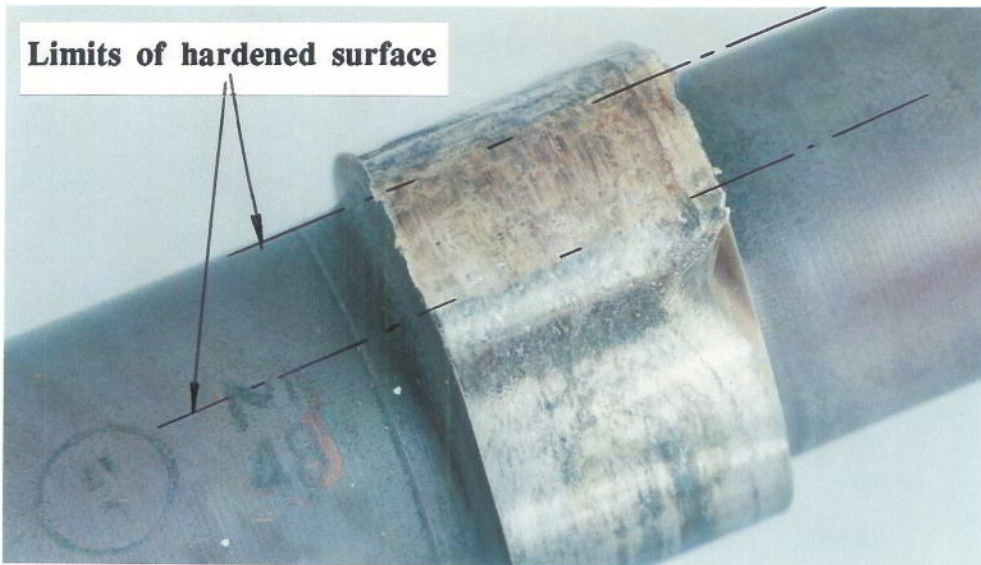
Worn cam lobe, No 1 cylinder inlet valve, showing region where approximately 1 mm of material is missing from peak

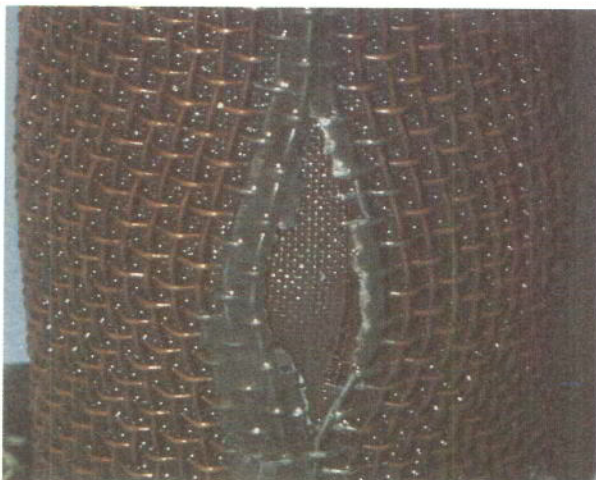
Burst area in oil pressure screen filter

A manufacturer's modification is available which replaces the pressure screen filter with either a spin-on disposable, or replaceable cartridge, type filter.

**93-44** In accordance with the manufacturer's recommendation (SB 480), and therefore the LAMS schedule, the CAA should emphasise to all relevant personnel that Cessna 172 aircraft, fitted with 0-320-H series engines which have pressure screen type filters, are subject to engine oil changes/filter inspection (together with oil additive renewal) at periods no greater than 25 hours, or four months, whichever occurs sooner, and that all direct drive engines are subject to a maximum period of four months between oil changes/filter inspection, irrespective of filter type.

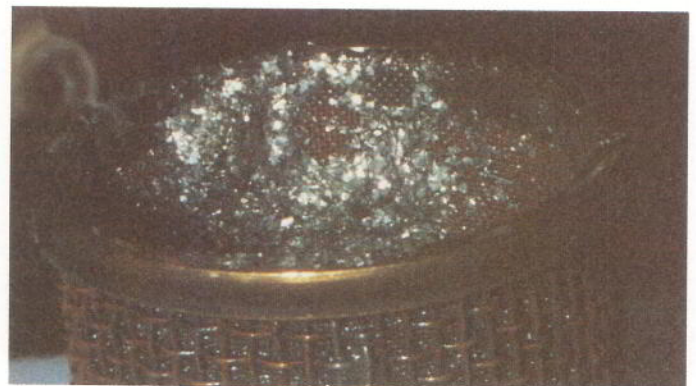
considered by the agency which performed the analysis to be consistent with oil that had been in use for some 33 hours but the ferrous metal content was, however, abnormally high.

Debris found in oil filter
