AIRCRAFT ACCIDENT REPORT 3/2014

**Report on the accident to
Agusta A109E, G-CRST
Near Vauxhall Bridge, Central London
on 16 January 2013**

Air Accidents Investigation Branch

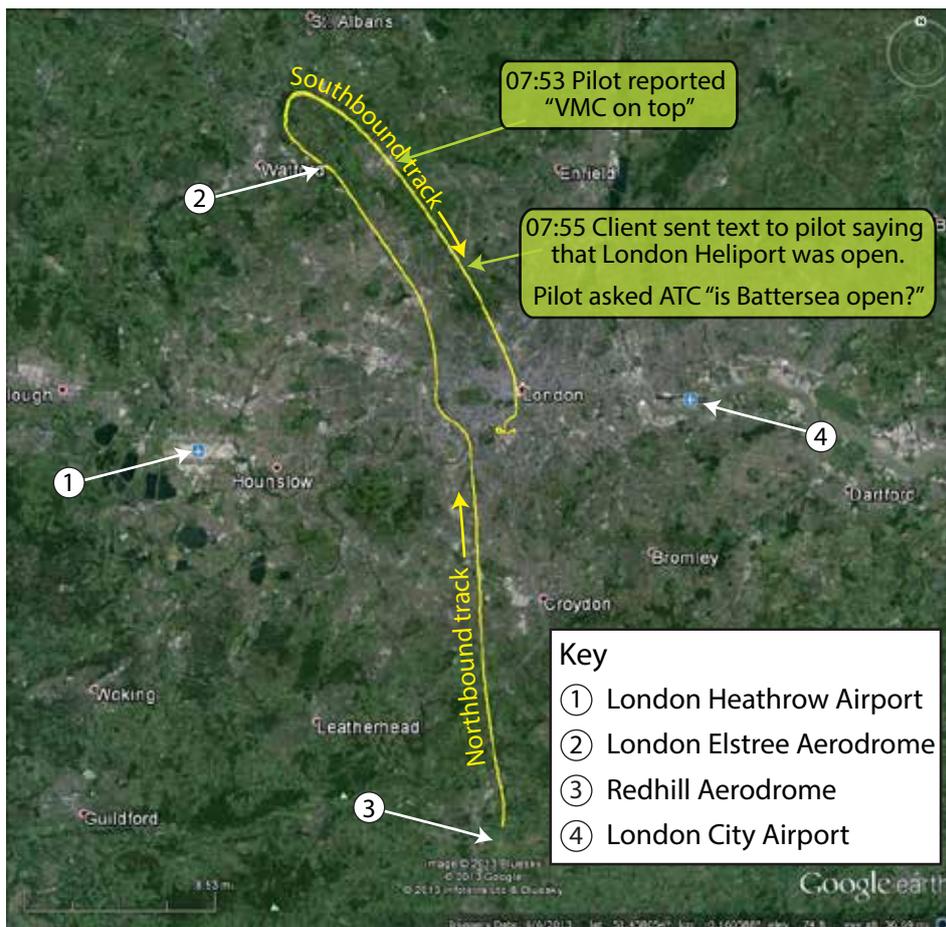
Figure 1

Track flown by G-CRST derived from Heathrow Airport radar

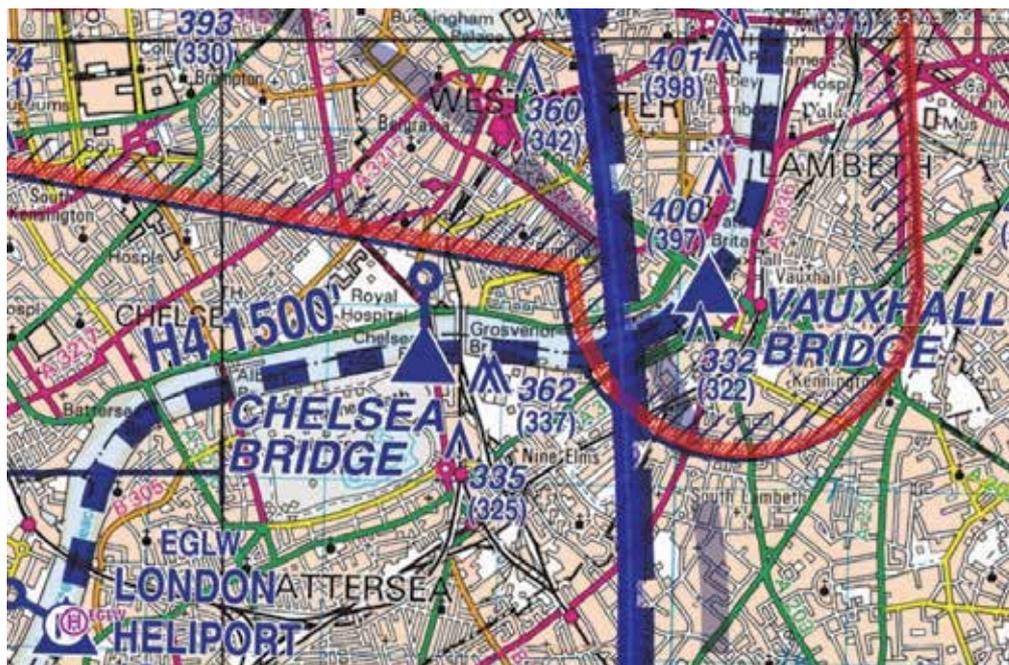
Figure 3

Hotel 4 (H4) is a helicopter route that follows the River Thames past Vauxhall Bridge and is shown in Figure 3. Class A airspace lies to the west of the blue north-south line drawn immediately to the west of Vauxhall Bridge and Class D airspace lies to the east of the line. When the pilot said that he could see Vauxhall, it was approximately 1,500 m ahead of him and the river (H4) was approximately 200 m to the east of him.

Helicopter route H4 near Vauxhall Bridge

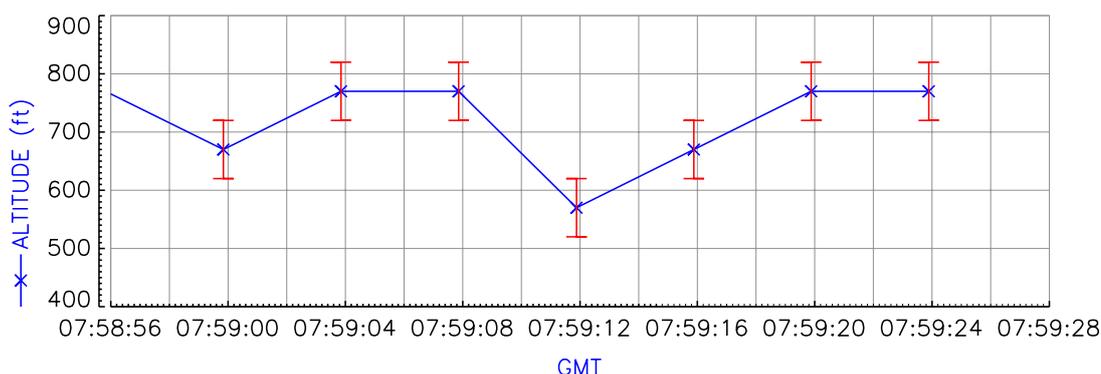
Figure 12

In addition, once the turn was complete and the helicopter began tracking eastbound along H4, the recorded altitude fluctuated between 570 and 770 ft (Figures 4 and 12). Over one four second period, the recorded altitude reduced by 200 ft, equivalent to a vertical speed in excess of -1,500 ft per min. Autopilot control of altitude in this helicopter is limited to a vertical speed of $\pm 1,000$ ft per min indicating that the autopilot was not being used to control altitude at this point.

G-CRST altitude profile with ± 50 ft markers

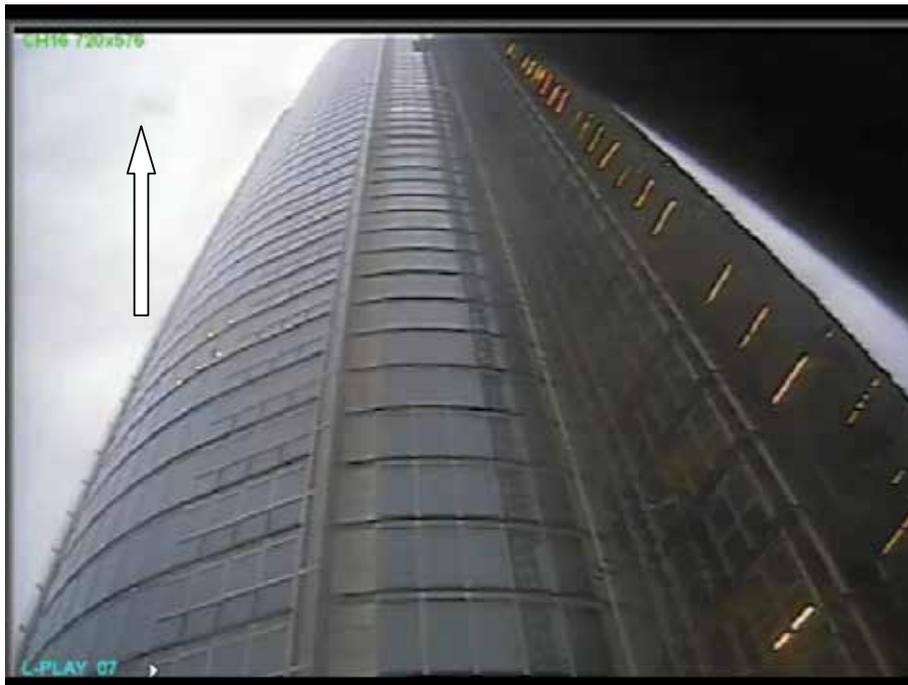
Figure 13

View from the St George Wharf CCTV camera, looking from the base of the building showing G-CRST silhouette

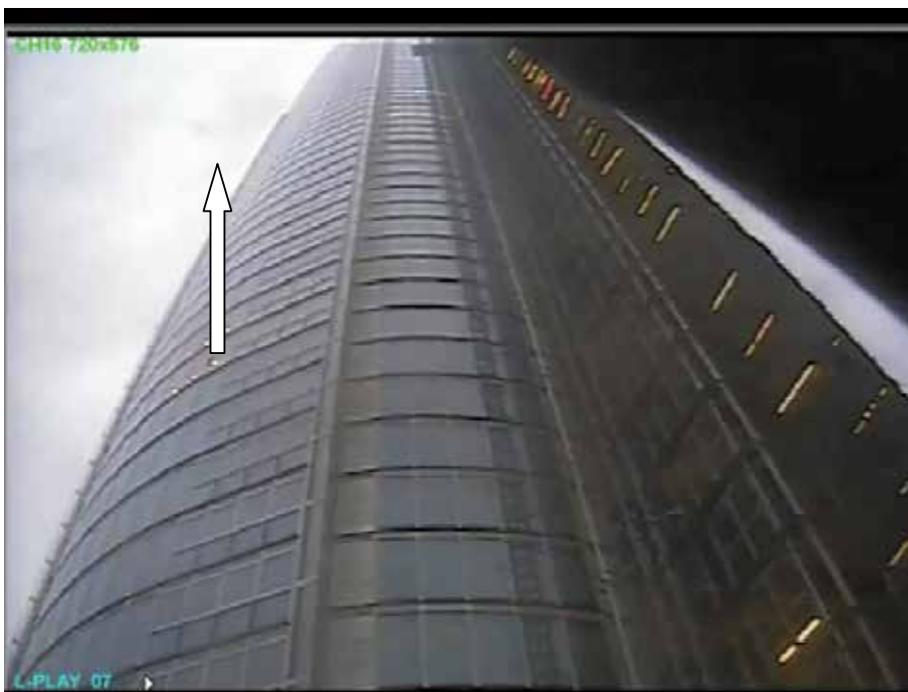
Figure 14

View from the St George Wharf CCTV camera, looking from the base of the building showing G-CRST silhouette

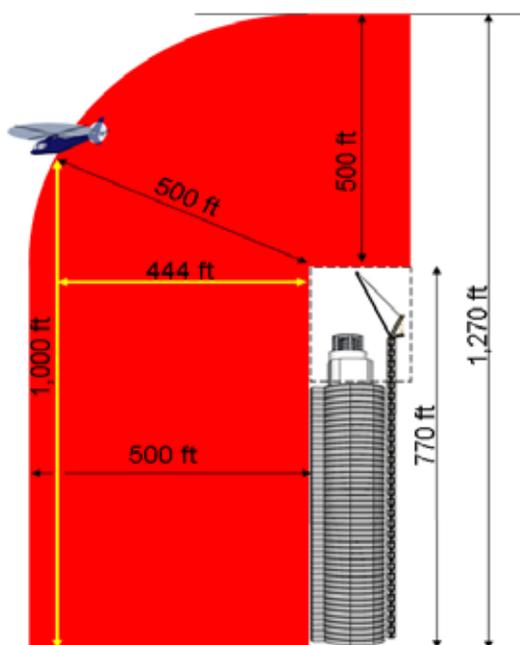
Rule 5 requires an aircraft to be flown no closer than 500 ft to any structure. Figure 15 shows a representation of the building and the crane as a cylinder of 770 ft elevation. The 500 ft clearance required by any passing helicopter is marked in red. If flying at 1,000 ft agl, a helicopter would be required to pass at least 444 ft from the south bank of the River Thames, assuming the south bank represents the edge of the building.

Building and crane with shaded areas showing less than 500 ft clearance (not to scale; for illustrative purposes only)

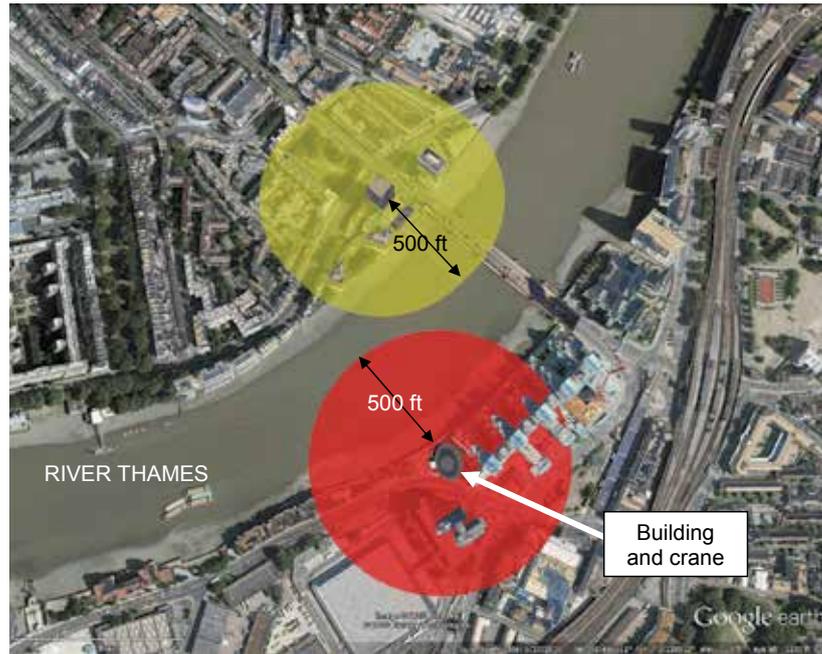
Figure 16

On the opposite side of the River Thames to this building, adjacent to Vauxhall Bridge, is a building approximately 240 ft tall, set back from the river bank by approximately 140 ft. Although not as tall as the building at St George Wharf, there are implications for maintaining 500 ft clearance from both buildings when flying at low level or if there is passing traffic on the opposite bank (see Figure 16). The River Thames is approximately 800 ft wide adjacent to the St George Wharf.

Tall buildings in the vicinity of St George Wharf, showing approximate 500 ft exclusion areas (for illustrative purposes only)

Combining the clearances required from these two buildings presents a challenging positional separation requirement for pilots if they plan to achieve the required 500 ft separation when the cloud base is low. The London Heliport can operate when the cloud base is 600 ft agl or greater. Figure 17 represents a view from 618 ft amsl facing towards the building and crane on the south bank.

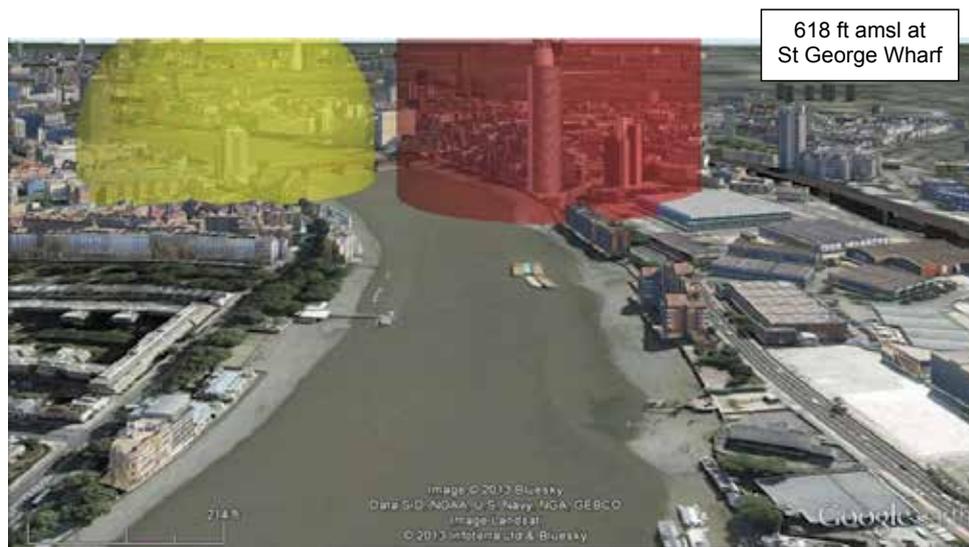
Figure 17

Representation of the approach to Vauxhall Bridge from the west with an eye level of 618 ft amsl (for illustrative purposes only)

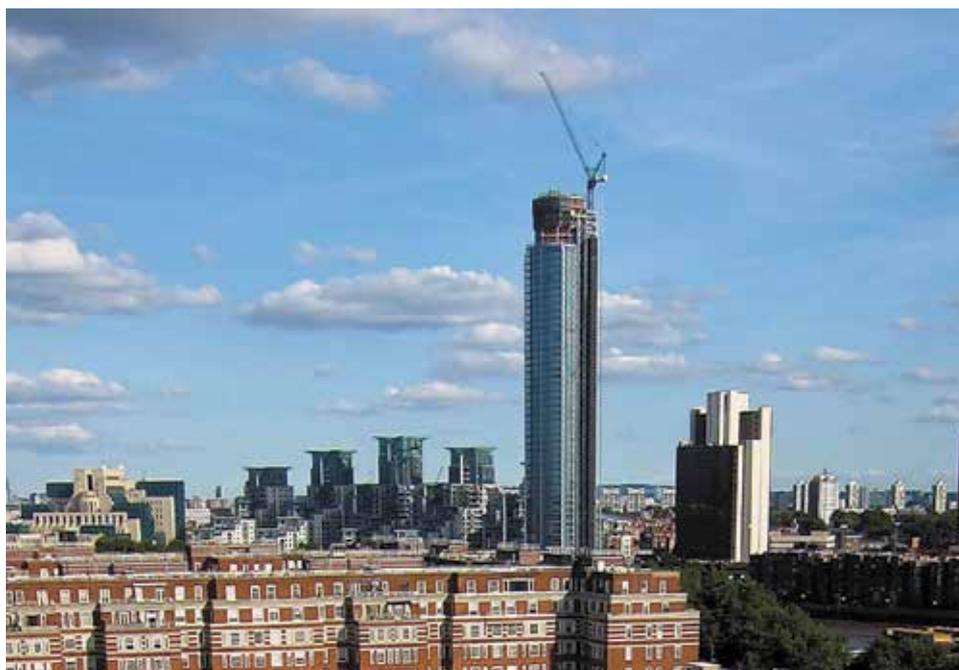
Figure 19

Figures 19 and 20 are images of the building at St George Wharf taken on 22 September 2012 and 18 February 2013¹⁷. The images show that the development had been dominant on the skyline for a considerable period before the accident. The developer reported that the top of the building would have been approximately 607 ft amsl on 12 December 2012, the last date for which there was evidence that the pilot of G-CRST had flown in the vicinity of Vauxhall Bridge.

Image of the building taken on 22 September 2012

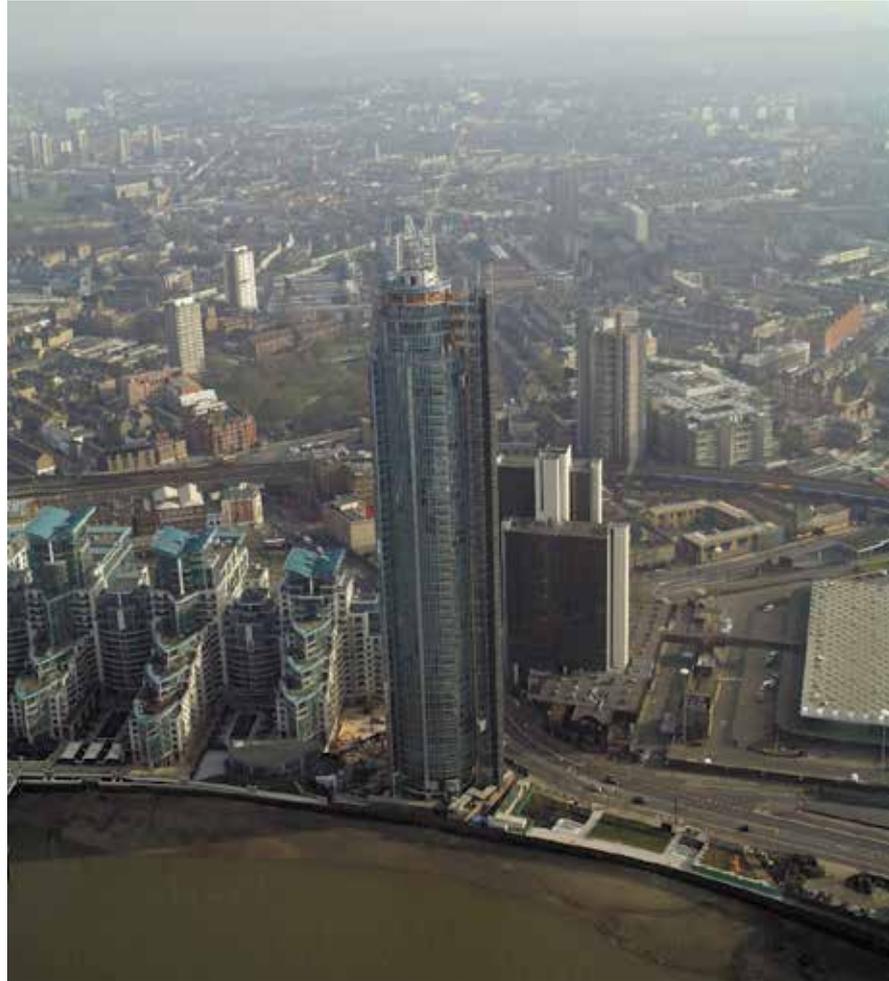
Figure 20

Image of the building taken on 18 February 2013
