<b>Aircraft Type and Registration:</b>	Robinson R22 Beta, G-BYTD	
<b>No &amp; Type of Engines:</b>	1 Lycoming O-360-J2A piston engine	
<b>Year of Manufacture:</b>	1999	
<b>Date &amp; Time (UTC):</b>	13 October 2004 at 0845 hrs	
<b>Location:</b>	Between Brafield and Hackleton, near Sywell, Northants	
<b>Type of Flight:</b>	Private	
<b>Persons on Board:</b>	Crew - 1	Passengers - None
<b>Injuries:</b>	Crew - Minor	Passengers - N/A
<b>Nature of Damage:</b>	Aircraft destroyed	
<b>Commander's Licence:</b>	Private Pilot's Licence	
<b>Commander's Age:</b>	50 years	
<b>Commander's Flying Experience:</b>	77 hours (all on type) Last 90 days - 5 hours Last 28 days - 1 hour	
<b>Information Source:</b>	Aircraft Accident Report Form submitted by the pilot

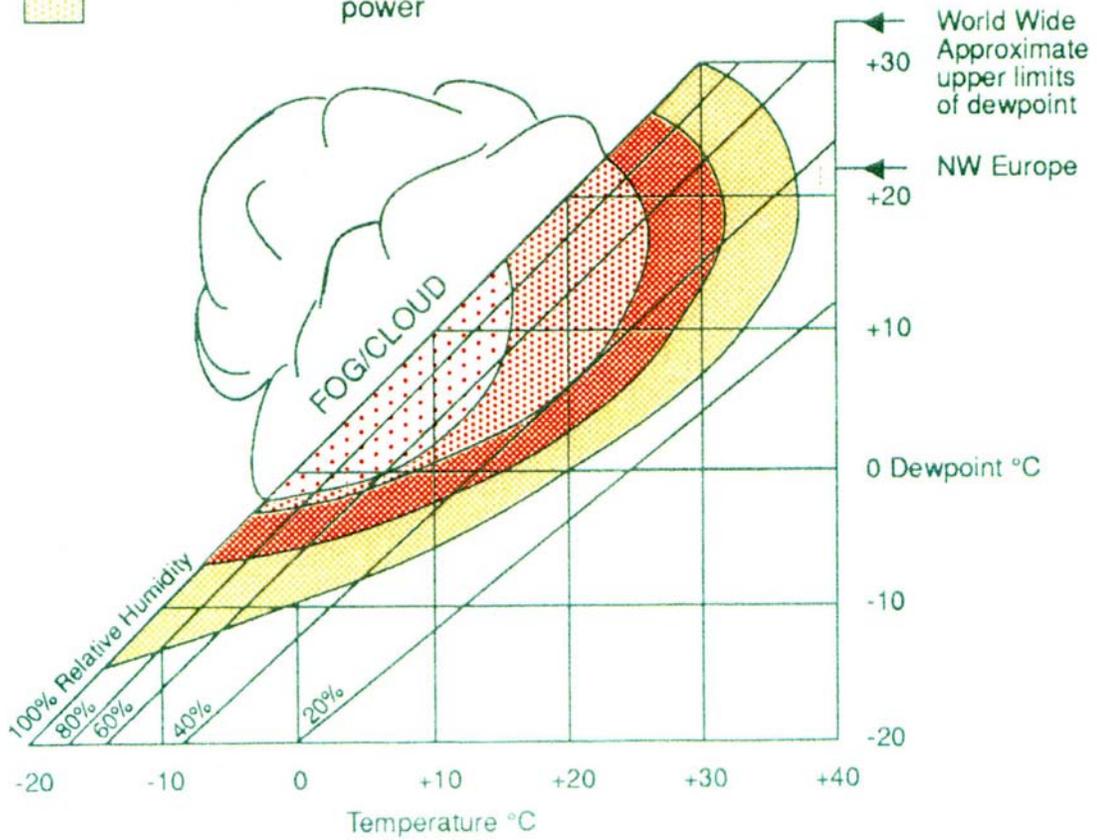
# CARB ICING

The air temperature at the surface and the dew point for the area at the time the aircraft was airborne were about 12°C and 9°C respectively, which gave a humidity of between 82% and 87%. Meteorological reports also indicated some cloud cover at 1,200 to 1,500 feet amsl, which would indicate higher humidity at that level. From the chart reproduced at the end of this report, it can be seen that these conditions are likely to cause serious carburettor icing, regardless of the power selected, if adequate carburettor heating is not applied.
