Figure 1 Location of Spoilers and Air brakes on BAe 146

**ABERDEEN DYCE ANEMOMETER RECORDINGS 1971 TO 1992,
OF MEAN HOURLY WINDS OF 12 KTS OR MORE WITH
GUST RATINGS GREATER THAN 1.8**

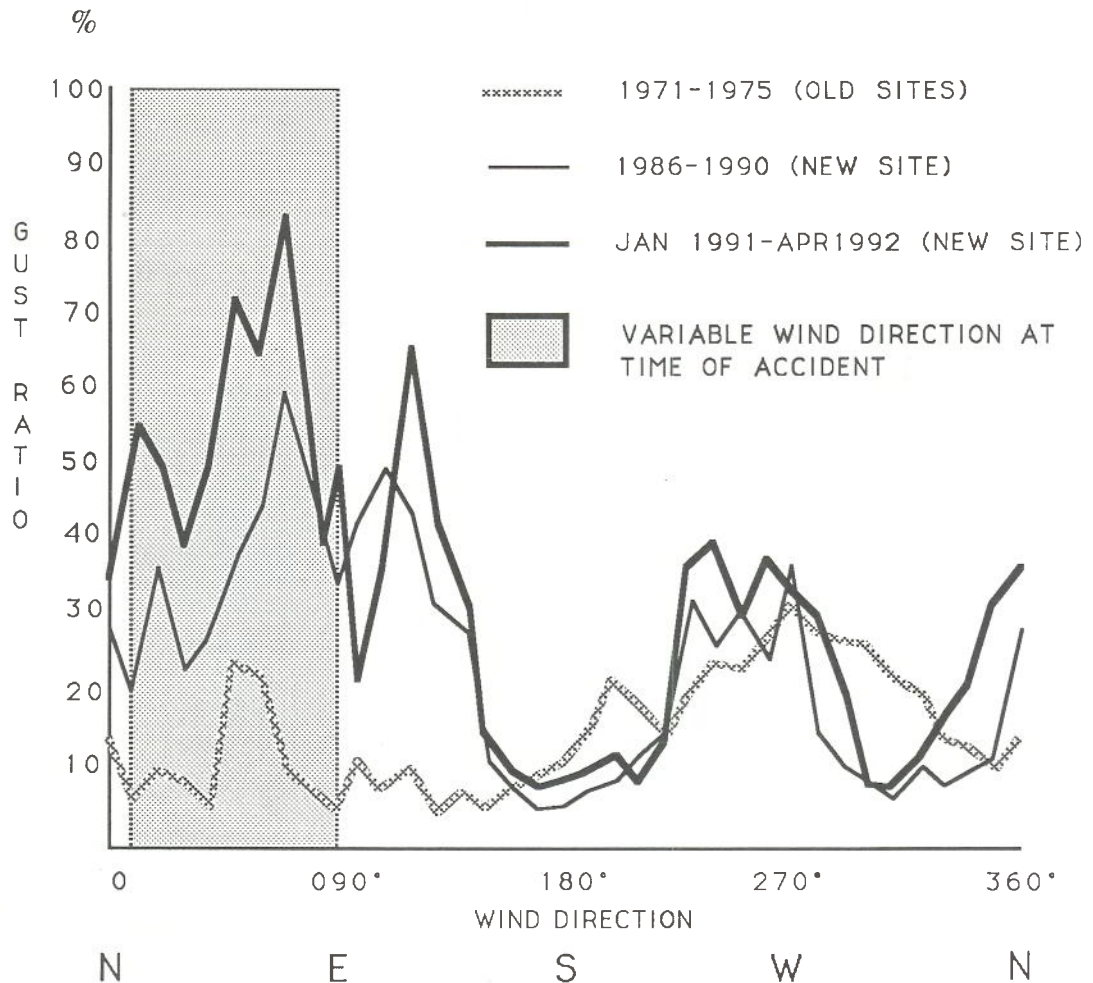
The Aberdeen Dyce anemometer has been located at its present site since 1976. Prior to that time it was located at two other sites.

The old sites (1971-1975) show very little gustiness with easterly winds.

Statistics for the new site show a marked increase in gustiness with easterlies as a result of a large surface feature to the east of the site.

For the period Jan 91 to Apr 92 data shows even higher values from 350° to 090° which could be due to recent construction to the east and close to the present anemometer location.

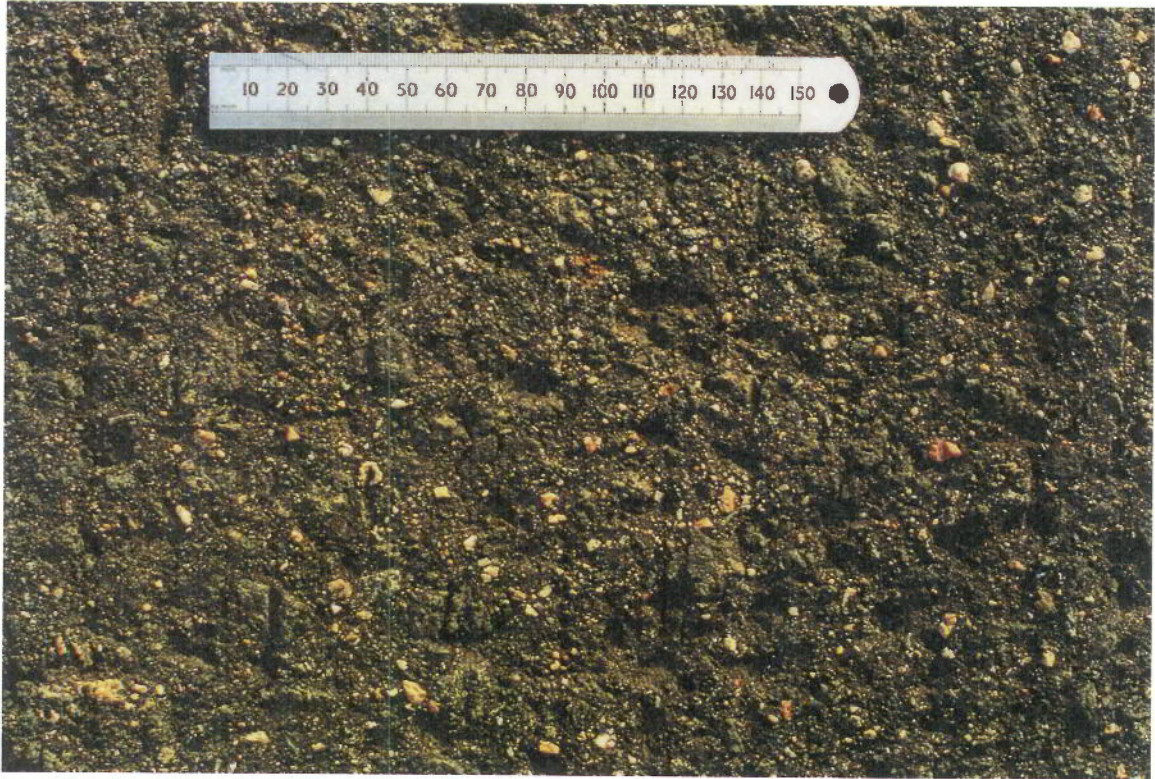
Figure 3 Close-up of old weathered runway surface at thresholds

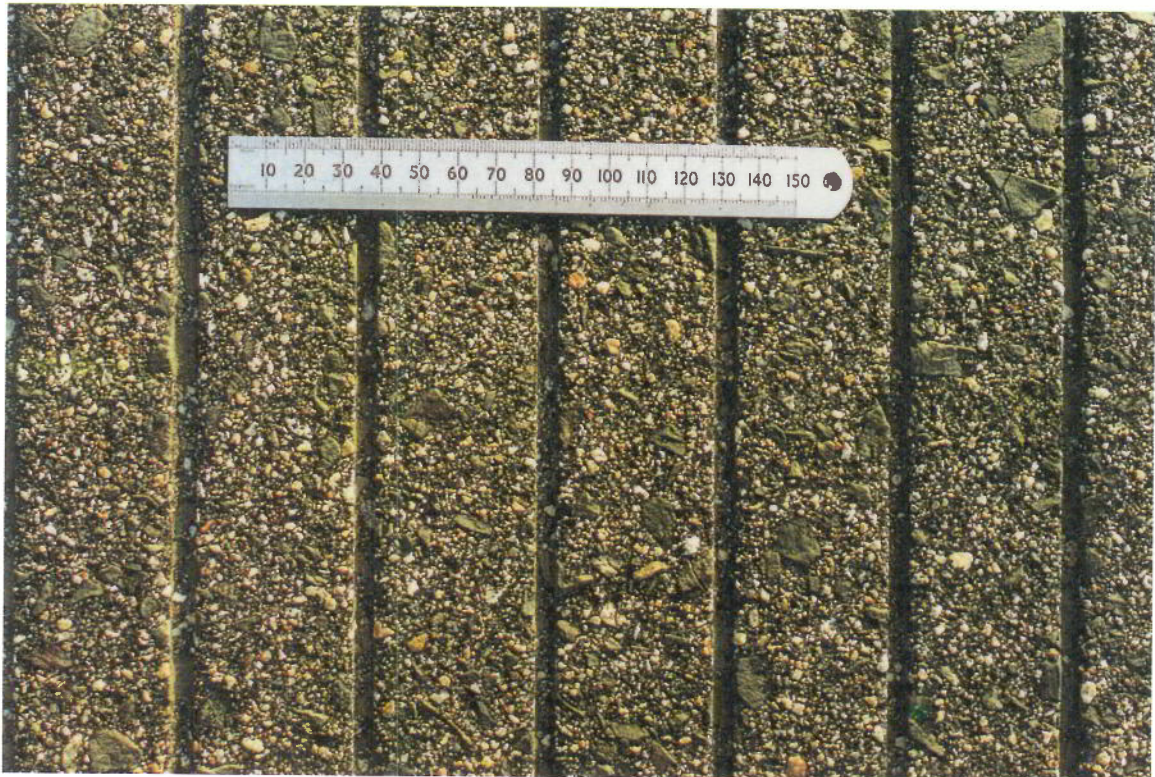
Figure 4 Close-up of runway surface laid in 1988

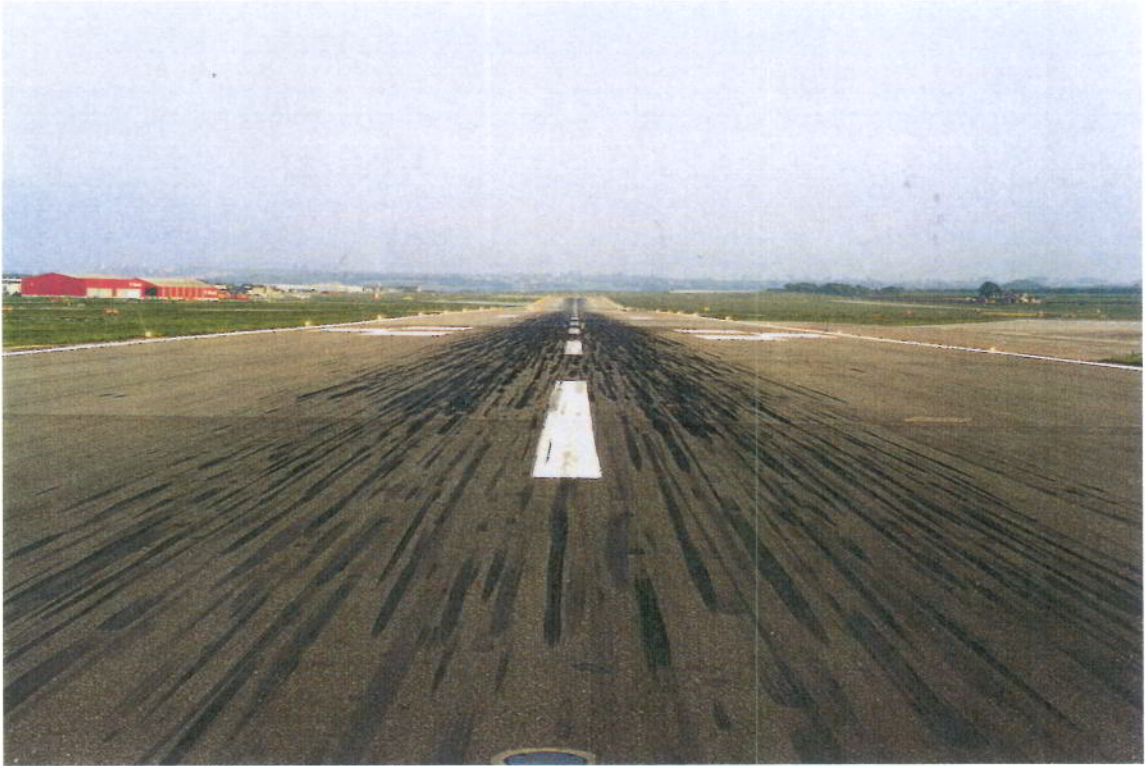
Figure 6 Rubber deposits at runway 16 threshold

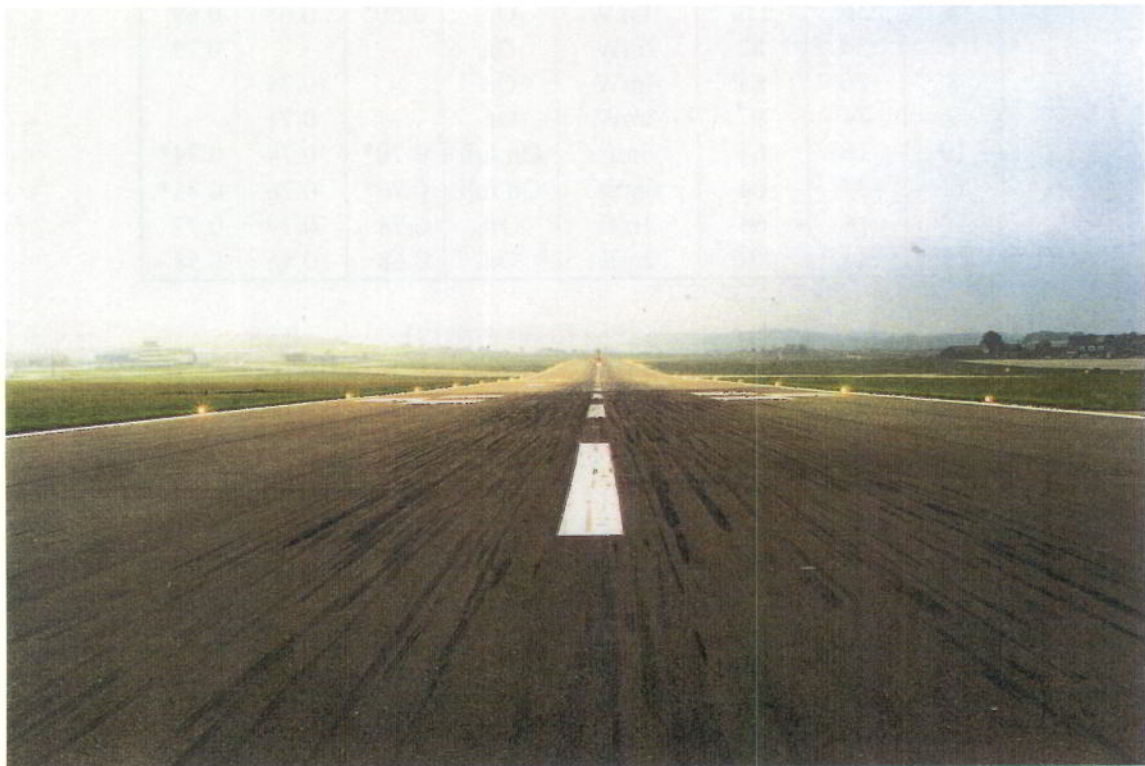
Figure 7 Rubber deposits at runway 34 threshold

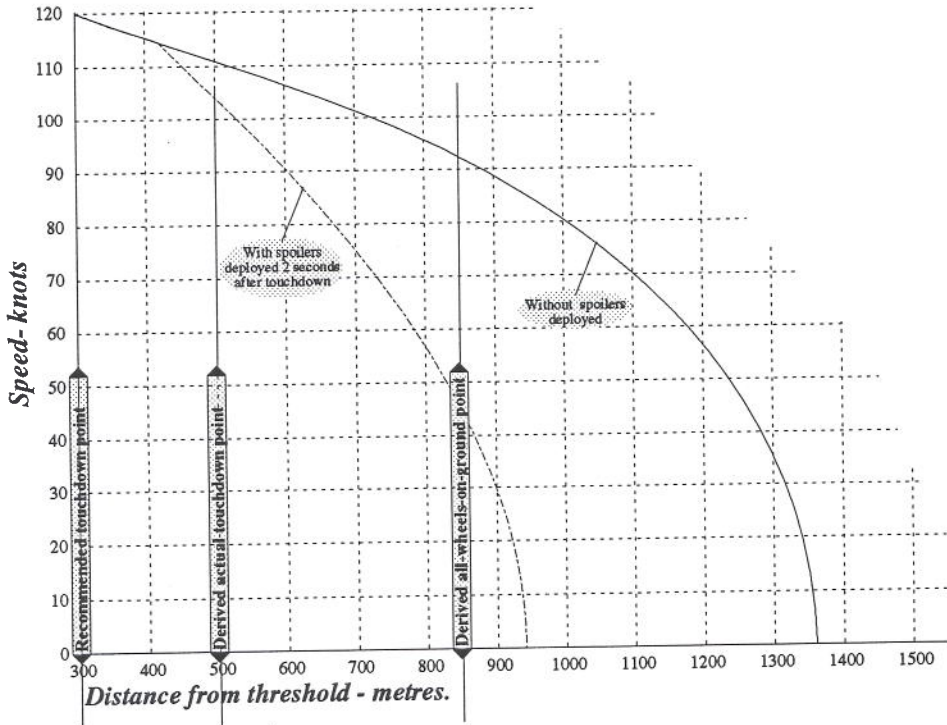
Plot 6 - Calculated landing ground roll following touchdown at 120 knots.
Air brakes fully out, wheelbrakes applied 1 second after touchdown.

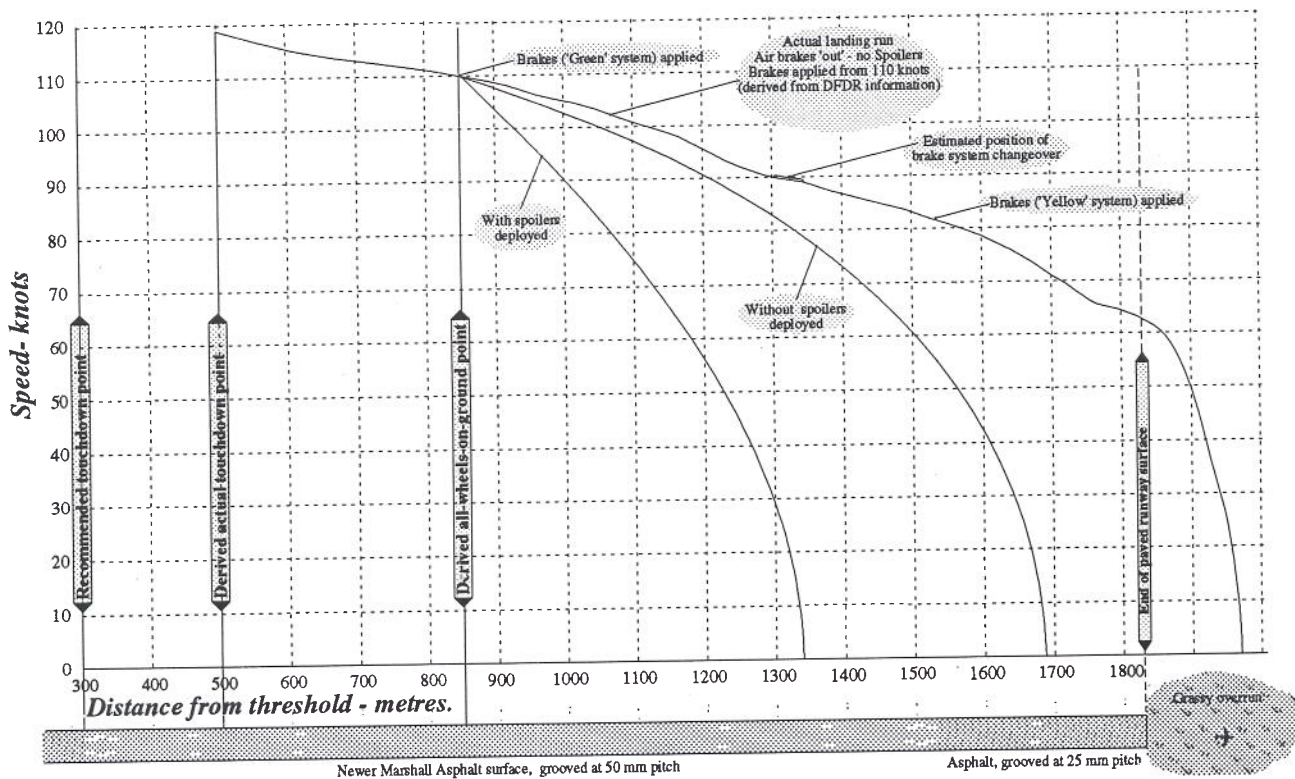
Plot 7 - G-UKHP landing ground roll derived from DFDR information.
Calculated ground rolls with maximum braking applied from 110 kts,
with and without spoilers deployed, shown for comparison
