ACCIDENT

Aircraft Type and Registration:	Dyn' Aero MCR01 Club, F-PYMD	
No & Type of Engines:	1 ROTAX 912 ULS piston engine	
Year of Manufacture:	1999 (serial no. 102)	
Date & Time (UTC):	30 September 2007 at 1352 hrs	
Location:	Near Fridd Farm Airstrip, Bethersden, Kent	
Type of Flight:	Private	
Persons on Board:	Crew - 1	Passengers - 1
Injuries:	Crew - 1 (Serious)	Passengers - 1 (Fatal)
Nature of Damage:	Aircraft destroyed	
Commander's Licence:	UK Private Pilot's Licence	
Commander's Age:	74 years	
Commander's Flying Experience:	537 hours Last 90 days - 7 hours Last 28 days - 5 hours	
Information Source:	AAIB Field Investigation

Summary

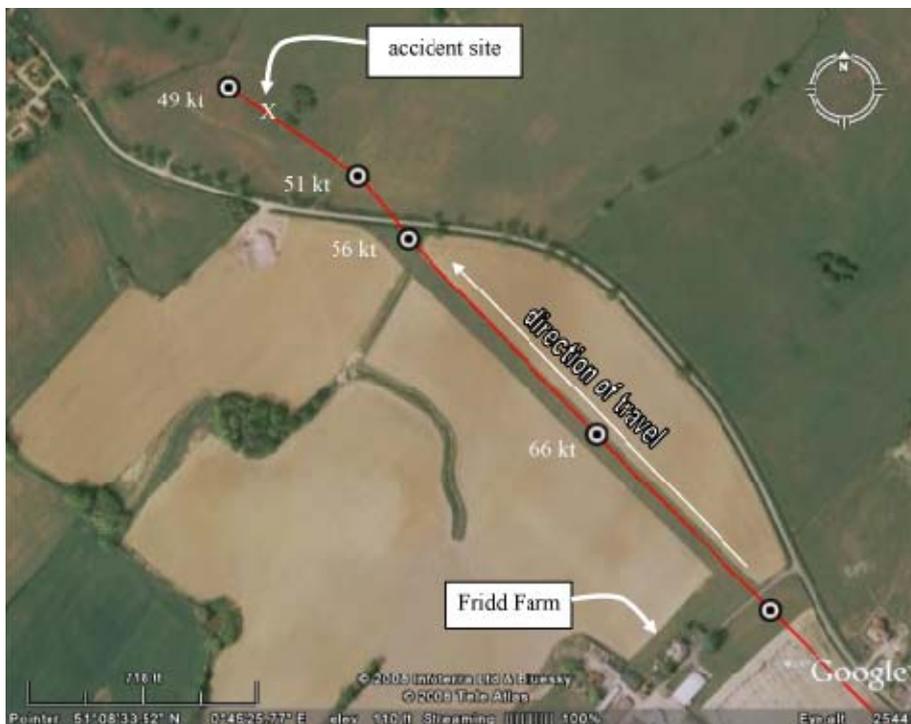
The aircraft was then seen taxiing towards the threshold of Runway 32. After waiting about two further minutes on the runway, the takeoff commenced at around 13:48:21. The aircraft lifted off and performed a right-hand circuit, achieving a maximum GPS altitude of 981 ft, before returning to the runway from which it had departed (Figure 1).

Just before the Runway 32 threshold, the groundspeed derived from GPS position and time was 76 kt with a heading of 315° True. F-PYMD crossed the runway threshold at around 13:51:00, just over two and a half minutes after takeoff commenced. Four further positions were recorded by the GPS as the aircraft continued tracking along the runway. The last five track points represented a ground track distance of 0.4 nm.

The last two GPS positions were located in fields just beyond the end of the runway. The final position was

Fridd Farm airstrip with final 5 recorded GPS trackpoints
(Google Earth™ mapping service/Infoterra Ltd & Bluesky /Tele Atlas)

recorded at 13:51:20, located around 56 metres from the location of the accident site:

Figure 1 also shows the aircraft groundspeeds as derived from the GPS positions over time. Due to the limited number of points over the runway and the inaccuracy of the final track point, speed measurements for the end of the flight cannot be considered accurate.

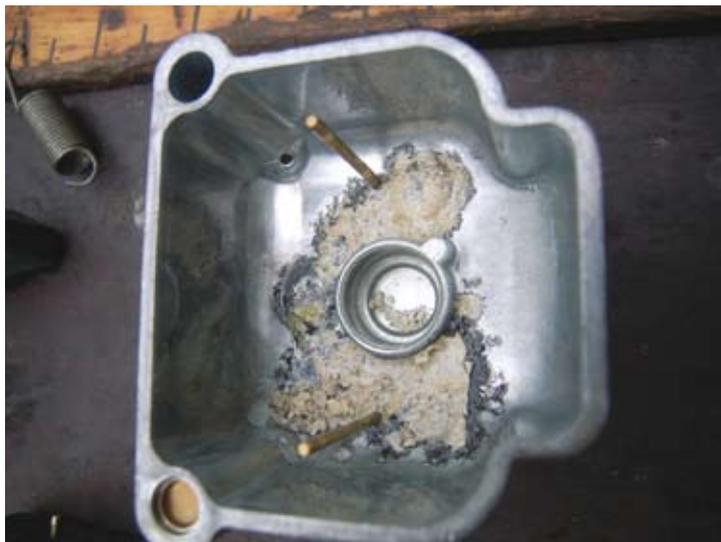
Figure 2

The right carburettor was removed and a well-defined area of exfoliating corrosion was found in the bottom of the carburettor bowl, a small piece of this material was also found in the main fuel jet, see Figures 2 and 3. There was no evidence of corrosion on the left carburettor bowl. The position and clearly defined nature of this material suggested the presence of water in the carburettor bowl. It was noted that the inclusion of a drip tray under the carburettor prevented removal of the carburettor bowl without first removing the carburettor from the intake manifold and there was no requirement to carry out an inspection of the bowls during routine maintenance. Burring found on screw heads around the carburettor did indicate that it had been disassembled at some point prior to the accident.

The right carburettor bowl was examined under a scanning electron microscope, which confirmed that the material in the bowl was a corrosion product of the zinc alloy bowl. Swabs taken for analysis confirmed the presence of chloride, bromide and acetate ions on the inner surface of the bowl. The concentration of these ions within the corroded area was found to be significantly higher than the surrounding material and sufficiently high to have initiated corrosion in the zinc

Corrosion in right carburettor bowl

alloy bowl in the presence of moisture. Whilst the origin of the chloride and bromide ions could not be positively determined, their level of concentration meant that they were probably introduced as a result of chemical contamination, possibly by a cleaning solution, rather than by natural residues.

It is recommended that ROTAX introduce a requirement into the engine maintenance schedule for engine type 912 series, to remove and inspect the carburettor bowls periodically for the presence of moisture and other contaminants.

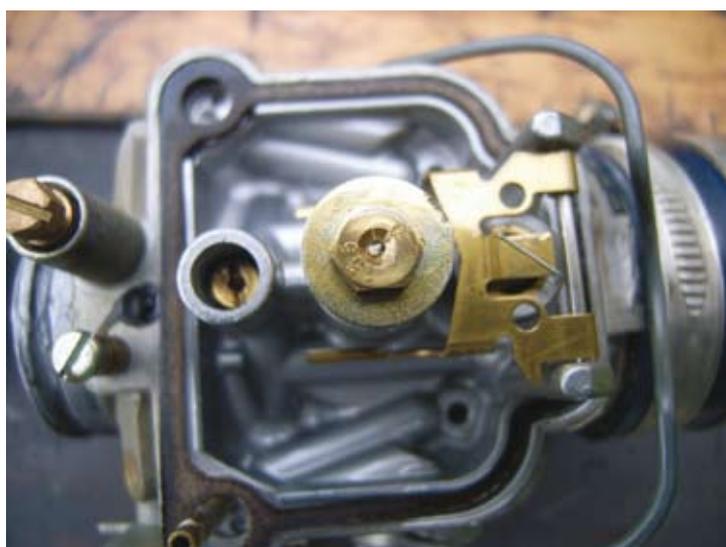
Figure 3

Blocked fuel jet

The loss of power was established to have been caused by the blockage of the right carburettor main fuel jet by corrosion products from the carburettor bowl. Analysis showed that the initiation of corrosion in the bowl was due to the presence of concentrations of chloride and bromide ions, normally associated with the residue of cleaning products. Whilst the origin of the chloride and bromide ions could not be positively determined, their level of concentration meant that they were probably introduced as a result of chemical contamination. The only work carried out on the engine which involved removal of the carburettor bowls was completed at the ROTAX agent's facility; it is possible that the contamination of the carburettor bowl occurred during one of the engine's visits. The installation of drip trays beneath each carburettor prevented the carburettor bowls being easily removed to check for the build-up of water or sediment/corrosion.

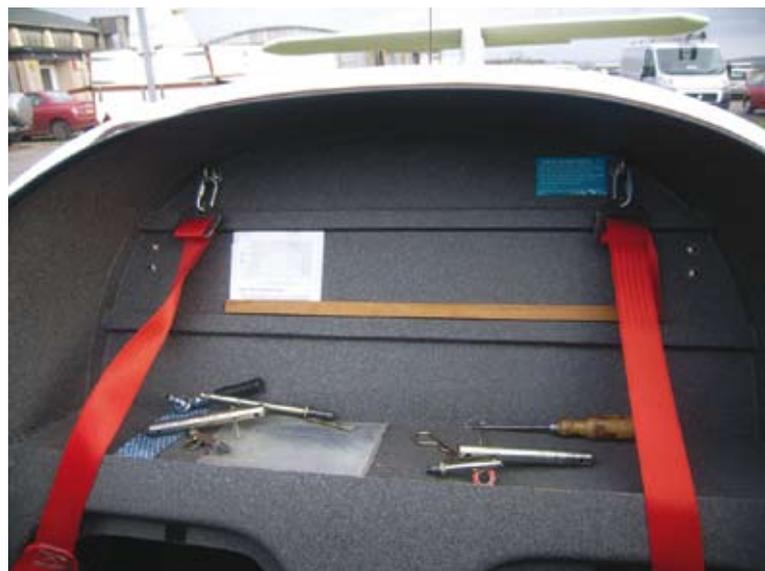
bonded carbon-fibre fittings, two on the cockpit floor beside the seat and a fitting secured to the inner surface of the upper fuselage, behind the rear cockpit bulkhead, see Figure 4. All the lower harness attachment points remained attached to the fuselage structure and, whilst the pilot's shoulder harness fitting remained attached to the fuselage, it had become disbonded from the fuselage at its forward edge. As noted earlier, on the right side of the fuselage the passenger's shoulder harness fitting had separated entirely.

Figure 4
Shoulder harness installation

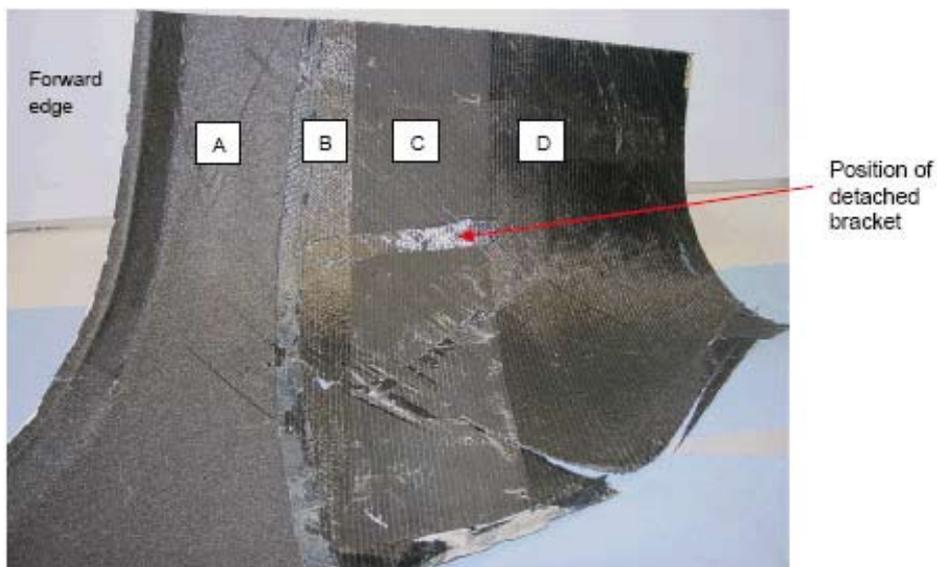
Figure 5

The inner face of the fuselage showed four areas of differing surface finish, see Figure 5. Area A was an area where no bonding had taken place and had been painted for aesthetic reasons, Areas B and D were shiny in appearance and had a smooth surface finish. Area C had a rough finish, normally associated with the

removal of a 'peel ply' from the composite structure¹. The manufacturer's documentation confirmed that the harness fittings were to have been bonded in Area C and, in the event that the bond extended beyond the 'peel ply' area, the surface finish in those areas was to have been abraded to improve the bond strength. The remains of the bond for the passenger harness fitting extended 45 mm forward and 18 mm aft of the peel ply area, whereas the pilot's fitting had, with the exception of the rearmost 25 mm, been bonded to area C. The positioning of area C across the fuselage was not uniform: the area was narrower and its forward edge was displaced aft on the right (passenger) side of the fuselage. Adhesive paste had extruded from both harness fitting joints which indicated that there was adequate adhesive present during the bonding process. However, the depth of adhesive varied across

A detailed examination of the area where the passenger attachment had been bonded revealed that in area B the surface of the carbon fibre remained highly reflective and the bond failure appeared to be 'adhesive' (the bond having failed at the interface between the adhesive and the composite surface). This was clear evidence of a relatively poor bond. There was evidence of light abrasion to the surface in areas B and D but this had not improved adhesion in those areas. In area C, the prepared area, the bond line had a dull appearance and was characteristic of 'cohesive' failure of the bond, with the surface of the composite structure being pulled away together with some of the underlying fibres.

Interior fuselage surface finish

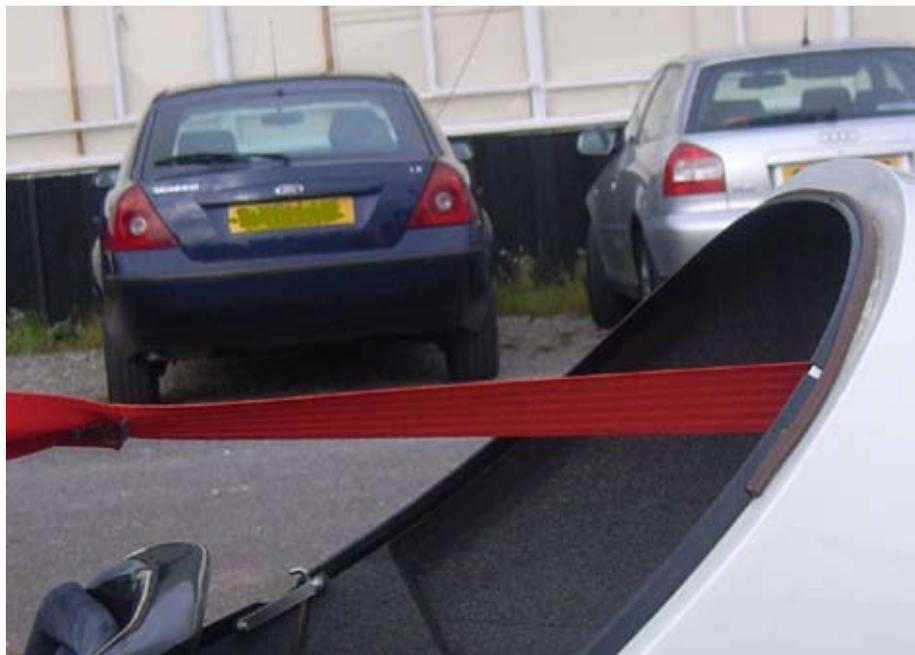
Figure 6 shows the normal position of the shoulder harness. The location of the shoulder harness fittings allows the shoulder harness to remain roughly horizontal when worn; however, given the contour of the fuselage, any application of load on the harness will produce a perpendicular 'peel' load on the bond between the harness fitting and the fuselage. These 'peel' loads would be increased as the size of the occupant of the seat decreased. The bulkhead, constructed of a thin lamination of carbon fibre through which the harness attachment passes, was found to offer little additional resistance to the application of peel loads. The curvature of the fuselage cross section in this area means that it is also possible to introduce torque loads into the fitting if it is not accurately aligned.

Normal shoulder harness position
