INCIDENT

Aircraft Type and Registration:	Dornier 328-110, D-CPRW	
No & Type of Engines:	2 Pratt & Whitney PW 119B turboprop engines	
Year of Manufacture:	1998	
Date & Time (UTC):	18 January 2006 at 1255 hrs	
Location:	On approach to Runway 24R at Manchester Airport	
Type of Flight:	Public Transport (Passenger)	
Persons on Board:	Crew - 3	Passengers - 17
Injuries:	Crew - None	Passengers - None
Nature of Damage:	None	
Commander's Licence:	Airline Transport Pilot's Licence	
Commander's Age:	46 years	
Commander's Flying Experience:	4,600 hours (of which 400 were on type) Last 90 days - 148 hours Last 28 days - 51 hours	
Information Source:	AAIB Field Investigation

Synopsis

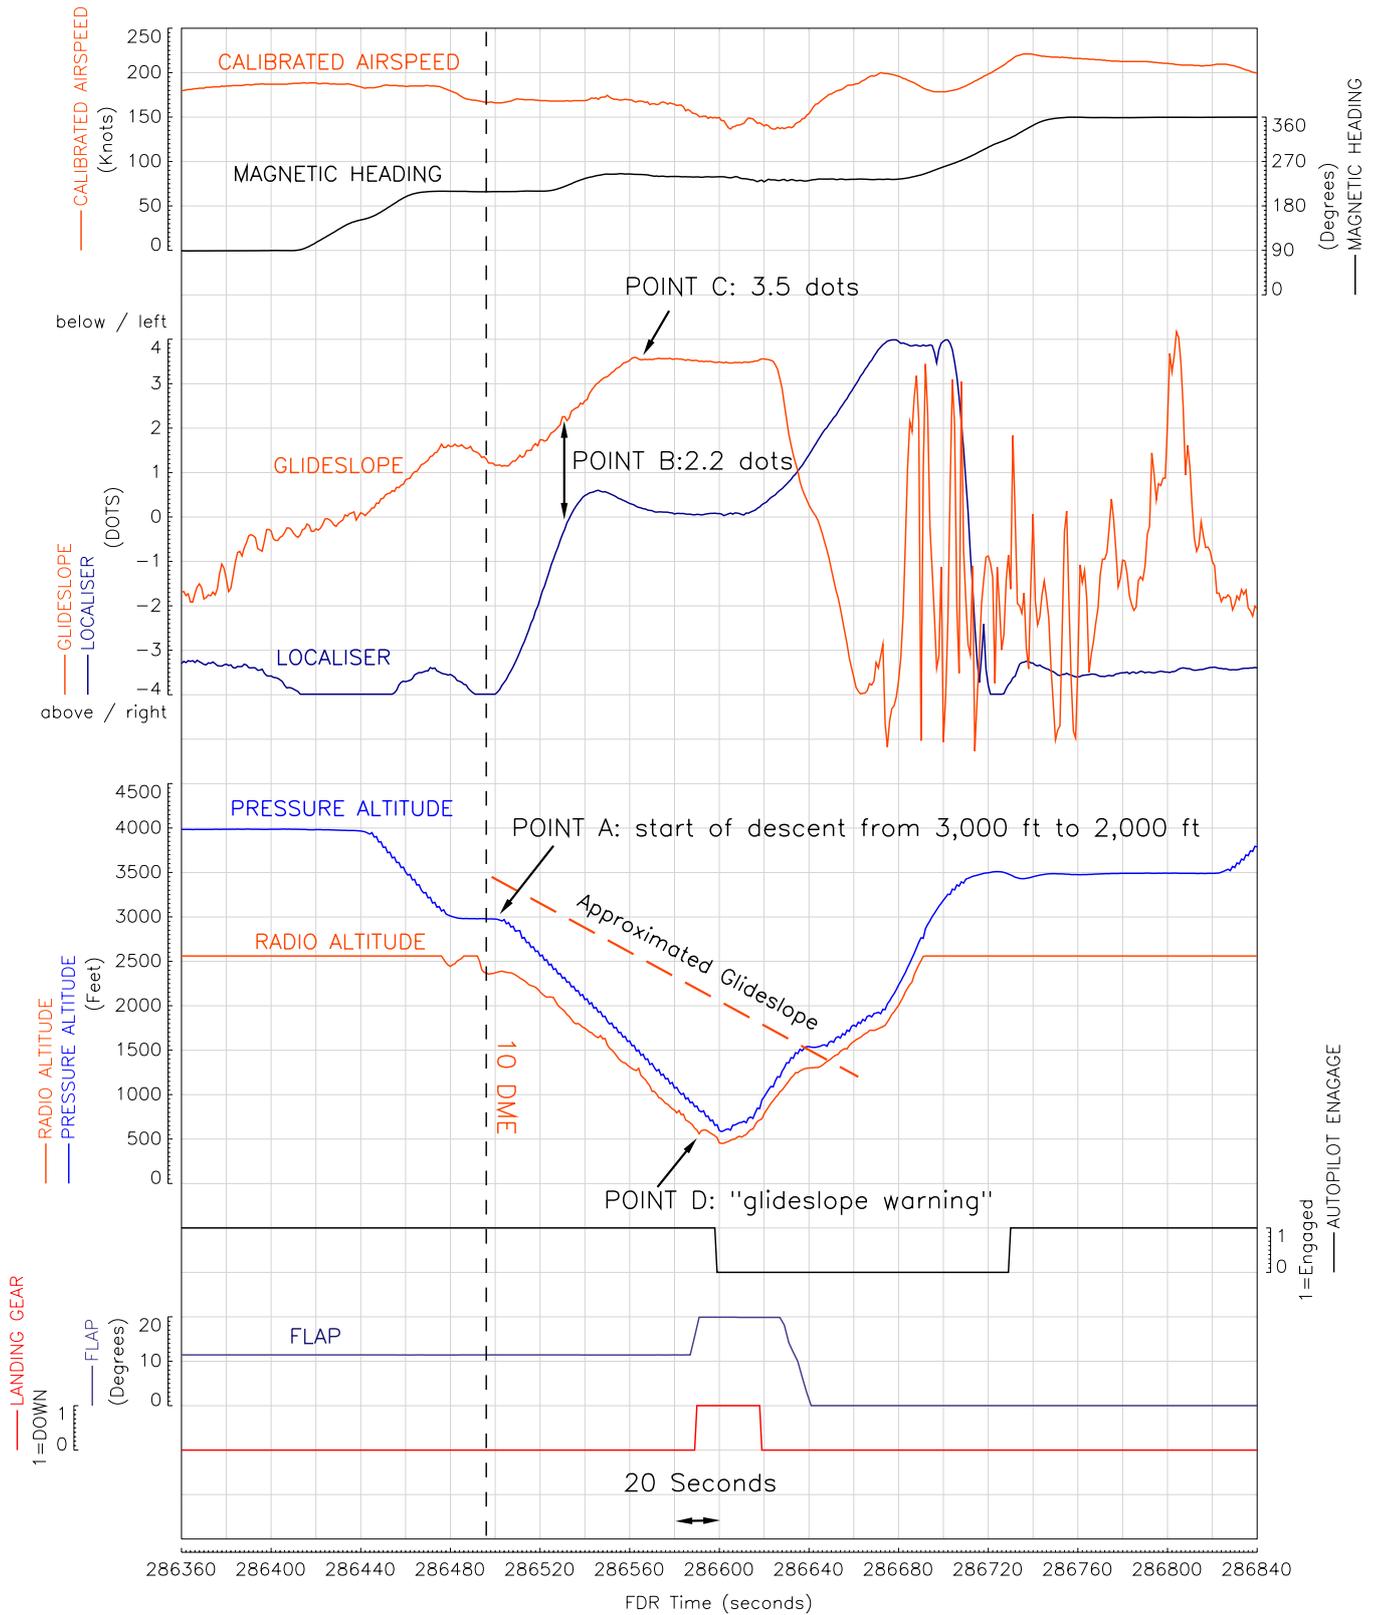
Figure 1
Salient FDR Parameters

Figure 1 is a plot of the salient parameters of the initial approach and go-around. At 1251 hrs, the aircraft was approximately 12.5 DME track miles from the runway and on a magnetic heading of 090°; the autopilot was engaged with the lateral mode in Heading Select, and the pitch mode in Altitude Hold. About that time, ATC instructed the crew to make their heading 155° and to descend to 3,000 ft; this was subsequently followed by a heading change instruction to 210°. The crew acknowledged both heading changes and the altitude change, and the aircraft started to make a right turn and descend. During the descent, the autopilot pitch mode initially changed to FLC CAS⁴, followed about 20 seconds later by a change to the V/S mode; the rate of descent increased to about 1,500 fpm. As the aircraft descended the crew said that the “NAV IS ARMED”⁵. As the aircraft approached 3,200 ft QNH, the autopilot pitch mode changed to Altitude Selected. Capture followed, 14 seconds later, by a change to Altitude Hold. The aircraft levelled off at 3,000 ft QNH, by which time it had completed its right turn and was on a magnetic heading of 209°. About that time, ATC advised the crew to maintain 160 kt to 4 DME.

When approximately 10 DME from the runway (Figure 1, Point A), ATC cleared the aircraft to descend to 2,000 ft for the ILS, which the PNF acknowledged. The autopilot Pitch mode then changed to V/S, the aircraft started to descend at about 1,500 fpm and, a short time later, the Altitude Alert ‘chime’ sounded⁶ as the aircraft descended through 2,700 ft QNH. There was no apparent response from the operating crew.

When the aircraft was at about 1,600 ft QNH, the glideslope deviation had increased to 3.5 ‘dots’ (Figure 1, Point C) and this remained at 3.5 ‘dots’ as the aircraft descended. Coincidentally, the autopilot lateral mode changed to APP LOC Track 1⁷, followed almost immediately by APP LOC Track 2⁸ and the aircraft stabilised on a magnetic heading of about 240°. Throughout this period, neither of the crew had referred to the aircraft’s altitude or glideslope capture status.

When at 6 DME, the aircraft was at about 890 ft QNH (600 ft agl), the flaps were extended to 20° and, a short time later, the landing gear was extended. As the gear was lowered, the commander said “WHY HASN’T THAT....UM”, but his comment was without reference. As the landing gear locked down, an EGPWS “GLIDESLOPE” alert then occurred, (Figure 1, Point D). Almost immediately, the commander said “GLIDESLOPE...PULL-UP” and, after a delay

of about six seconds, the autopilot was disconnected, the aircraft pitched up and started to climb. The aircraft had descended in IMC to about 450 ft above the ground. The commander subsequently advised ATC that they were going around due to an autopilot and ILS problem.

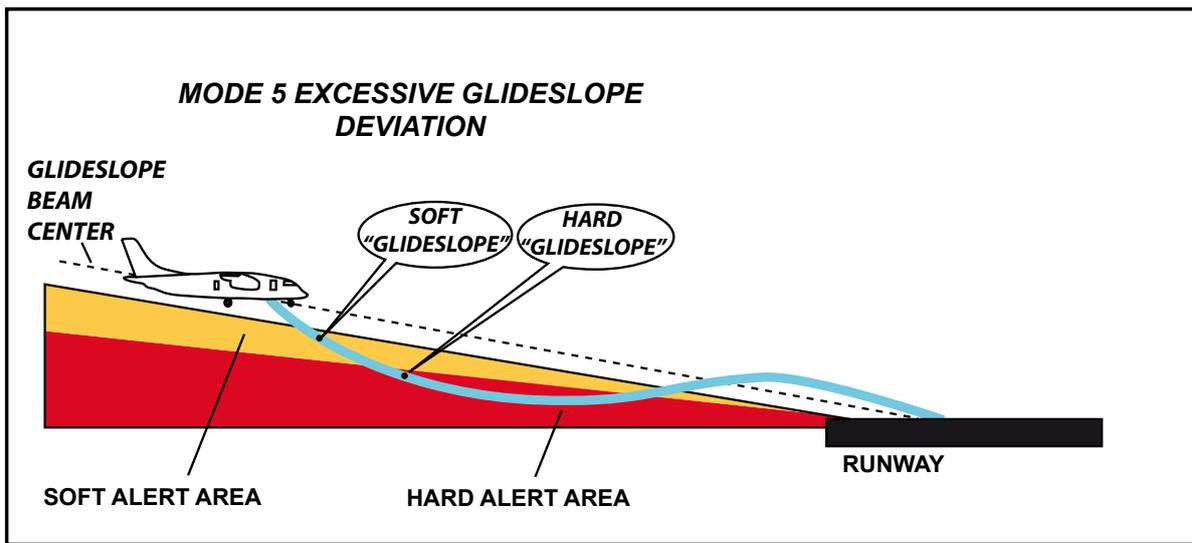
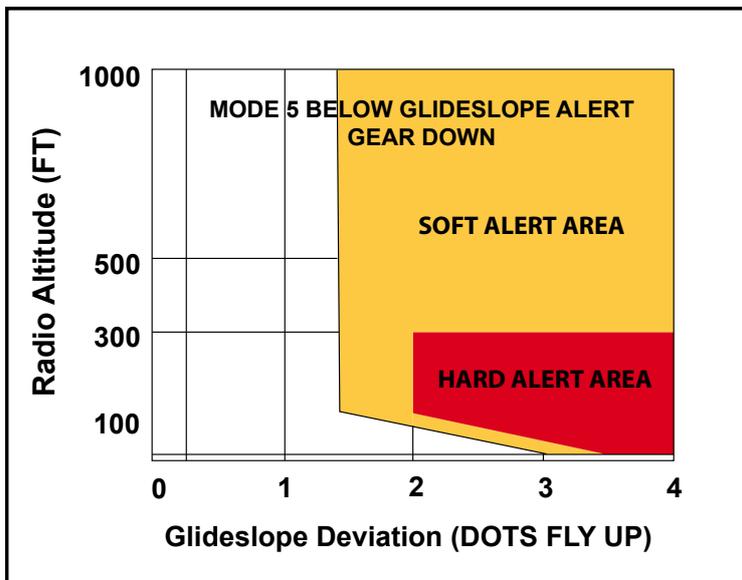
Figure 2

one of which was Mode 5, and this provides two levels of alert whenever an ILS frequency is tuned and the aircraft descends below the glideslope with the landing gear down, see Figure 2. The first level alert occurs if the aircraft is below 1,000 feet radio altitude (RA) and the aircraft is 1.3 'dots' or greater below the glideslope. Alert lights in the flight deck illuminate and a 'soft' audio alert is generated; termed 'soft' because the audio message "GLIDESLOPE" is annunciated at half volume when compared to the second level of alert volume. A 20% increase in the glideslope deviation causes additional "GLIDESLOPE" messages to be aurally annunciated.

The second level alert occurs if the aircraft is below 300 ft RA, with 2 'dots' or greater glideslope deviation. This is called a 'hard' alert as a louder "GLIDESLOPE, GLIDESLOPE" message is aurally annunciated every four seconds until the 'hard' envelope is exited. The alert lights remain on until a glideslope deviation of less than 1.3 'dots' is achieved.

Once the aircraft descended through 1,000 ft RA, the aircraft would have entered the EGPWS Mode 5 first level alert area. When it was at about 600 ft RA, the landing gear was lowered and, almost immediately, the EGPWS generated a soft “GLIDESLOPE” warning, which was heard by the commander. The aircraft continued to descend for a further six seconds before the autopilot was disconnected and a missed approach carried out.
