INCIDENT

Aircraft Type and Registration:	Airbus A321-231, G-EUXL	
No & Type of Engines:	2 International Aero Engine V2533-A5 turbofan engines	
Year of Manufacture:	2007 (Serial no: 3254)	
Date & Time (UTC):	20 December 2011 at 1542 hrs	
Location:	Near London Heathrow Airport	
Type of Flight:	Commercial Air Transport (Passenger)	
Persons on Board:	Crew - 7	Passengers - 116
Injuries:	Crew - None	Passengers - None
Nature of Damage:	None	
Commander's Licence:	Airline Transport Pilot's Licence	
Commander's Age:	44	
Commander's Flying Experience:	8,570 hours (of which 3,445 were on type) Last 90 days - 68 hours Last 28 days - 18 hours	
Information Source:	AAIB Field Investigation

Synopsis

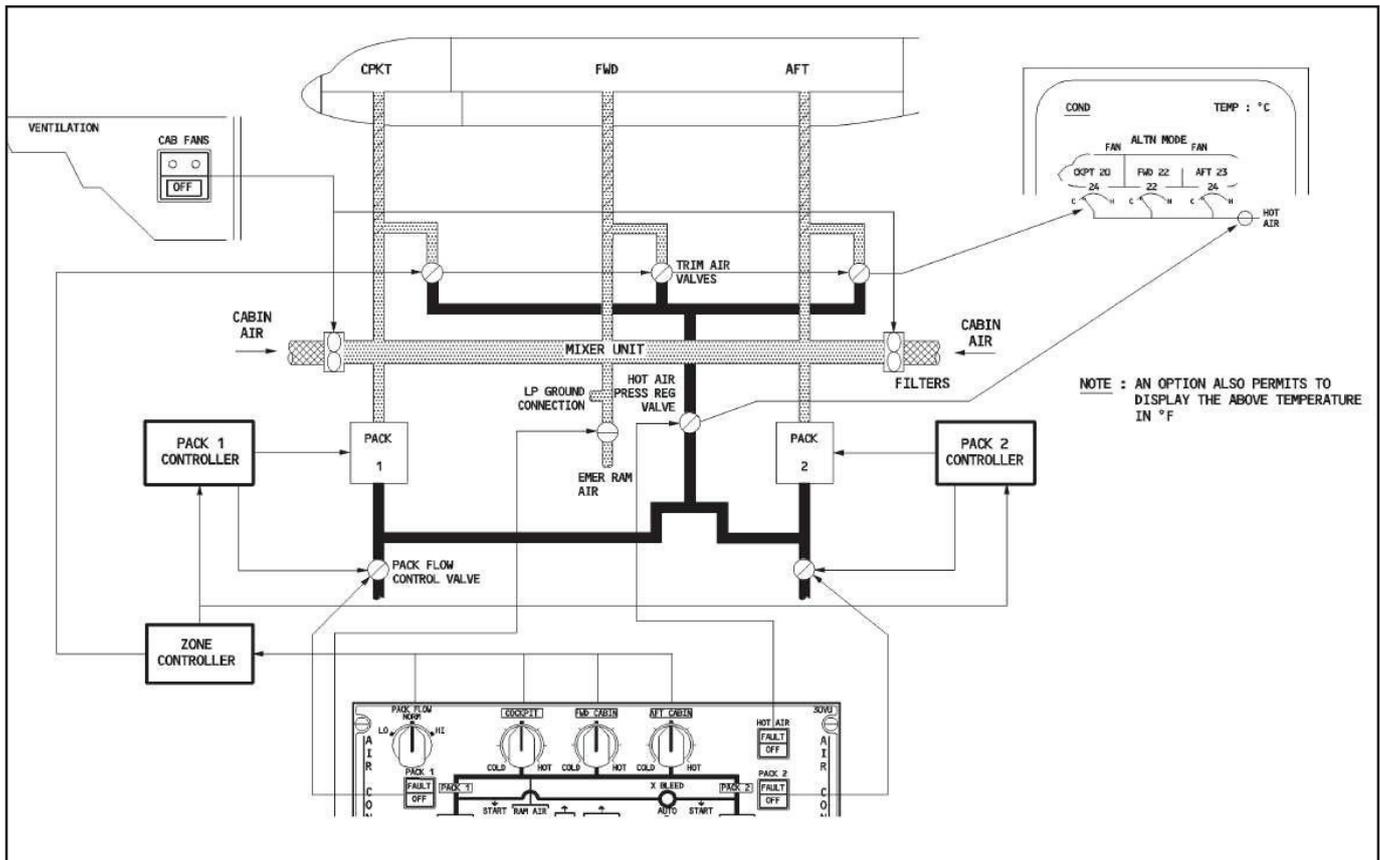
Figure 1

Schematic diagram of air conditioning system

bleed air and air conditioning systems, including the inside of ducting, were then thoroughly inspected. No anomalies or evidence of contamination were found. The aircraft subsequently flew without any reports of similar incidents.

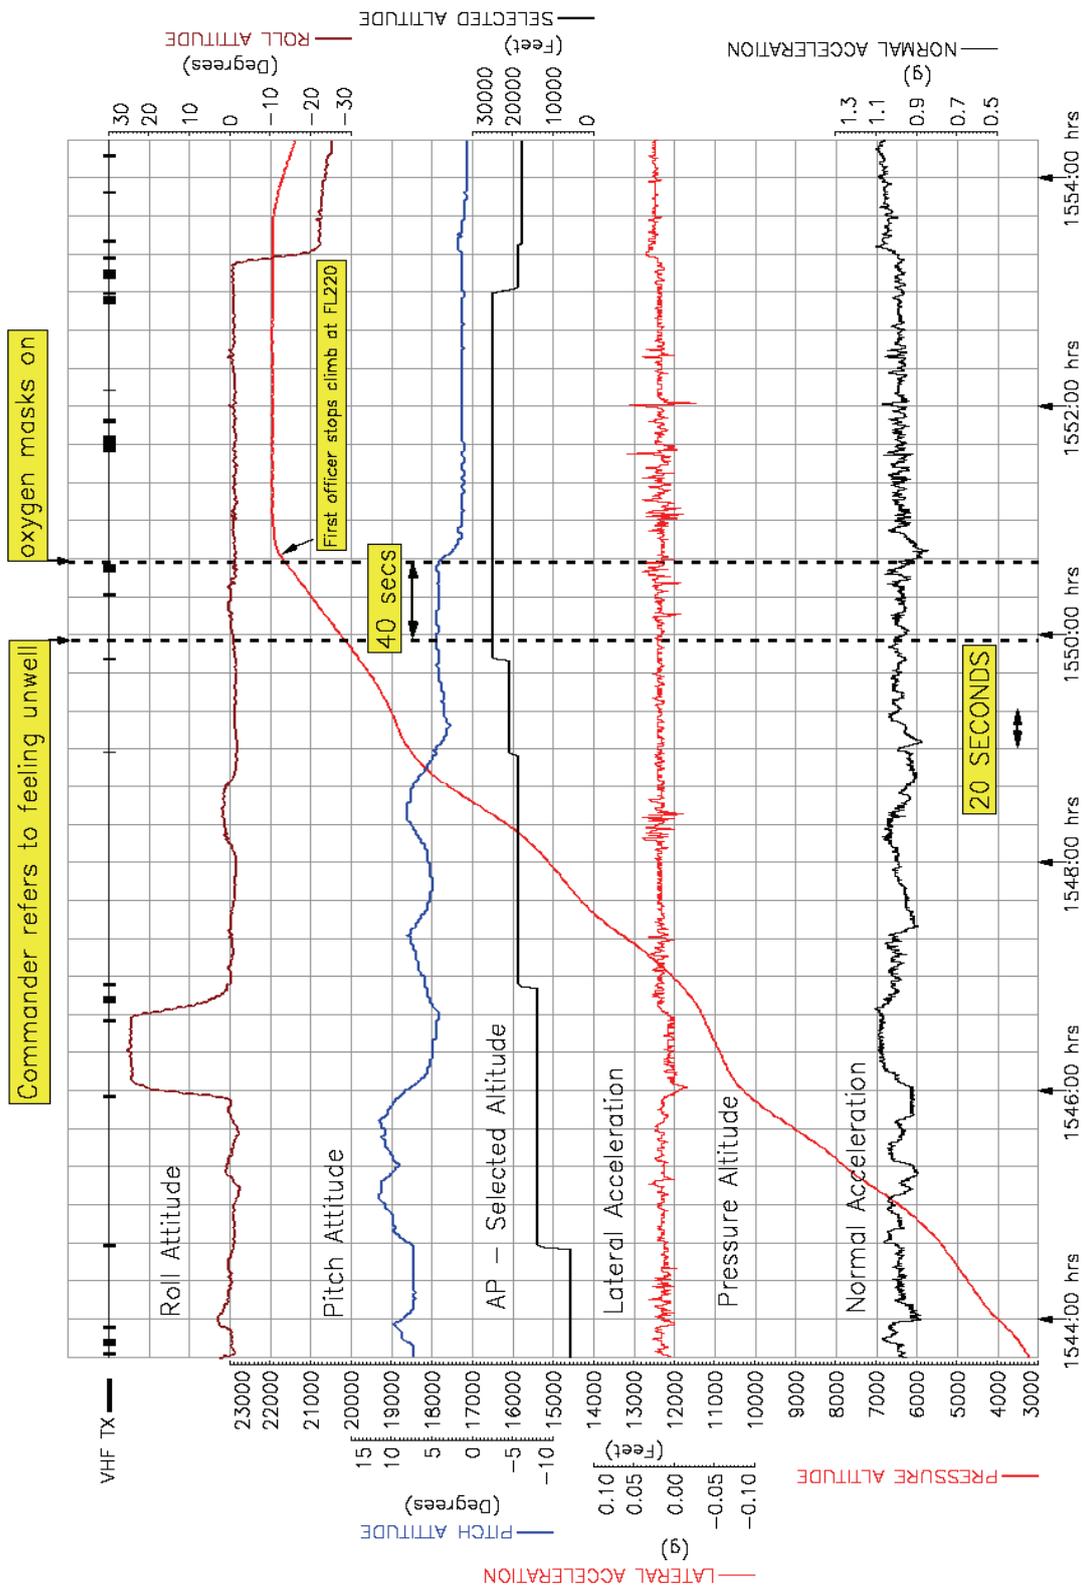
The FDR and DAR data was analysed and no defect with the aircraft's environmental control system was identified. Figure 2 contains a plot of salient parameters commencing shortly before the flight crew felt unwell.

Figure 2
Aircraft attitude and vibration levels

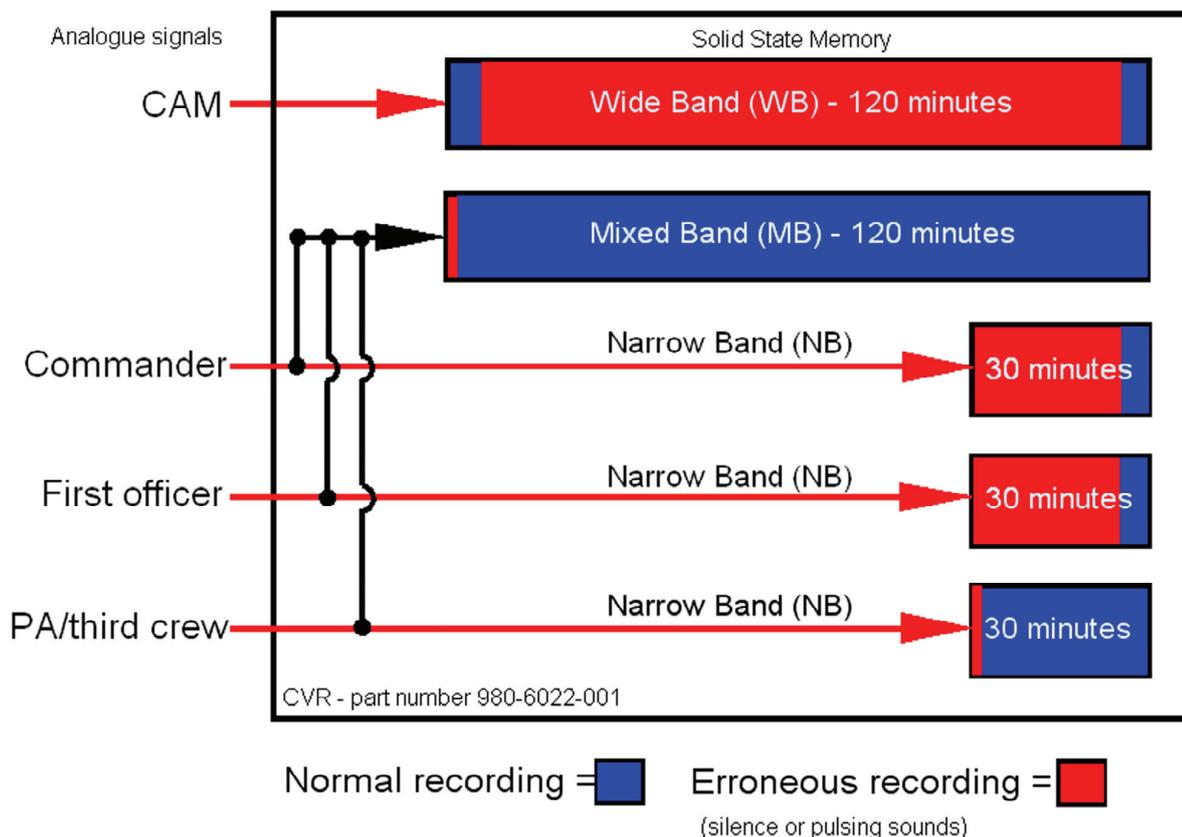
From information provided by the manufacturer, the AAIB developed its own software tool which generated 30-minute records for each of the NB channels. The PA/third crew member's channel was found to contain 30 minutes of normal audio, other than at the beginning, where there was a very short duration erroneous pulsing sound. For the commander's and co-pilot's NB channels, only the most recent five minutes contained normal audio. The beginning of these channels also contained a very short duration erroneous pulsing sound, which was followed by 25 minutes of erroneously recorded silence. Figure 4 depicts the erroneous recordings on each channel.

Erroneous recording

It was demonstrated that the CVR's erroneous recording of both erroneous silence and a pulsing sound was a result of an intermittent failure of the data packer IC. The physical inspection of the IC was inconclusive, although analysis of the data and test findings by the manufacturer indicated that the multiplexer circuit within the IC was at fault.

It was shown that the CVR's BIT function was ineffective in identifying the fault, and the design of the audio monitor function is such that the erroneous audio would not be evident at the monitor output. Thus, neither the Push-to-test nor the operational test of the CVR on the

It is recommended that Honeywell Aerospace notify all relevant operators and repair organisations of the symptoms that may be observed when the data packer integrated circuit (Honeywell part number 718-1239-007), fitted to Cockpit Voice Recorder (CVR) part number 980-6022-001 and similar models, malfunctions. Honeywell should draw attention to the fact that such a malfunction may only be detectable by conducting a full readout of the CVR.
