INCIDENT

Aircraft Type and Registration:	Britten-Norman BN2A Mk III-1 Trislander, G-LCOC	
No & type of Engines:	3 Lycoming O-540-E4C5 piston engines	
Year of Manufacture:	1974	
Date & Time (UTC):	7 June 2006 at 0530 hrs	
Location:	Saint Brieuc, Brittany, France	
Type of Flight:	Public Transport (Passenger)	
Persons on Board:	Crew - 1	Passengers - 3
Injuries:	Crew - None	Passengers - None
Nature of Damage:	Baggage door damaged	
Commander's Licence:	Commercial Pilot's Licence	
Commander's Age:	40 years	
Commander's Flying Experience:	2,900 hours (of which 205 were on type) Last 90 days - 75 hours Last 28 days - 27 hours	
Information Source:	Aircraft Accident Report Form

Synopsis

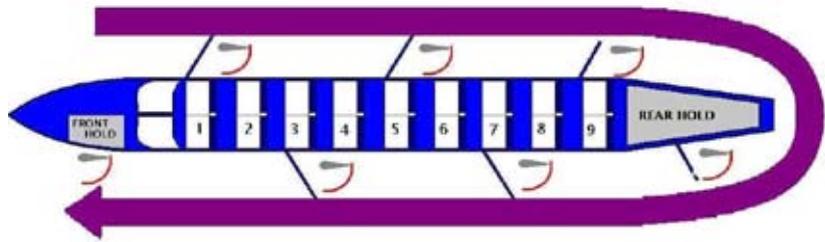
Figure 1

Trislander walk-round route for ground staff

instructed ground staff to walk clockwise around the aircraft from its starboard to its port side, checking each door in turn. The new procedure has been successful in eliminating this type of occurrence. The operator of G-LCOC stated that it intends to introduce a similar procedure, the relevant text of which is reproduced below together with a diagram (Figure 1).

- a. Remove steps from the vicinity of the aircraft.*
- b. Walk down the starboard side of the aircraft, checking each door is secured.*
- c. Remove the pogo-stick¹ (if being used) and secure in the hold.*
- d. Walk up port side of the aircraft, checking all the doors.*
- e. Ensure that the Captain has a copy of the load sheet, and no door warning lights are showing in the cockpit.*
