## ACCIDENT

<b>Aircraft Type and Registration:</b>	Medway Microlights Raven X, G-MYVW	
<b>No &amp; Type of Engines:</b>	1 Rotax 447 piston engine	
<b>Year of Manufacture:</b>	1995	
<b>Date &amp; Time (UTC):</b>	9 June 2006, between 1332 hrs and 1412 hrs	
<b>Location:</b>	North of Cliffe, Kent	
<b>Type of Flight:</b>	Training	
<b>Persons on Board:</b>	Crew - 1	Passengers - None
<b>Injuries:</b>	Crew - 1 (Fatal)	Passengers - N/A
<b>Nature of Damage:</b>	Aircraft destroyed	
<b>Commander's Licence:</b>	Student Pilot	
<b>Commander's Age:</b>	41 years	
<b>Commander's Flying Experience:</b>	40 hours (of which 18 were on type) Last 90 days - 7 hours Last 28 days - 7 hours	
<b>Information Source:</b>	AAIB Field Investigation

## Synopsis

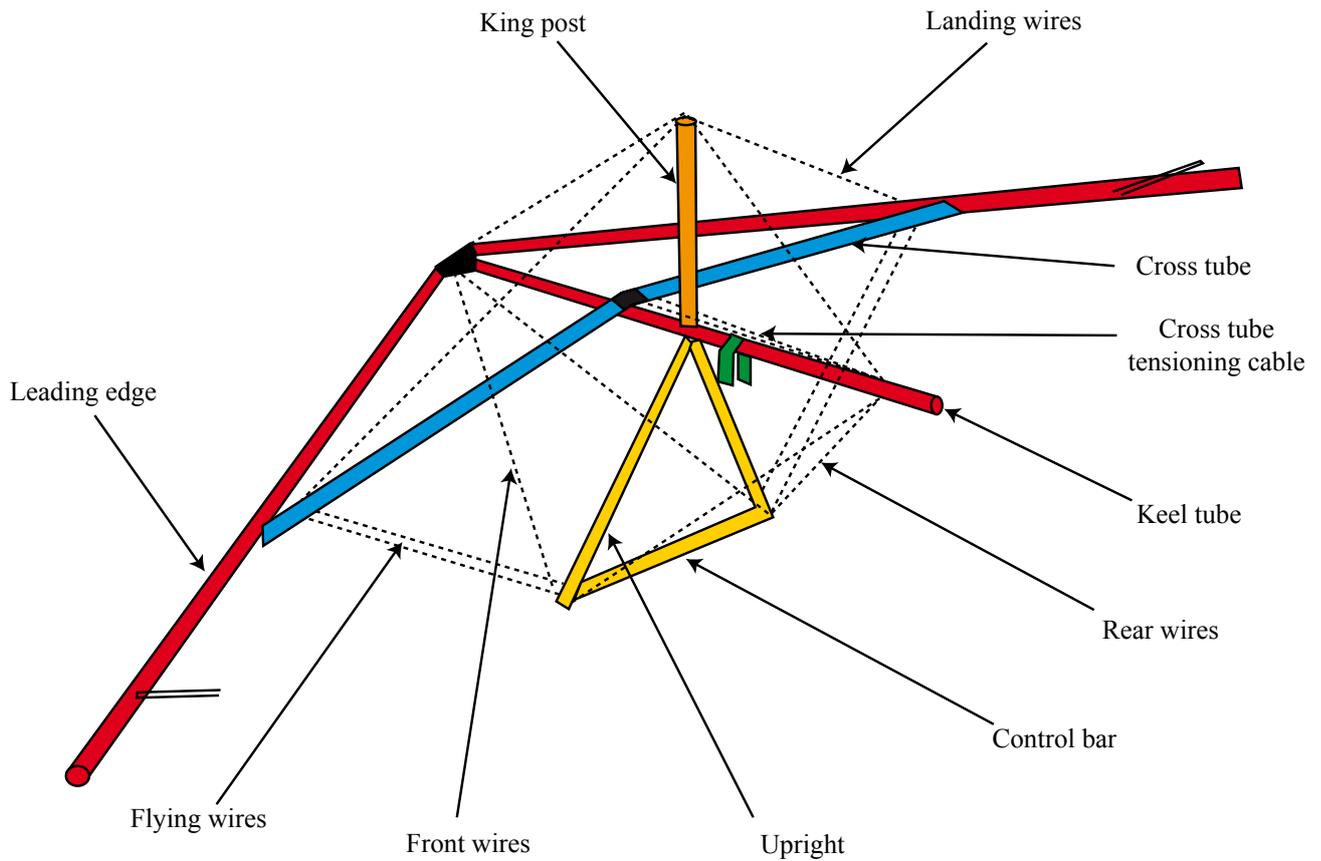
**Figure 1**

Examination of the various structural cables showed that the two rear flying cables running from the 'A' frame aft to attach to the wing keel had failed, as well as the cross-tube tension cable and its backup cable. In addition, one of the luff lines<sup>1</sup> and the right wing landing wire had failed, but apart from these all the other cables were intact (see Figure 1). Further information and discussion of the cables is contained later in this report.

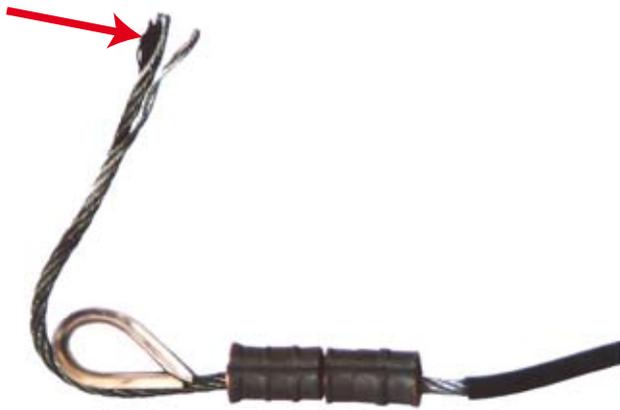
**Figure 3**

In the case of G-MYVW, the rear flying cables had pulled through the swage fittings at one end (see Figure 3), leaving just a thimble attached to each side of the ‘A’ frame.

Broken rear cable from G-MYVW

Note that the cable has pulled through the ferrules and the fibre core (arrowed)

Detailed examination concluded that the swaged joints were of poor quality, probably as a result of the use of fibre-cored cable. In comparison, some original cables supplied by the manufacturer, and of about the same age as those fitted to G-MYVW, were significantly stronger and the swaged joints were satisfactory. Considerably greater strength would have been achieved if the correct cable had been used.

The British Microlight Aircraft Association should promulgate the information that fibre-cored cables should not be used on aircraft, unless specified by the manufacturer, and that the Nicopress swaging tool was not designed for fibre-cored cables and will therefore not produce a correctly swaged joint.

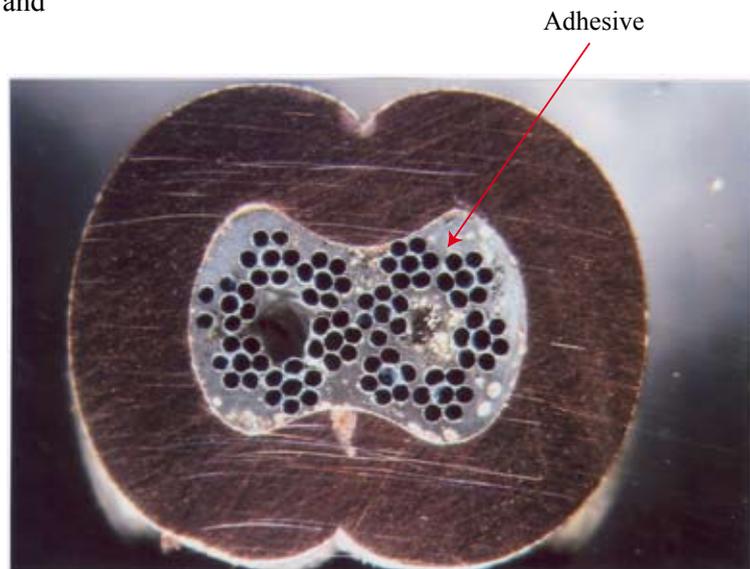
**Figure 4**

Consultation of the cable-makers’ data for steel and fibre-cored cables of the same diameter indicated that there is not, surprisingly, much difference in the Ultimate Tensile Strength (UTS) of either variety; the fibre-cored type having about 7% less UTS. However, the manufacturer of the hand press tool, Nicopress, which was used to make the swages, confirmed that it was never intended for use on fibre-cored cable because the tool compresses the fitting down to a pre-determined dimension. The greater compressibility of the fibre core would mean that the copper fitting does not form itself around the outer strands as was intended. This was confirmed when several unbroken swages from G-MYVW were sectioned (see Figure 4).

Section through an unfailed swage, showing poor grip of the cable strands by the ferrule. Note that the fibre core is not readily apparent (although present) and that the grey material filling the voids is cyanoacrylate adhesive, applied to stabilise the assembly during sectioning

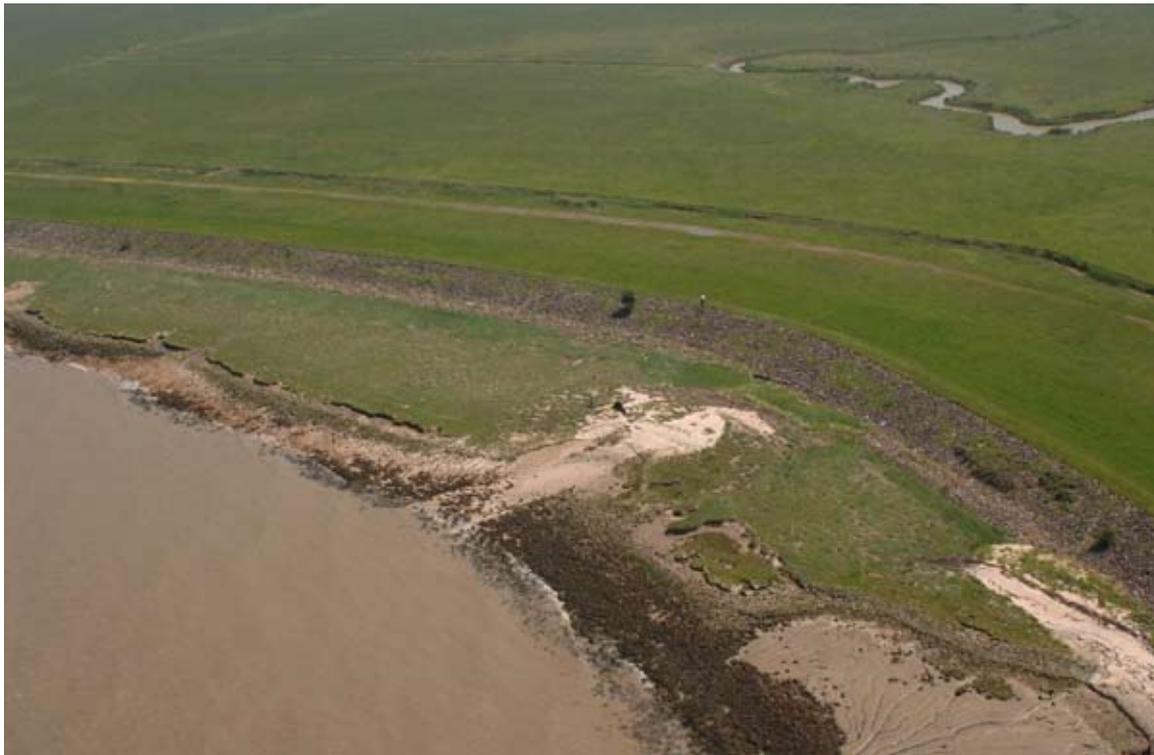
**Figure 5**

It transpired that the microlight school's chief instructor had almost certainly flown over the accident site during his initial search but the black and yellow upper wing surface and pilot's dark green flying suit made the site relatively inconspicuous from the air (see Figure 5). Manufacturers now use white as the default colour for the upper wing surface but bright clothing and reflective strips would also improve visual conspicuity. Some microlight flying schools advocate the carrying of a switched-on mobile telephone in order to provide a signal for rescue services to use should incapacitation prevent a call being made. This accident demonstrated that a mobile telephone signal alone cannot be relied
