Avid Speedwing (Modified), G-FOLD

AAIB Bulletin No: 8/2003

Ref: EW/C2002/08/02

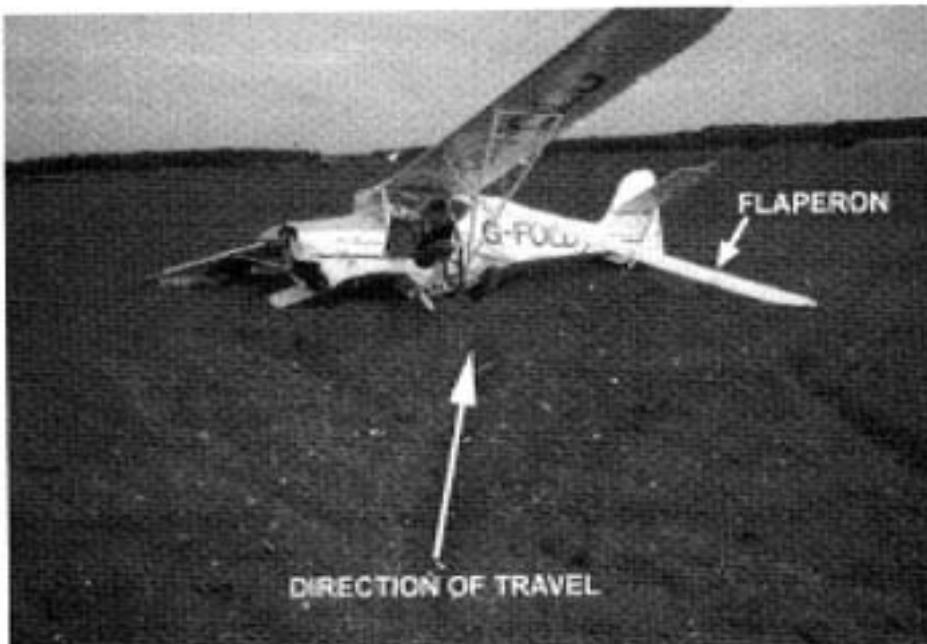
The impact marks in the ploughed field indicated that the aircraft had struck the ground in a left wing low attitude, with approximately 20 to 30 degree left bank. The aircraft had then yawed to the left and impacted travelling sideways. The sideways motion caused the right wheel to collapse underneath the fuselage and it had formed a track in the field along the direction of travel (see Figure 1). The direction of travel of the right wheel track was 151°M. The aircraft is estimated to have impacted at a speed of between 50 kt to 70 kt and travelled a distance of 25 metres along the ground. The right wing appeared to have dug into the soil, collapsing the wing tip, and absorbing some of the impact energy. Fortunately, the vertical impact was not sufficient to cause any spinal injury to the pilot. The tailwheel had bent to the left and dragged through the soil producing another track. The left wing was undamaged apart from slight rub and soil marks where the left wing tip had grazed the soil. The left wing aft lift strut threaded rod attachment had fractured. The left wing struts had also buckled forwards. The left flaperon had detached from the wing, but was still attached to its control rod - it was probably torn off when the left wing tip touched the ground. The right flaperon had detached and was buckled. It had separated from its control rod as the right wing had dug into the ground.

Figure 1 Accident Site

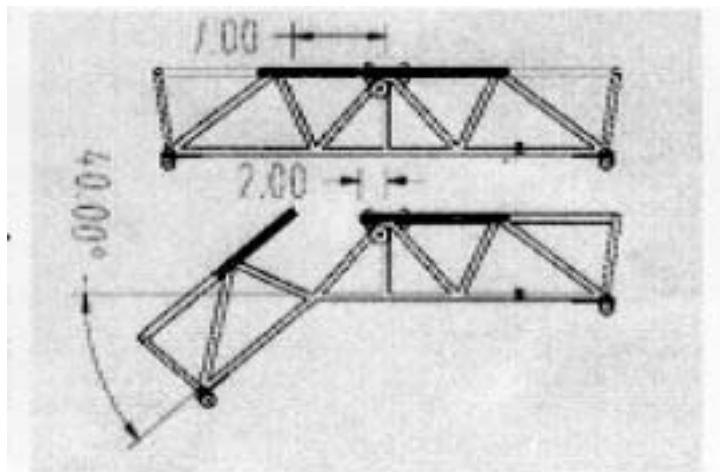
The most extensive damage to the fuselage structure was to the landing gear truss as shown in Figure 2. The upper cross tube had fractured as a result of the sideways load on the right gear forcing the gear to fold underneath the fuselage. The cross tube is normally hollow but the fracture revealed that two steel rods had been inserted. There was also evidence of a weld repair to the cross tube. It became apparent that, on a previous occasion, this cross tube had probably been bent during a hard landing and that it had been straightened and steel rods inserted during the repair. No entry regarding

this repair was found in the aircraft logbook and it was ascertained that it was not a PFA-approved repair scheme.

Figure 2 Diagram of truss with steel rod insert
(looking aft)

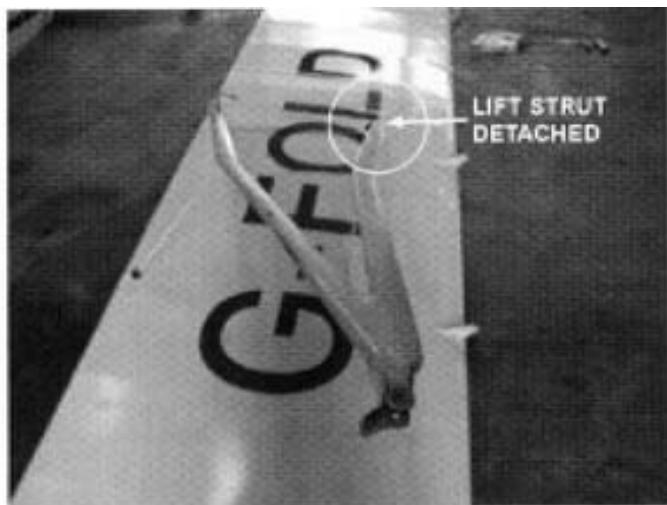
The tail structure of the aircraft was relatively undamaged, apart from the right aft corner of the elevator that was bent on impact. The right wing tip was extensively damaged as it had dug into the soil on impact. The right wing forward spar pickup had also fractured allowing the wing to sweep forwards. The right wing lift struts were undamaged. Although the left wing, apart from the flaperon, was not damaged the left wing aft lift strut had detached and both struts had buckled (see Figure 3).

Figure 3 Buckled Left Wing Struts (aft strut has detached at wing end)

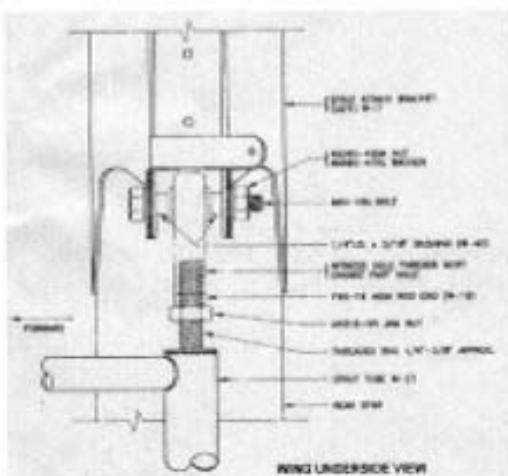
Figure 4 Left Wing Aft Lift Strut Attachment

The left wing aft lift strut is attached to the wing via a threaded rod and an adjustable eye end (see Figure 4). The strut had fractured at the threaded portion of the steel rod (see Figure 5).

The lift strut attachment design permits the wing twist to be adjusted after the aircraft has been built to eliminate any lateral asymmetry. The right wing aft lift strut does not have an adjustable rod end. It was not readily apparent that this failure had been caused during the impact and therefore the fractured rod was sent to a metallurgist for examination.

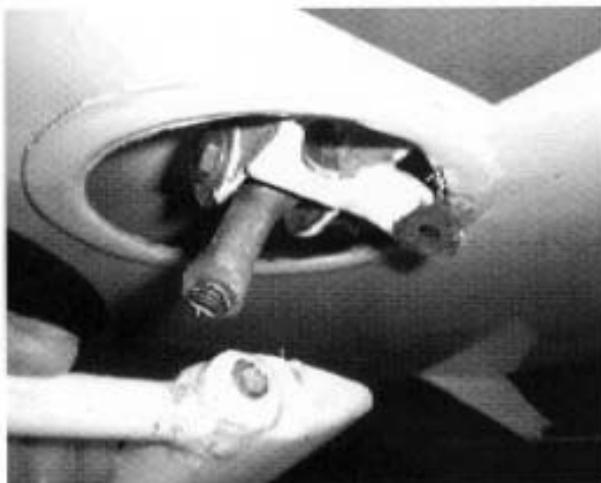
The left wing aft lift strut is attached to the wing via a threaded rod and an adjustable eye end (see Figure 4). The strut had fractured at the threaded portion of the steel rod (see Figure 5).

Figure 5 Fractured left wing aft strut

The metallurgist concluded that the fracture had occurred as a consequence of overload bending and that this had resulted from the application of high compressive loads. He also noted that the threaded rod had bent plastically and that vibratory loads had been applied during the bending, thus causing cyclic changes in the rate of separation. However, he ruled out fatigue and corrosion as possible causes of this fracture. Further examination showed that the rod had been manufactured from low carbon rolled steel bar and that the threads had been cut, rather than rolled. A Vickers hardness test gave a value of approximately 300 HV(10), which corresponds to an approximate tensile strength of

As a result of the investigation into this accident, the Popular Flying Association (PFA) issued an Airworthiness Information Leaflet (MOD/189/007) on 26 September 2002. This leaflet required that the lift strut threaded attachment rods on all Avid aircraft be inspected within five flying hours from receipt of the leaflet, or at permit renewal, whichever was soonest. The PFA has also promulgated this information to the Experimental Aircraft Association (EAA) in the USA.

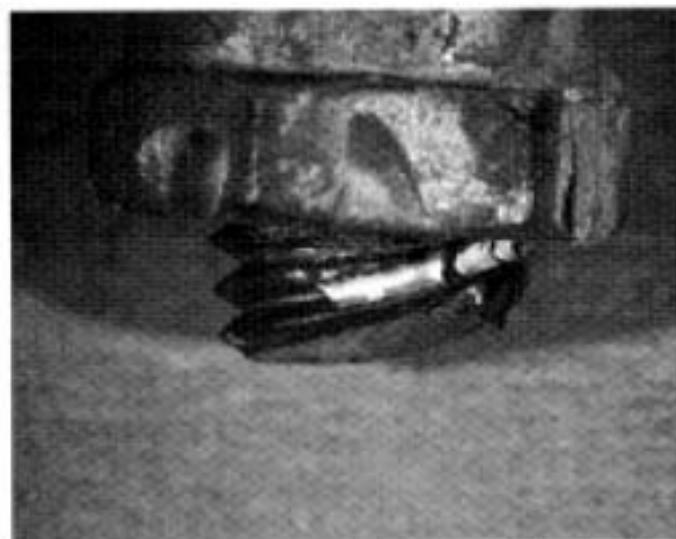
925 Newtons (N) per square millimetre, which is typical for this type of material. Figure 6 shows a close-up of the fracture at the wing attachment end. The rod had bent inwards towards the fuselage.

Figure 6 Close-up of bend in fractured rod (bend is inwards towards fuselage)

The lift strut is effectively pin-jointed at both ends. Therefore, the flight loads can only induce either a tensile or a compressive load in the threaded rod. However, this rod had failed in bending. The rod had therefore either failed due to impact loads or it was bent prior to flight. If the rod had been bent prior to flight, then a compressive load acting during the takeoff roll could have caused the rod end to buckle, resulting in a bending failure.
