Ref: EW/G90/08/30

Aircraft Type and Registration: Piper PA-34-200T, G-BEHU

Nature of Damage: Fire damage to aircraft nose

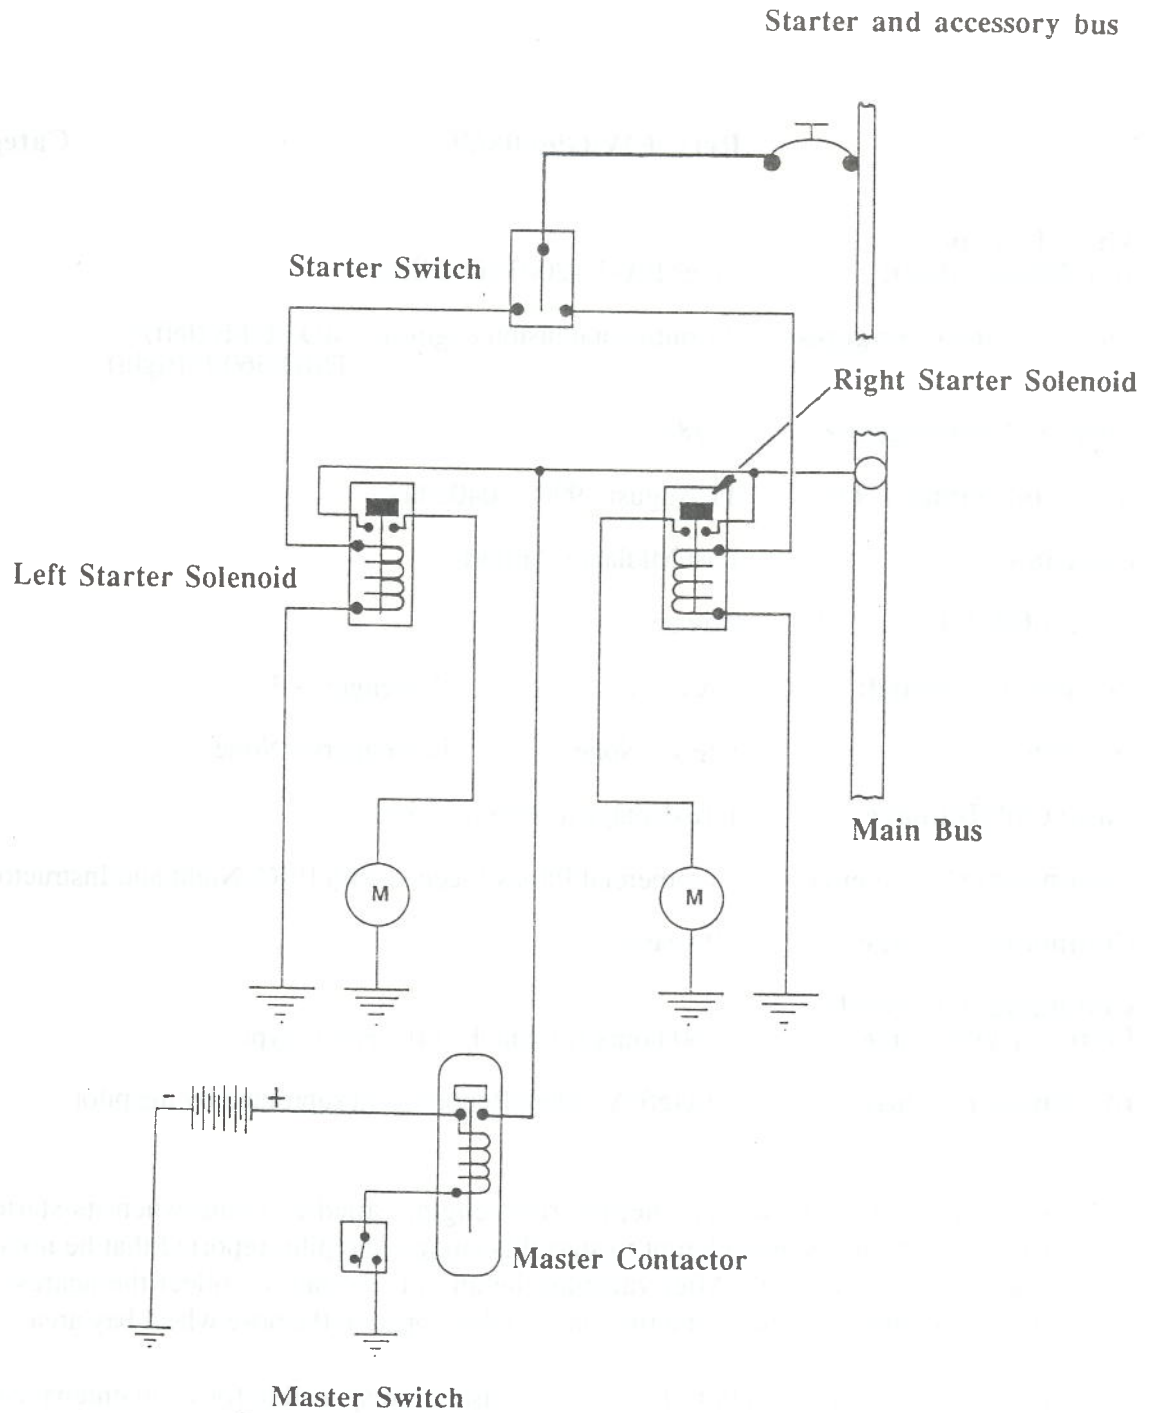
FIGURE 1

A simplified version of the engine starter circuits is shown at figure 1 and, as may be seen, each motor is fed, in turn, from the main electrical busbar without the protection of a fuse or circuit breaker. Thus if the starter solenoid is energised for a period of time, any points of electrical resistance in that circuit will generate heat to a greater or lesser extent, dependant on the level of resistance, as a result of the excessively high current that can be delivered from the battery with such a stalled starter motor. In this situation it is likely that the internal resistance of the battery itself would be of most significance (typically 1 to 1.5 ohms), thereby generating heat internally and possibly inducing internal electrical "shorting" and consequent fire.
